PALM STREET WATER PLANT CONDITION ASSESSMENT

City of Huntsville

November 9, 2015

FREESE AND NICHOLS, INC.
11200 Broadway Street
Offices West, Suite 2332
Pearland, TX 77584
832-456-4700

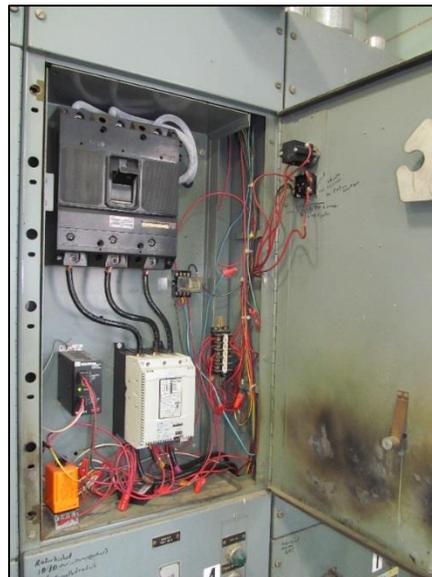
The Motor Control Center (MCC) was installed in the 1960s, has passed its life expectancy of thirty years, and is no longer supported by the manufacturer. Individual MCC components will no longer be available after they fail. Parts are replaced with comparable components that will fit within the shallow buckets and safety clearances are compensated to get the equipment into working conditions. Wiring inside the MCC is insulated with cloth, which loses its protective properties over time and subjects the equipment to faults. Past faults are evident within the MCC by the indications of carbon deposits on the interior walls. Inside the MCC are water lines used to monitor the tank water level. Water pipe installed inside electrical gear is no longer a good practice because of the ramifications of water leaking on electrical wires, busses and components.

Recommendation: Replace wiring and the MCC.

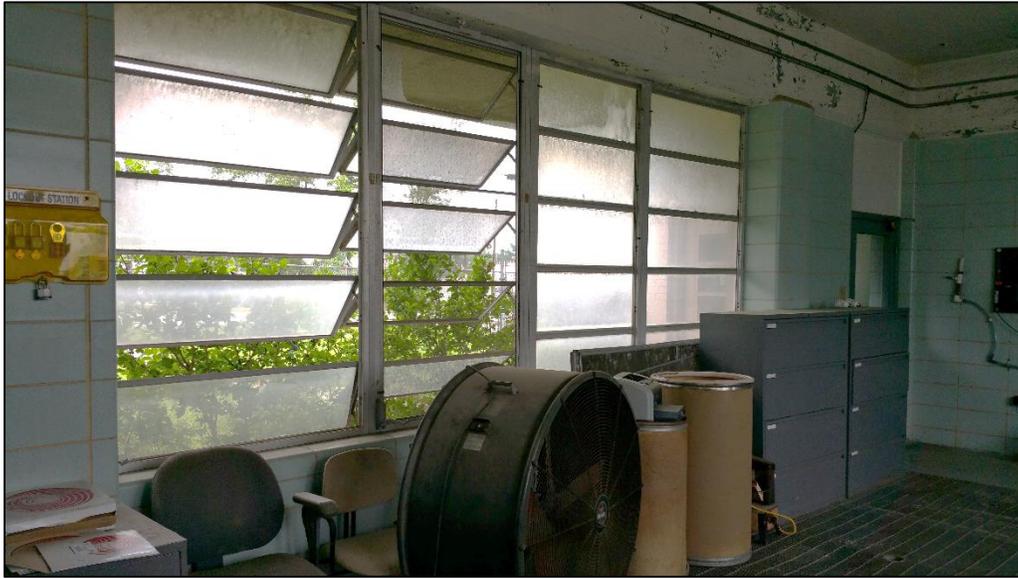
The HVAC in the old pump station consists of a single thermostatically controlled gas-fired unit heater for freeze protection, a floor portable rolling fan to circulate air, and operable windows. The single unit heater is in good condition, but the lack of redundancy and the lack of a permanent ventilation system lead to the overall HVAC condition being considered poor. The pump station has operated without a permanent mechanical ventilation system since it was built, so the impact of the lack of a ventilation system is low.

It is recommended that a second unit heater be added to the space for redundancy, to ensure that if one unit heater fails, the other can protect the space from freezing. It is also recommended that a dedicated mechanical ventilation system be installed. Although the pump station has been operating without one, a dedicated mechanical ventilation system would help increase the motor life by preventing overheating. Installing this system would involve removing a section of windows on one side of the building, and replacing it with a motorized combination louver/damper for air intake. On the opposite wall, a wall-mounted propeller exhaust fan would be installed for cross ventilation. The fan would be controlled by a thermostat so that when the room reached a certain temperature setpoint, the fan would turn on, the damper would open, and the system would ventilate the space until the setpoint was reached.

Recommendation: Install wall mounted exhaust fan, combination louver damper, and gas fired unit heater.

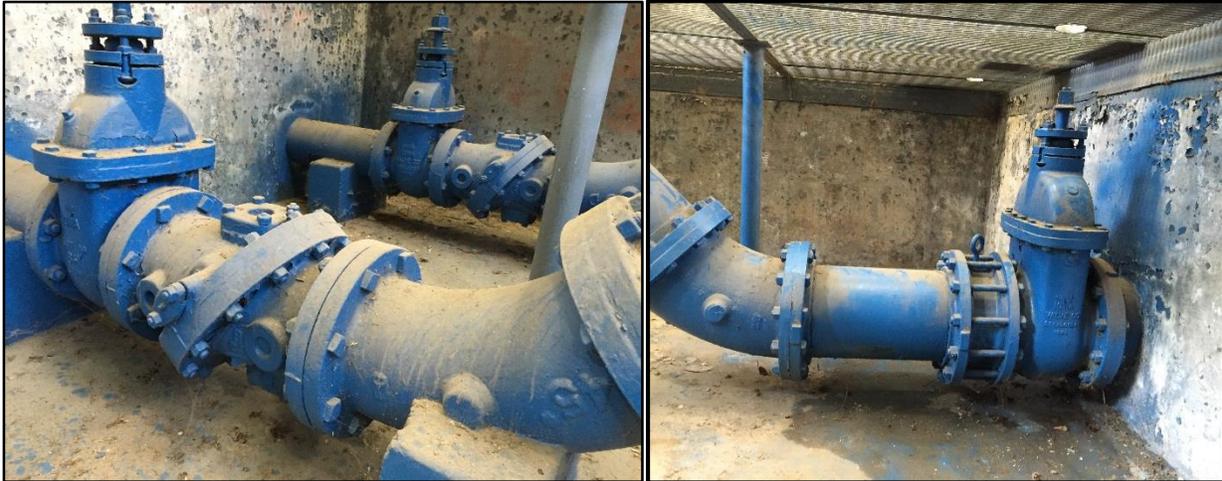
The piping at the Old Pump Station is original though it has been recoated since the original installation. The piping itself is in good condition but the coating has begun to crack and peel in some places. The pipe is made of ductile iron and will corrode if the coating is not repaired. The piping for the two larger pumps (Pumps 3 & 4) is not supported at the bends and valve the way the smaller pumps (Pumps 1 & 2) are supported.

Recommendation: Replace aboveground piping.

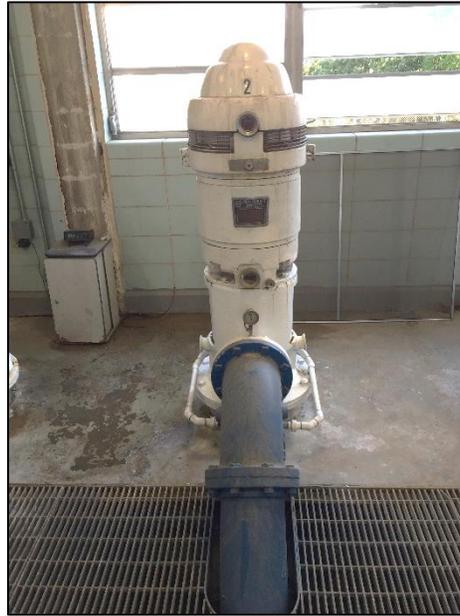
The pumps are Layne 12WMC and 12THC pumps originally installed in 1960. Each pump is in a different condition, but for the purposes of this report the overall condition has been given a 'poor' rating. Specifically, Pumps 1 & 2 are in poor condition, Pump 3 is in fair condition, and Pump 4 is in very poor condition. Below is a list of the notable issues with each pump.

- Pump 1
 - The discharge head is in good condition.
 - The coupling guard could not be removed.
 - The highest vibration reading is 0.918 in/sec rms, or seven (7) times higher than the HI limit.

- Pump 2
 - The discharge head is in good condition.
 - The coupling guard could not be removed.
 - The highest vibration reading is 0.297 in/sec rms, or two (2) times higher than the HI limit.

- Pump 3
 - The discharge head is in good condition.
 - The stuffing box is severely corroded and it appears the packing gland studs are gone.
 - The packing gland was not perpendicular to the shaft

- The highest vibration reading is 0.189 in/sec rms, slightly higher than the HI limit.
- Pump 4
 - The discharge head is in good condition.
 - The stuffing box is severely corroded and it appears the packing gland studs are gone.

Generally these pumps are seeing vibration well above the recommended Hydraulic Institute (HI) limit. The vibration was tested by Smith Pump Co. and can be seen in Appendix C. The coupling guards are recommended to be replaced due to the difficulty in accessing the pump shaft. Visual inspection of the pump shaft indicated significant corrosion as well as a leaking seal. The hydraulic results from the pump tests were not realistic due to the non-ideal placement of the strap on flow meter. There was no straight section of pipe with adequate length available to obtain an accurate flow reading. Since these pumps are original and given the observed corrosion and vibration issues, it is likely that the pumps are not running very efficiently. Additionally, any cast parts are not likely to be available if a repair is needed.

Recommendation: Replace all four pumps, due to age and unavailability of cast parts.

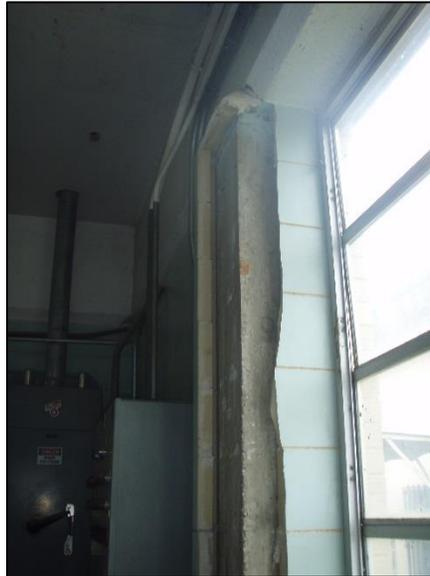
The interior face of glazed tile is cracked at two columns on each side of one window. It appears the glazed tile may have become load bearing which resulted in cracking. Also, the glazed tile is cracked in one corner by an interior door. Exterior brick veneer is in good condition. Some minor rust spots were observed on steel lintel angles supporting brick veneer over windows and doors. The paint on exposed concrete beams is peeling and flaking.

No signs of distress in the concrete beams and columns was observed.

Recommendation: Replace broken glazed tile and repaint.

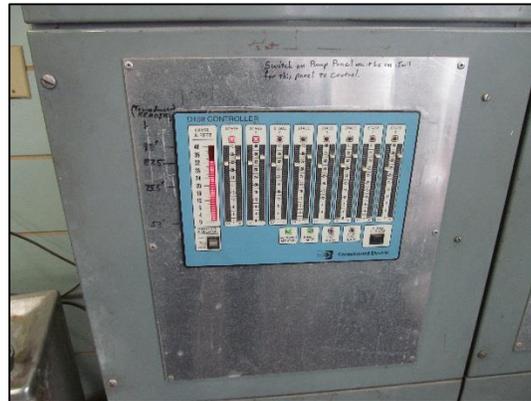
A pump controller is mounted to the front of an MCC door and is an older technology. The pump controller is used to automatically control the pumps based on level in the tanks. The manufacturer no longer supports the current controller and past repairs required the plant to send the controller to a third party repair service. The company supporting repairs has recently stopped repairing similar controllers for the lift stations. A manual control panel for the old and new pump station is located near the MCC and the pushbuttons, lights, and wiring needs to be updated for proper documentation. Over the years, repairs and modifications have not been documented and future repairs can become problematic to troubleshoot.

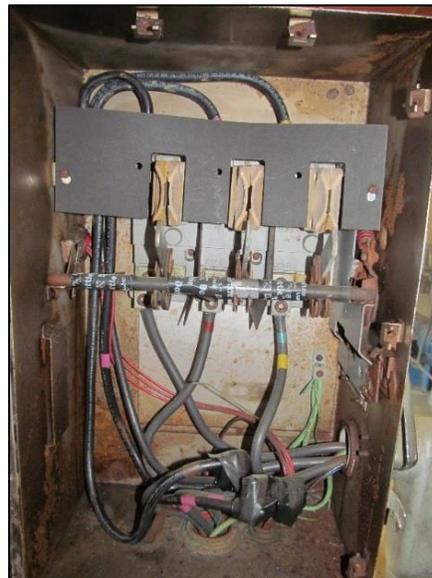
The Motor Control Center (MCC), installed in the mid-1980s, has passed its life expectancy of thirty years and parts are not readily available. An infrared camera was used during the site visit and temperatures indicate the equipment is operating within manufacturers specifications. A few hot spots were detected at wire terminations which can be corrected by the City’s electrician. Although the infrared camera is used to help determine the operating temperature of the equipment, failures can occur due to other protective characteristic changes due to age.

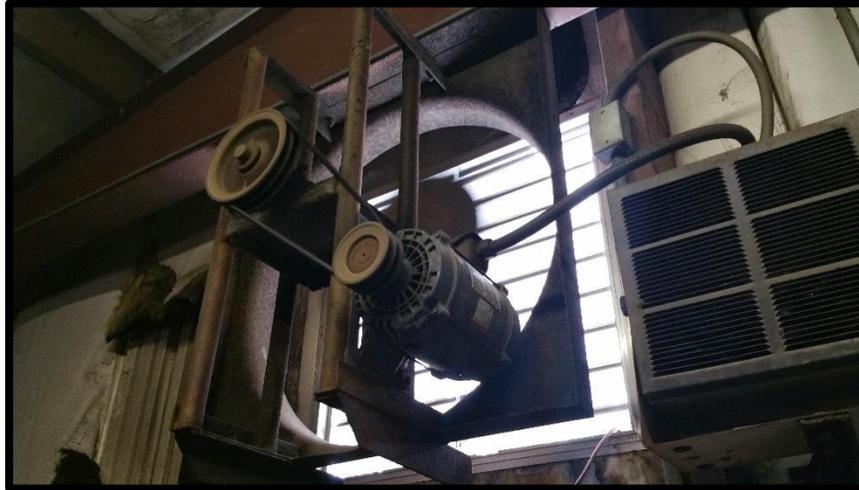
The current HVAC system consists of a wall-mounted propeller exhaust fan, two wall-mounted gravity dampers, and a single electric unit heater. The ventilation system in the new pump station is operable, but in need of repair.

The exhaust fan is nearing the end of its useful life and should be replaced. Included in the fan replacement, should be a wall-collar, OSHA guards, and a weatherhood. The gravity dampers in the doors allow water penetration and should be replaced with combination louver/damper rated for wind-driven rain. The electric unit heater, used for freeze protection in the space, is nonfunctional and should be replaced. It is also recommended that a second unit heater be added for redundancy; this would insure that if one unit heater was to fail, the other would protect the pipes from freezing.

It is recommended the exhaust fan should be replaced immediately. Also, the grille high in the wall should be replaced with a properly installed industrial grade wall-mounted louver.

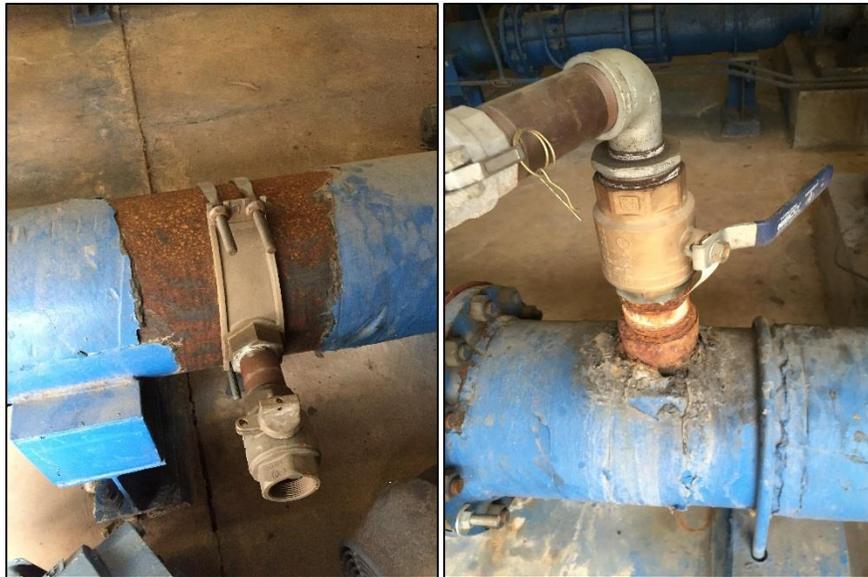
The piping at the new pump station is steel and is in fair condition. There are a few segments where taps have been made or other work done on the pipe that have removed the coatings and have allowed for significant corrosion, specifically on Pump 1. There are also a few sections of pipe that have been damaged as evidenced through visible dents in the pipe. The suction piping does not follow HI standards due to the eccentric reducer being located too close to the pumps.

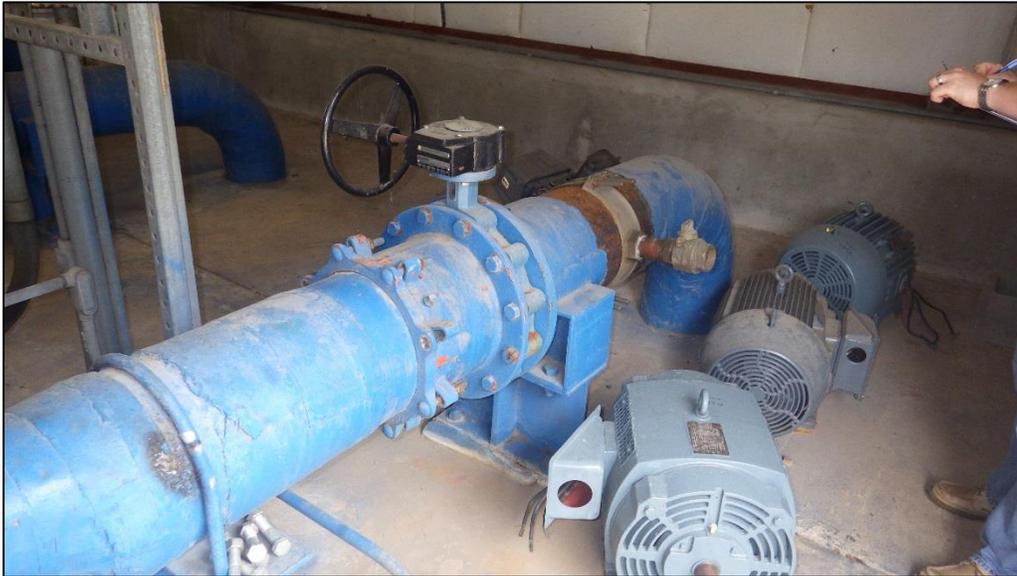
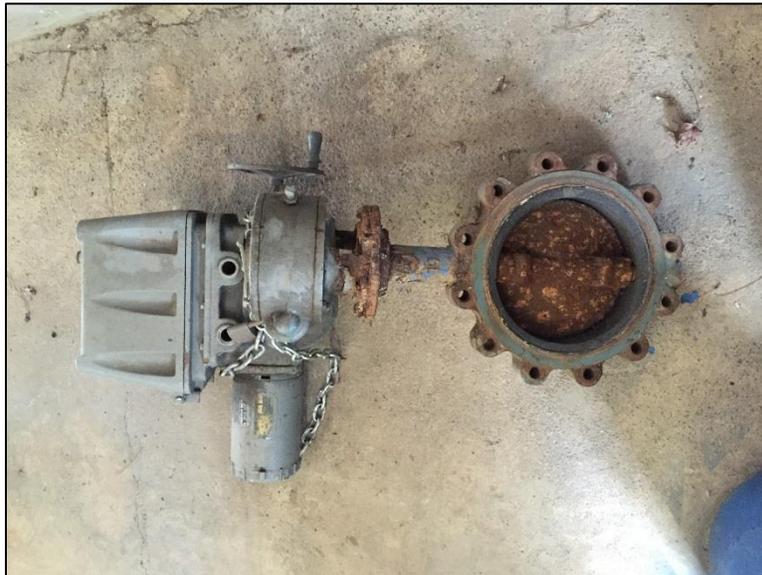
Butterfly valves are currently utilized for both the suction and discharge sides of the pump. Some noise was observed by the upstream butterfly valve, which indicates turbulent flow and the potential for cavitation. Additionally, an older valve that had been pulled was still on site and showed evidence of significant corrosion. Flow characteristics through the pumps could be improved if the upstream butterfly valves were replaced with a full port valve.

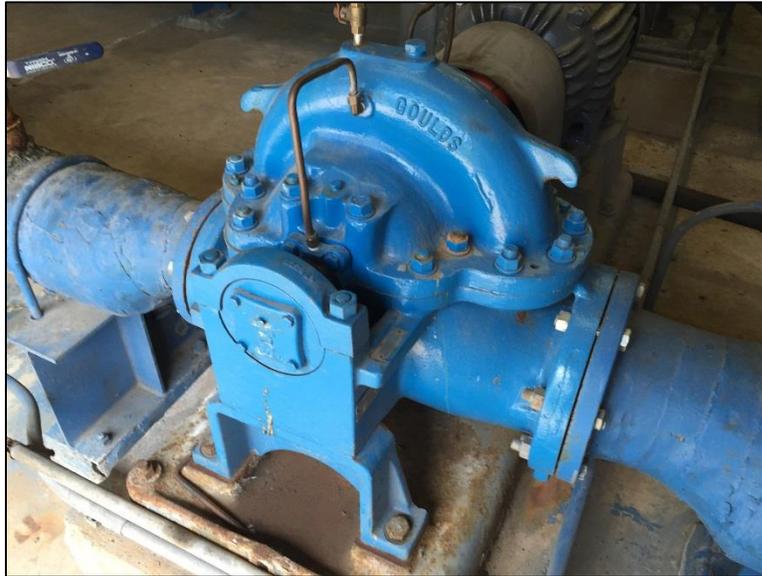
Plant operators have indicated that these pumps have given them more difficulties than the pumps at the Old Pump Station. It was noted by Smith Pump Co. that several of the pump alignments were off. Most of the pumps had low vibration except for Pump 4 which was close to the HI limit but still below it. Pump curves were not available for pumps 2, 3, and 4, though the hydraulic performance appeared to be close to the pump curve for Pump 1.

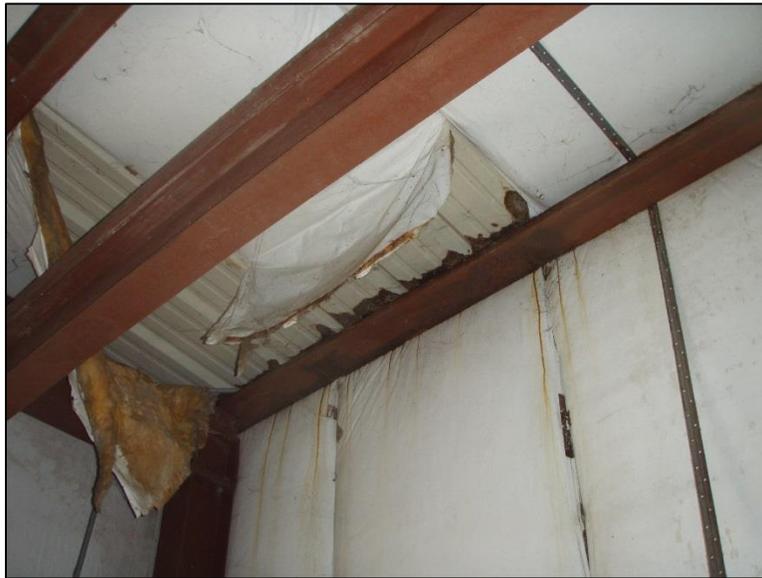
The electrical building is a pre-engineered metal building and is in good condition. There are minor dents on exterior face of metal wall panels.

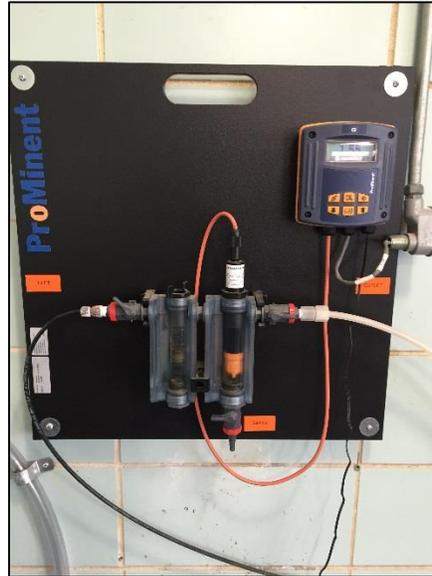
While the existing analyzer is in good condition, the City prefers to have a new chlorine analyzer at the new pump station similar to the ProMinent Chlorine Analyzer that was recently installed at the old pump station.

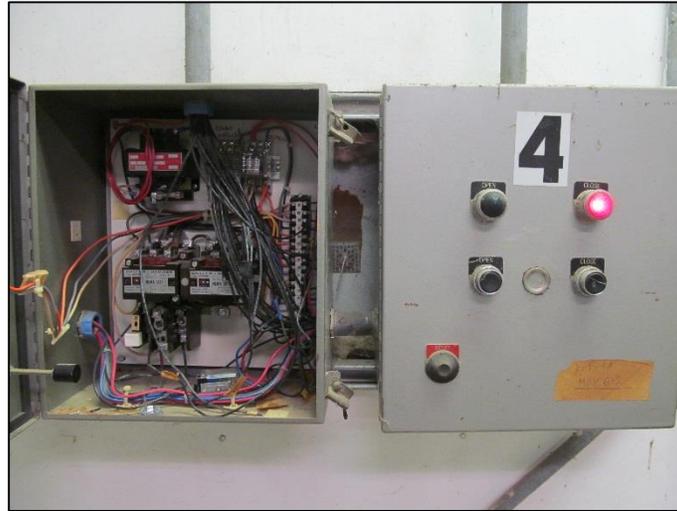
The pumps are controlled from relays in the old pump station. Control stations can wear out with use over time. Control stations can wear out over time. Replacement parts are readily available. Modifications to the controls for pump number 1 have left little documentation for wiring causing potential extended outages due to troubleshooting.

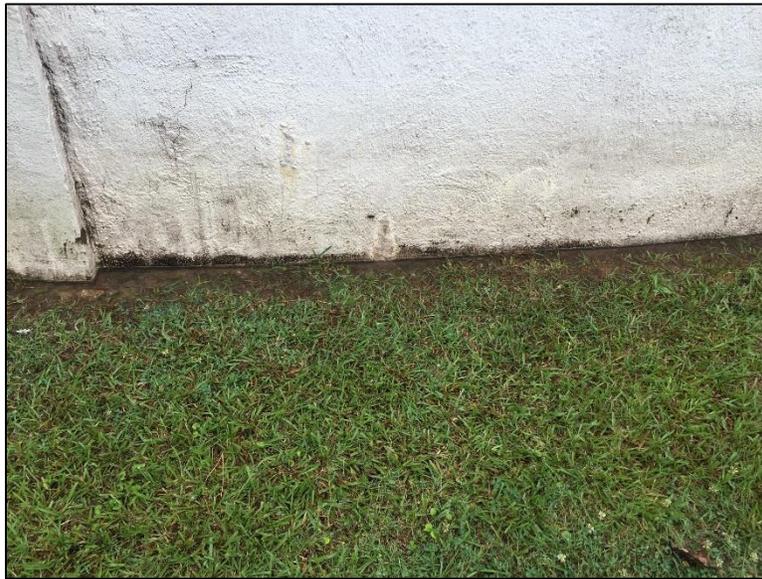
During the site visit it was observed that there was ponding in a few areas across the site, specifically, around the ground storage tanks and underneath the elevated storage tank. This is likely due to ground settlement after construction. While it does not appear to have caused any problems to date, it could allow for corrosion to begin at the base of the tanks.

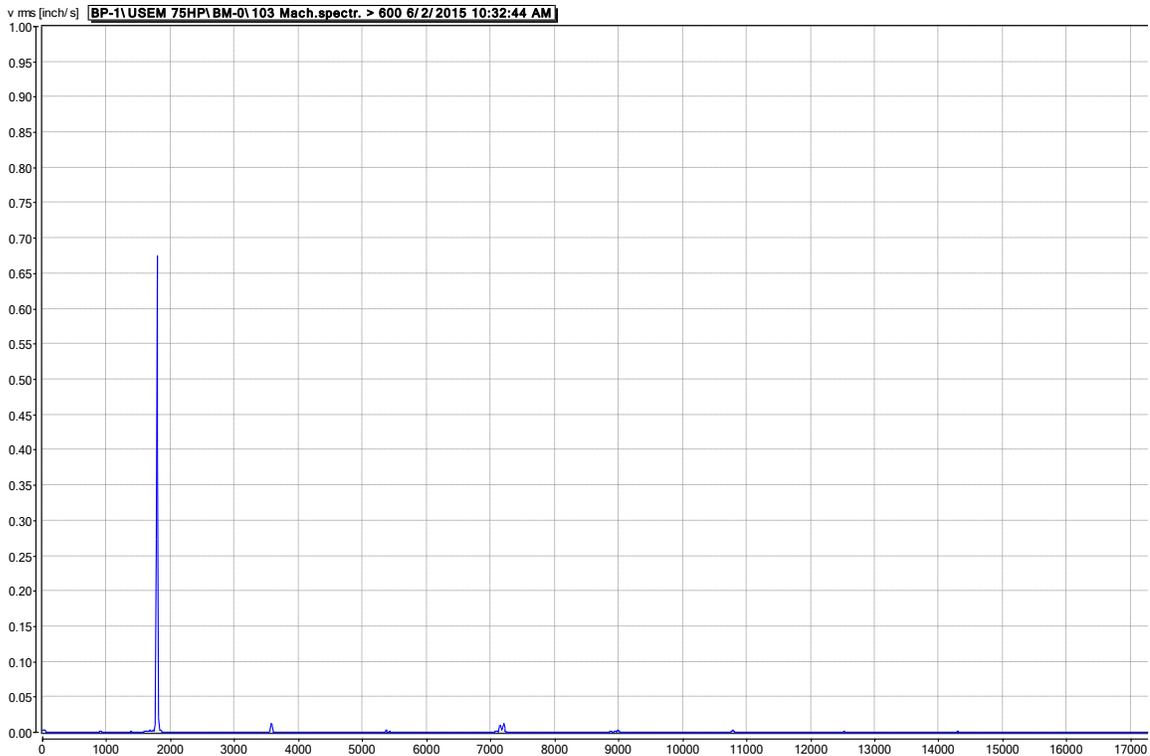
Figure 11: MB-0 Filtered Vibration, highest peak is 0.675 in/sec at 1,788 cpm (1X run speed)

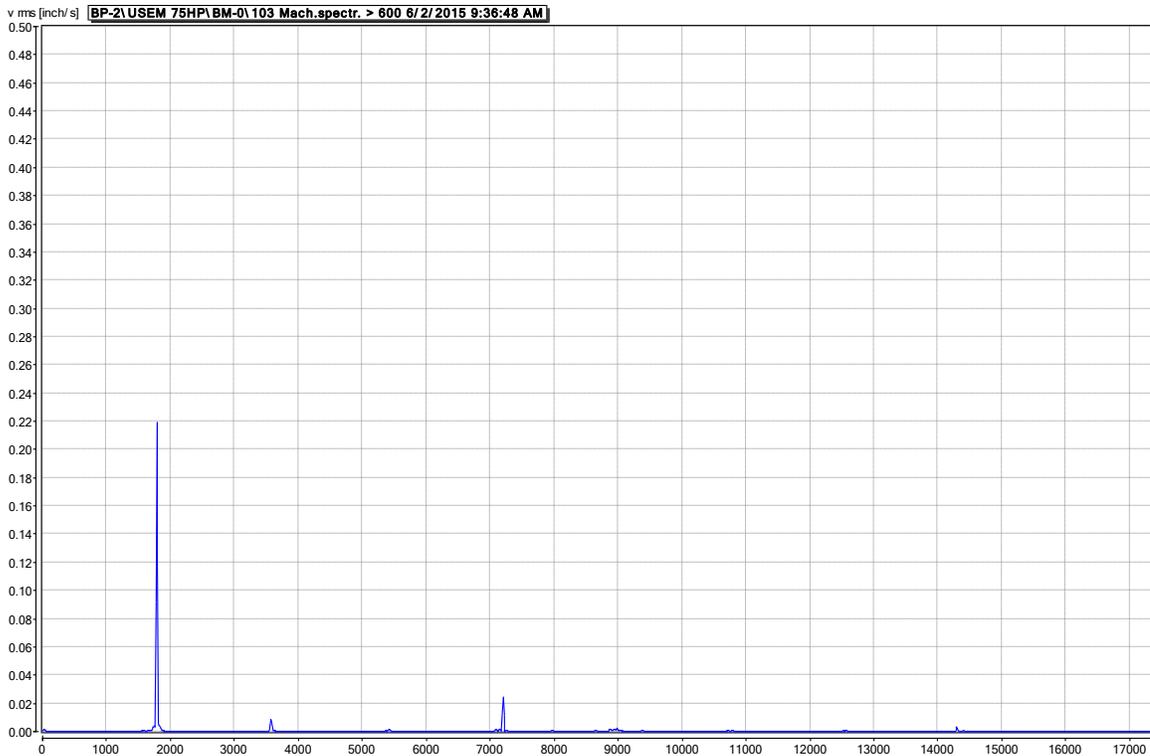
Figure 19: MB-0 Filtered Vibration, highest peak is 0.219 in/sec at 1,785 cpm (1X run speed) and the next highest peak is 0.025 in/sec at 7,200 cpm (4X run speed)

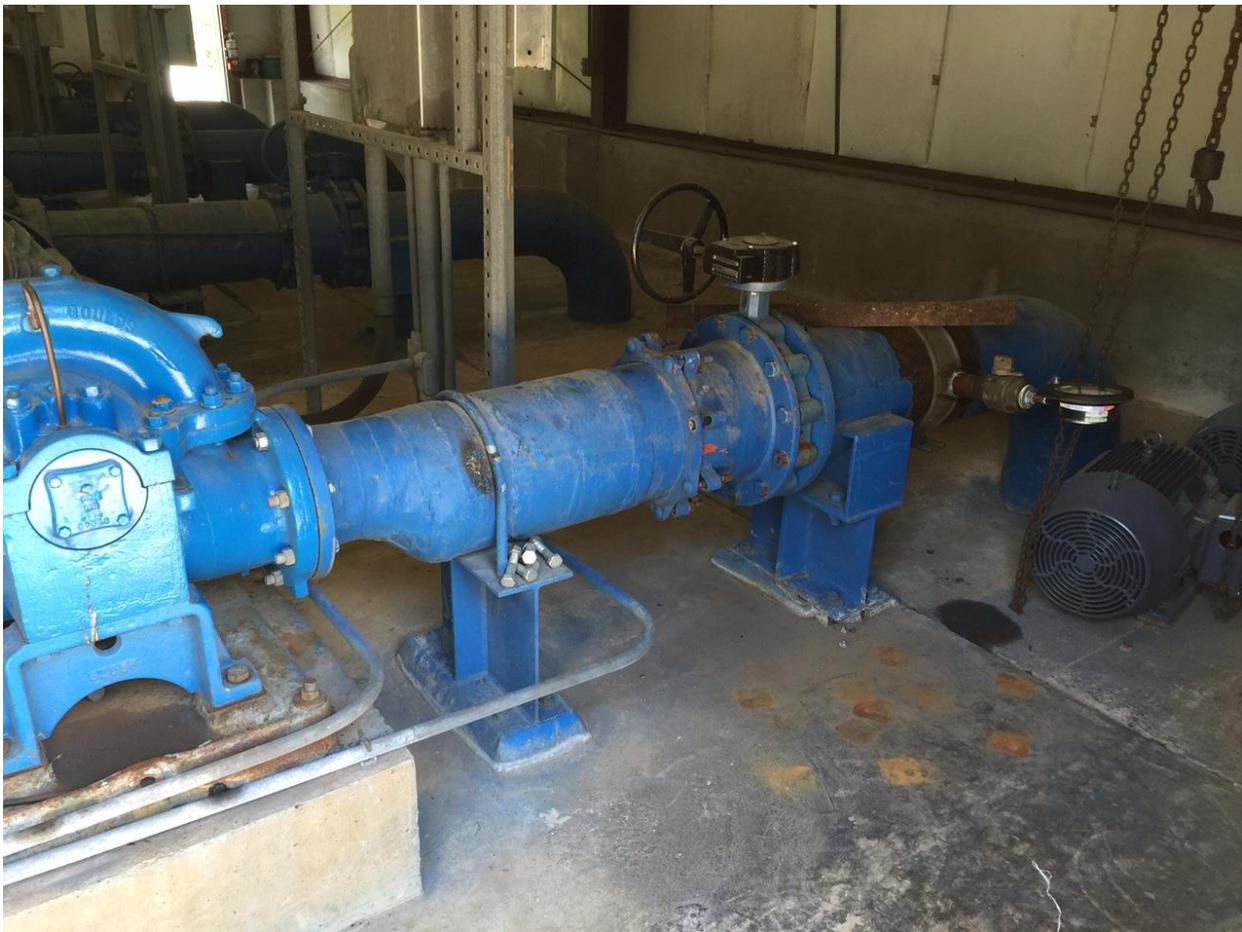
Figure 47: Suction Piping of Booster Pump #1

The eccentric reducer on the suction side of the pump is located too close to the pump, see Figure 47. This reducer should be positioned farther from the pump to ensure no cavitation or hydraulic issues.
