## **APPENDIX C**

### **Water System Field Testing Results**

**PROJECT:** Water and Wastewater Condition and Capacity Assessment Studies  
Spring Lake Water Plant Pump Testing

### Water and Wastewater System Condition and Capacity Studies

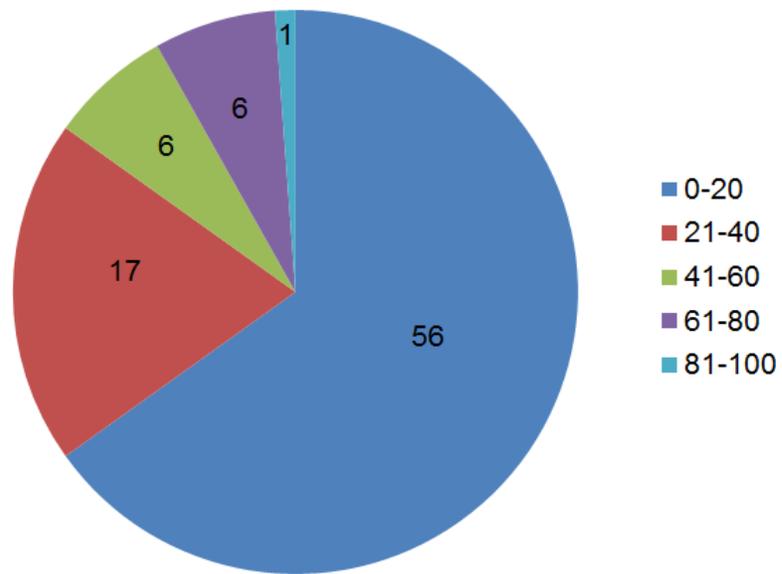
Figure 1: Total Manhole Inspection Scores

The individual scores and defects for each manhole are provided in the attached appendix. The highest priority manholes are Manholes 0087, 0364, 0366, 0104, and 0369. Manholes are scored on a 0 (best) to 100 (worst) system. Figure 1 displays the number of manholes within each score range.

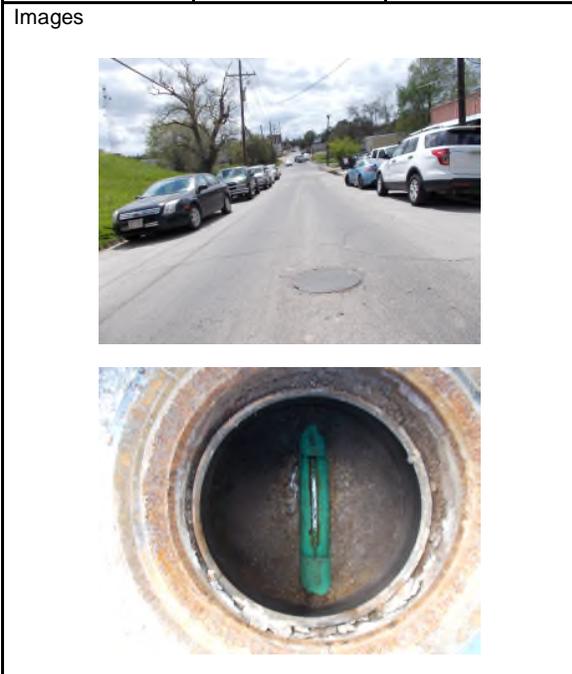
Defects		<i>Overall Score</i>
Cover Fit Tight		Total
Cover seal missing		<b>18</b>
Channel mortar missing moderate
