PALM STREET WATER PLANT CONDITION ASSESSMENT

City of Huntsville

November 9, 2015

FREESE AND NICHOLS, INC.
11200 Broadway Street
Offices West, Suite 2332
Pearland, TX 77584
832-456-4700

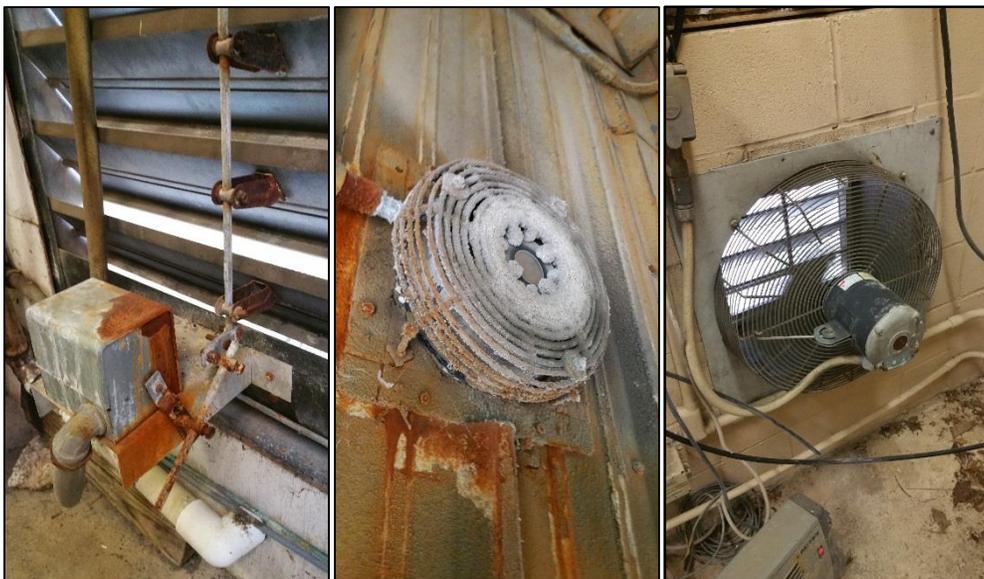
The ventilation system in the fluoride room consists of a wall-mounted exhaust fan, door mounted louver, and residential style grille installed in the wall above the door. The overall condition of the equipment is poor. The exhaust fan is highly corroded and almost no airflow is being allowed through. The grille above the door is not properly installed, is not the proper type, and allows water penetration

It is recommended the exhaust fan should be replaced immediately. Also, the grille high in the wall should be replaced with a properly installed industrial grade wall-mounted louver.

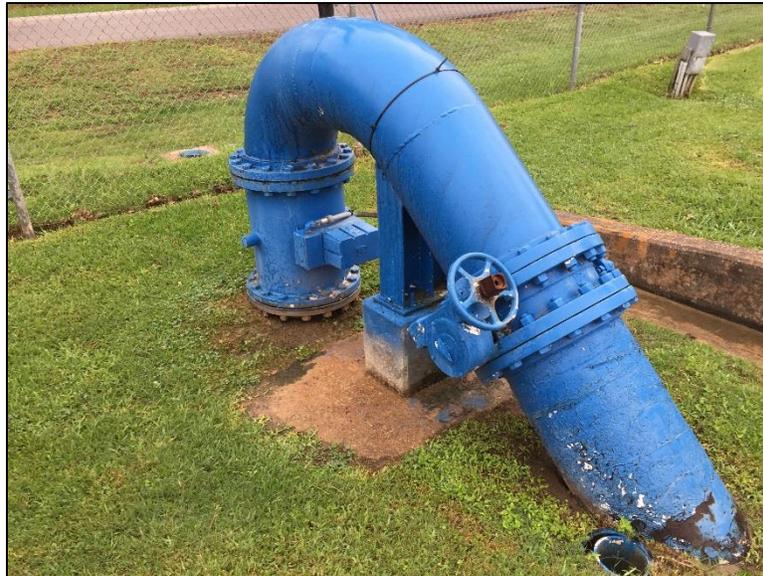
The flow meter on the discharge header of the New Pump Station is above ground in a vertical position directly downstream of a 135° bend. This does not meet the typical standard for mag meters which requires five upstream pipe diameters of straight pipe and two downstream pipe diameters of straight pipe. Relocating this valve to a straight section of pipe would provide more accurate readings for the flow

coming from the New Pump Station. However it is our understanding that the meter is calibrated annually and is achieving acceptable levels of accuracy.

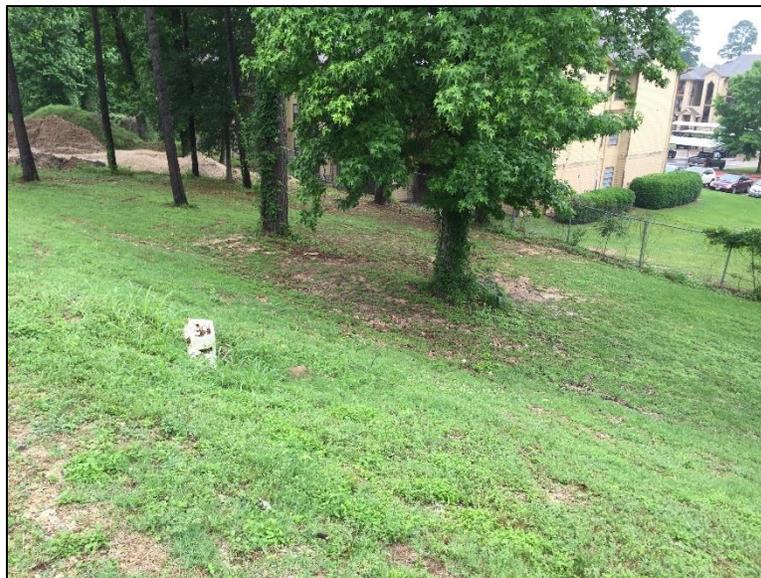
The existing tank overflows discharge on the north side of the plant on a slope away from the tanks offsite towards an apartment complex. Under normal circumstances any overflow water would still drain away from the apartment complexes but there is some risk of erosion on the slope. High flows or unforeseen circumstances may put the adjacent apartment complex at risk of flooding. The tank overflow piping could be extended to the northeast to discharge into the drainage ditch to mitigate this risk.

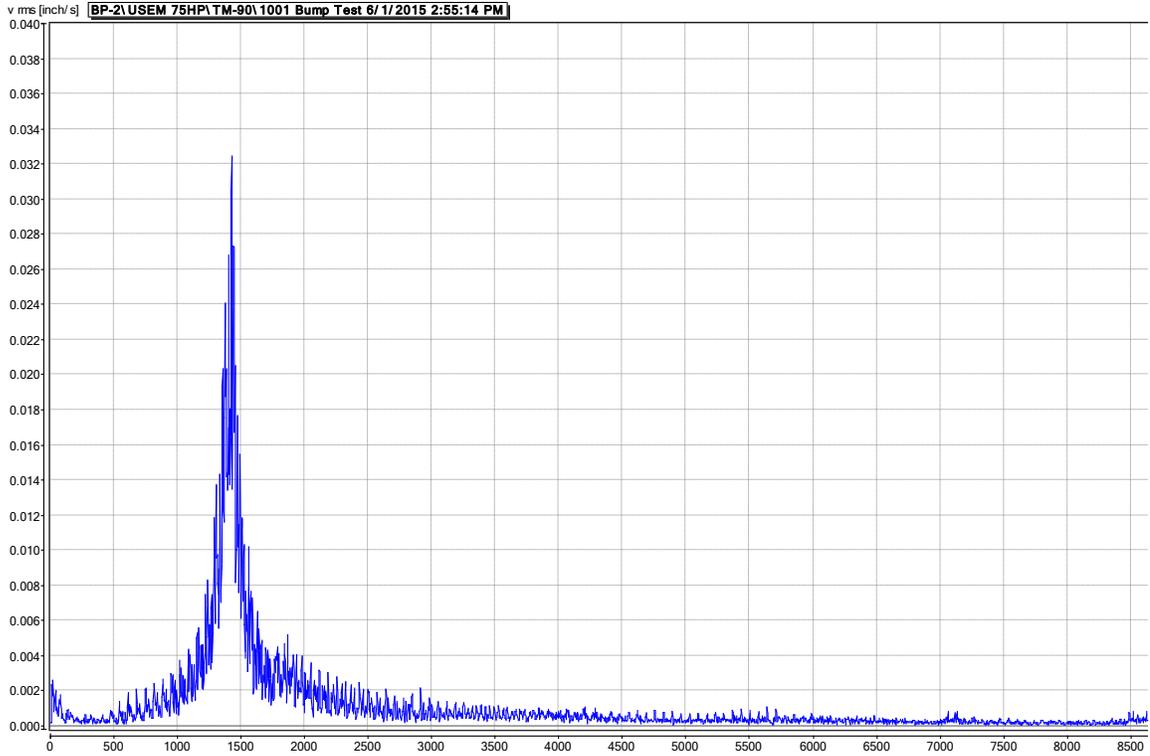
Figure 5: MT-90 Bump Test, Reed Frequency at 1,424 cpm, Motor Speed is 1,785 rpm

The reed frequency, as shown in Figures 5, is at 1,424 cpm 90 degrees to discharge which is 20% from run speed and should not cause any issues. The reed frequency, as shown in Figure 6, is at 1,789 cpm which is at run speed and will exacerbate and amplify any vibration.

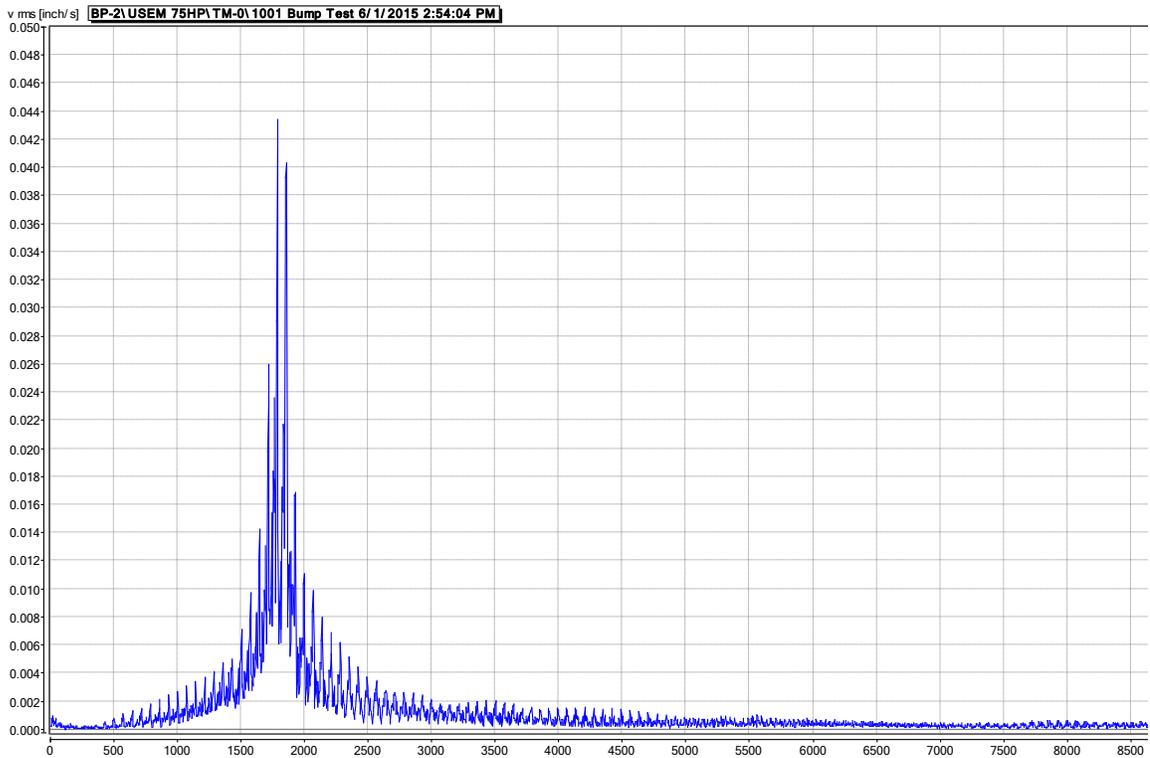
Figure 6: MT-0 Bump Test, Reed Frequency at 1,789 cpm, Motor Speed is 1,785 rpm

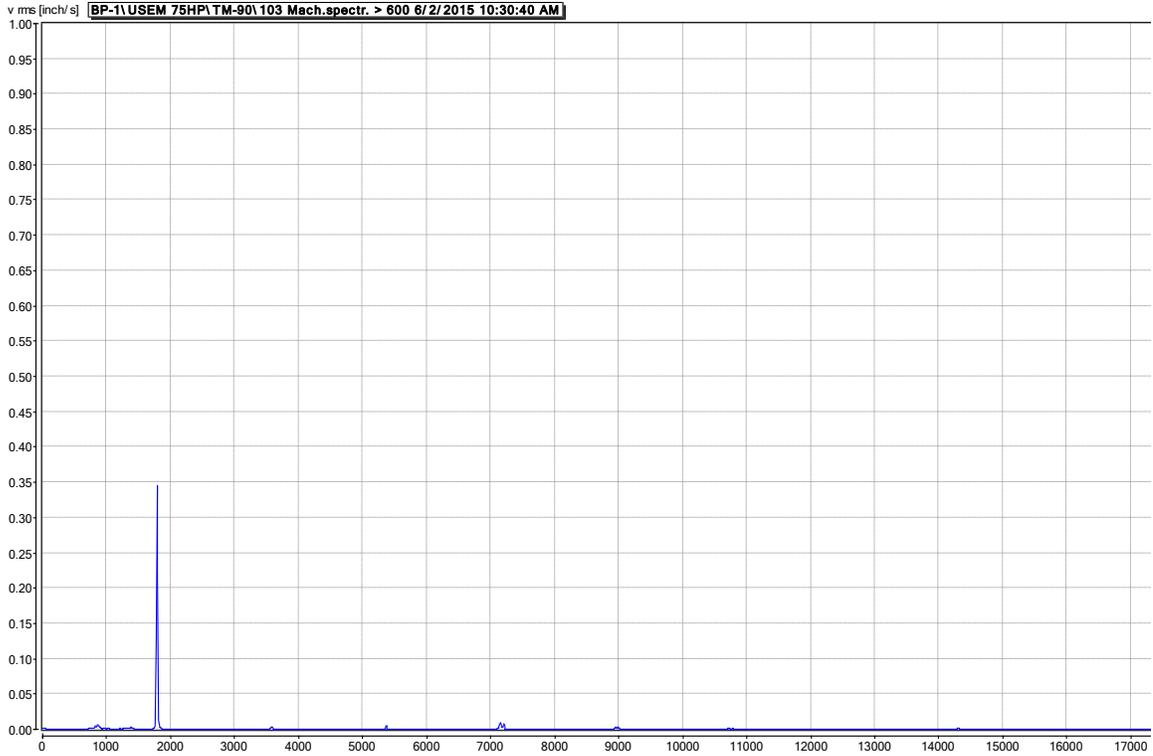
Figure 7: MT-90 Filtered Vibration, highest peak is 0.346 in/sec rms at 1,788 cpm (1X run speed)

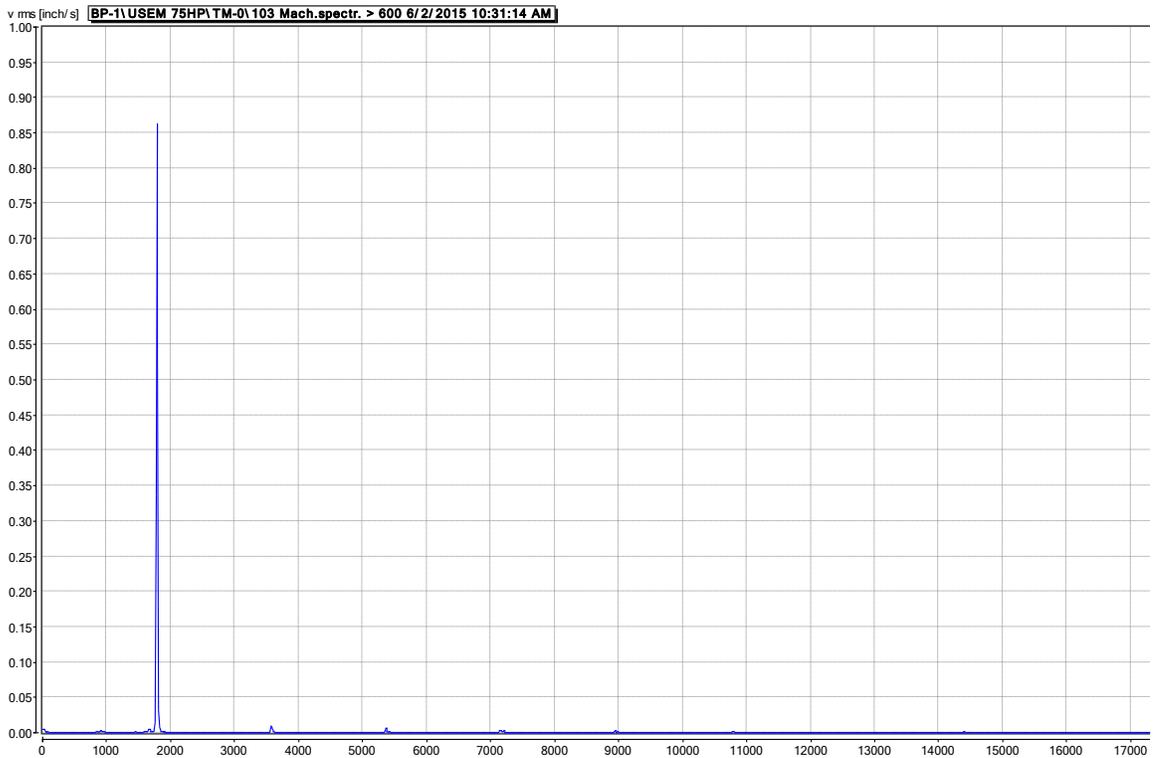
- Pump 1
 - The discharge head is in good condition.
 - The coupling guard could not be removed.
 - The highest vibration reading is 0.918 in/sec rms, or seven (7) times higher than the HI limit.

Figure 8: MT-0 Filtered Vibration, highest peak is 0.863 in/sec at 1,788 cpm (1X run speed)

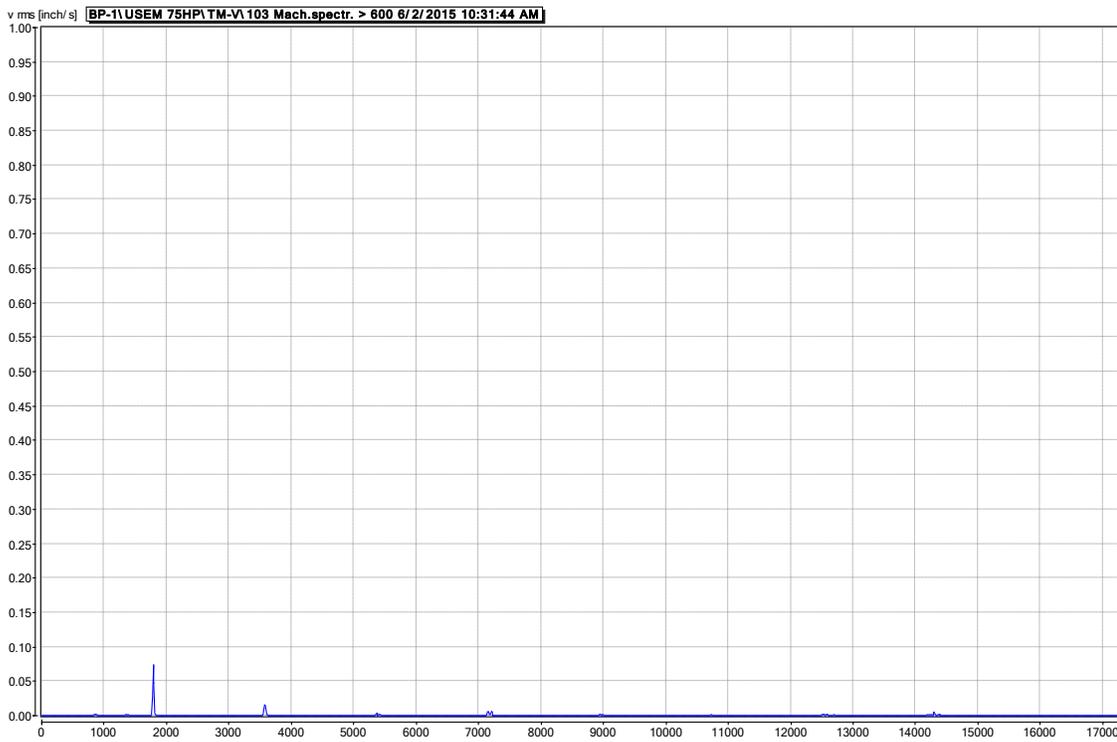
Figure 9: MT-V Filtered Vibration, highest peak is 0.074 in/sec at 1,788 cpm (1X run speed) and the next highest peak is 0.016 in/sec at 3,574 cpm (2X run speed)

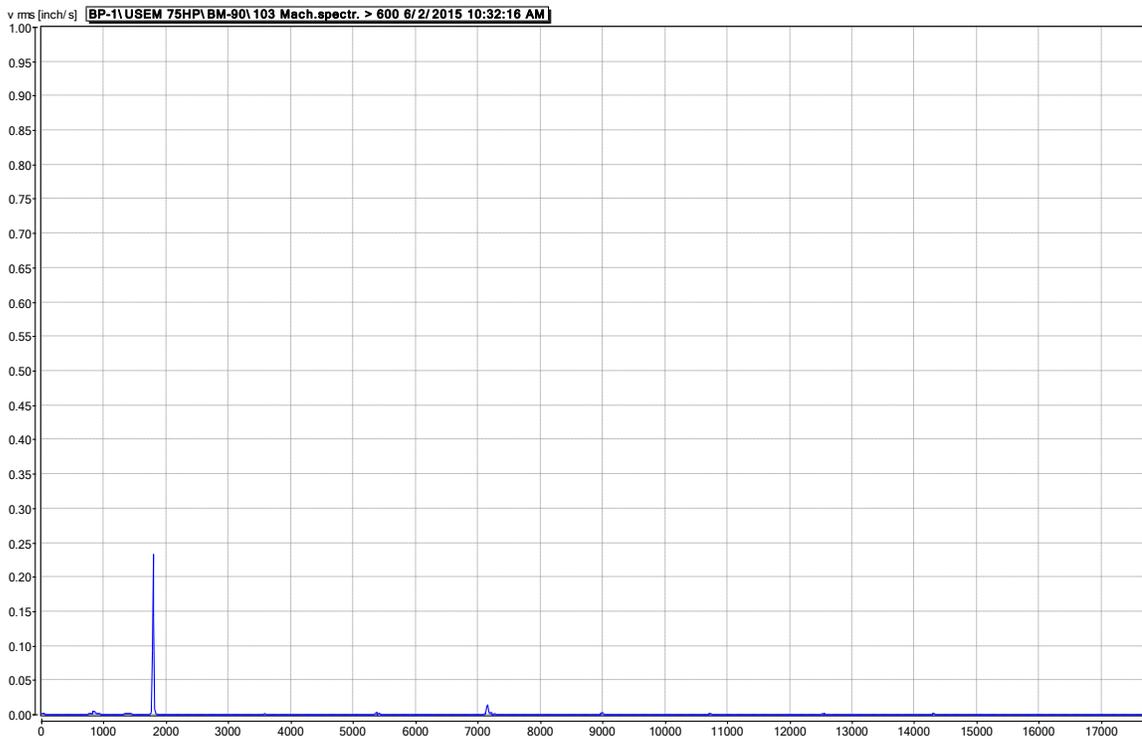
Figure 10: MB-90 Filtered Vibration, highest peak is 0.223 in/sec at 1,788 cpm (1X run speed), the next peak is 0.014 in/sec at 7,148 cpm (4X run speed)

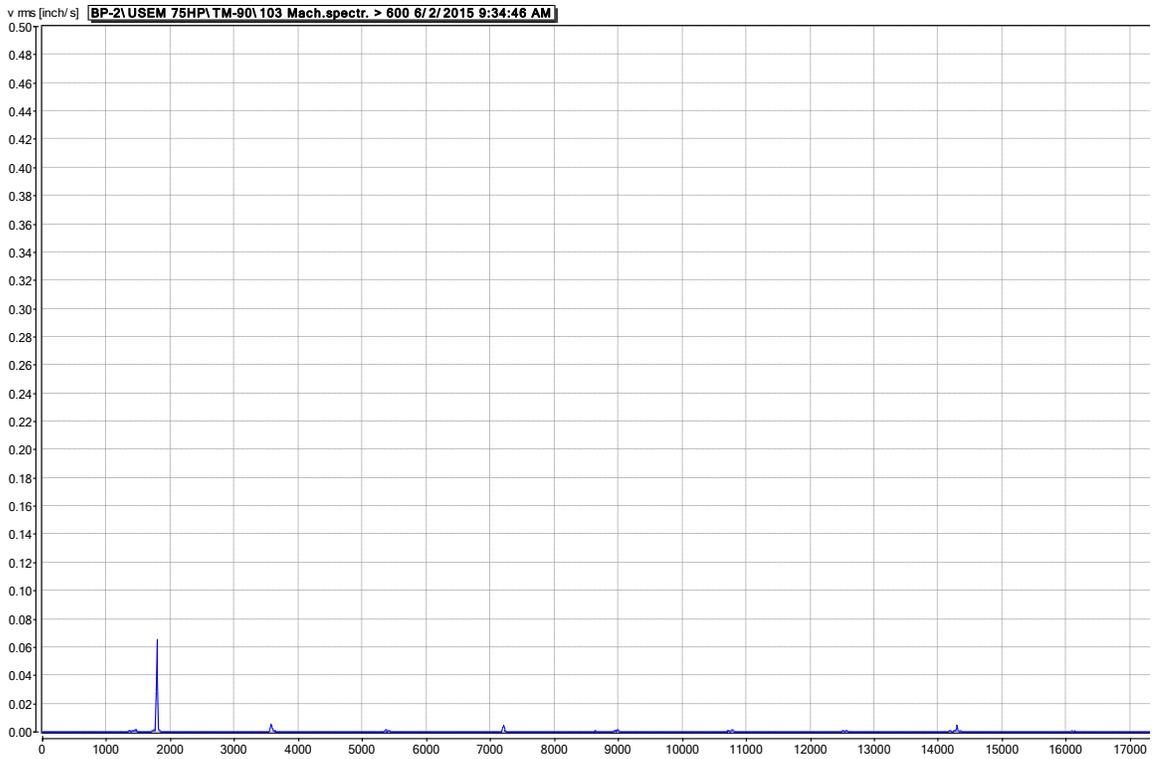
Figure 15: MT-90 Filtered Vibration, highest peak is 0.065 in/sec rms at 1,785 cpm (1X run speed)

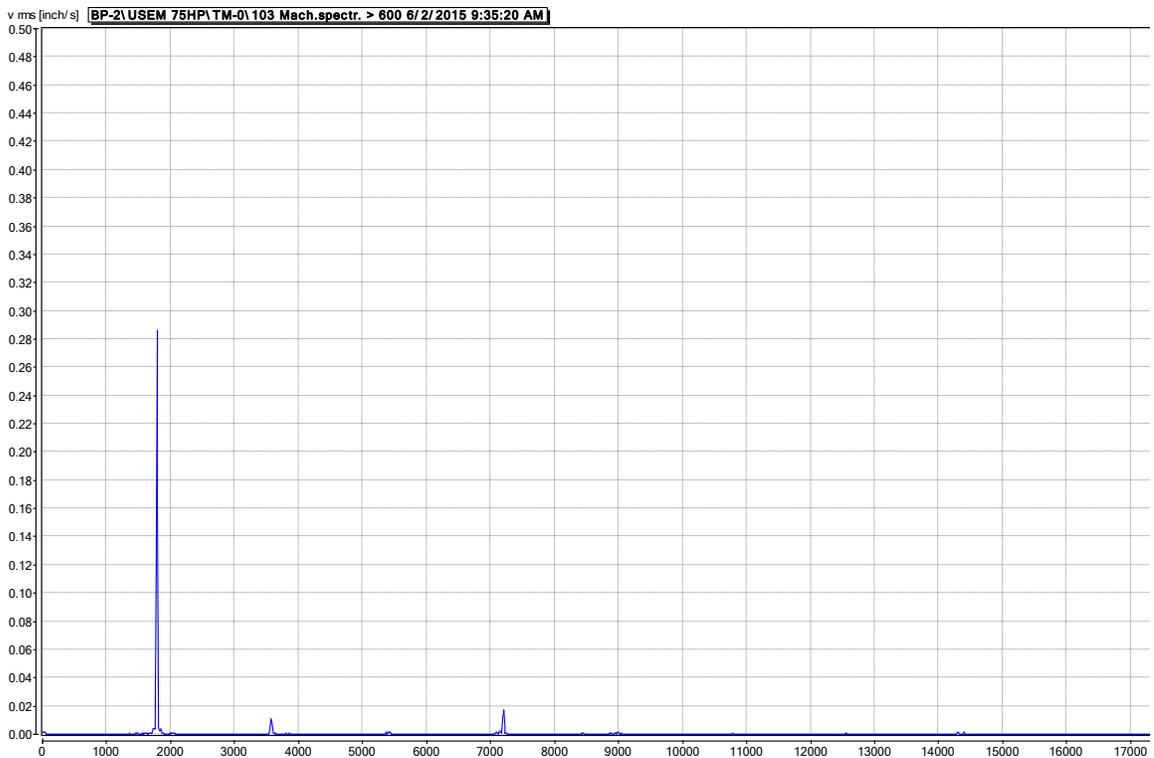
- Pump 2
 - The discharge head is in good condition.
 - The coupling guard could not be removed.
 - The highest vibration reading is 0.297 in/sec rms, or two (2) times higher than the HI limit.

Figure 16: MT-0 Filtered Vibration, highest peak is 0.286 in/sec at 1,785 cpm (1X run speed) and the next highest peak is 0.017 in/sec at 7,196 cpm (4X run speed)

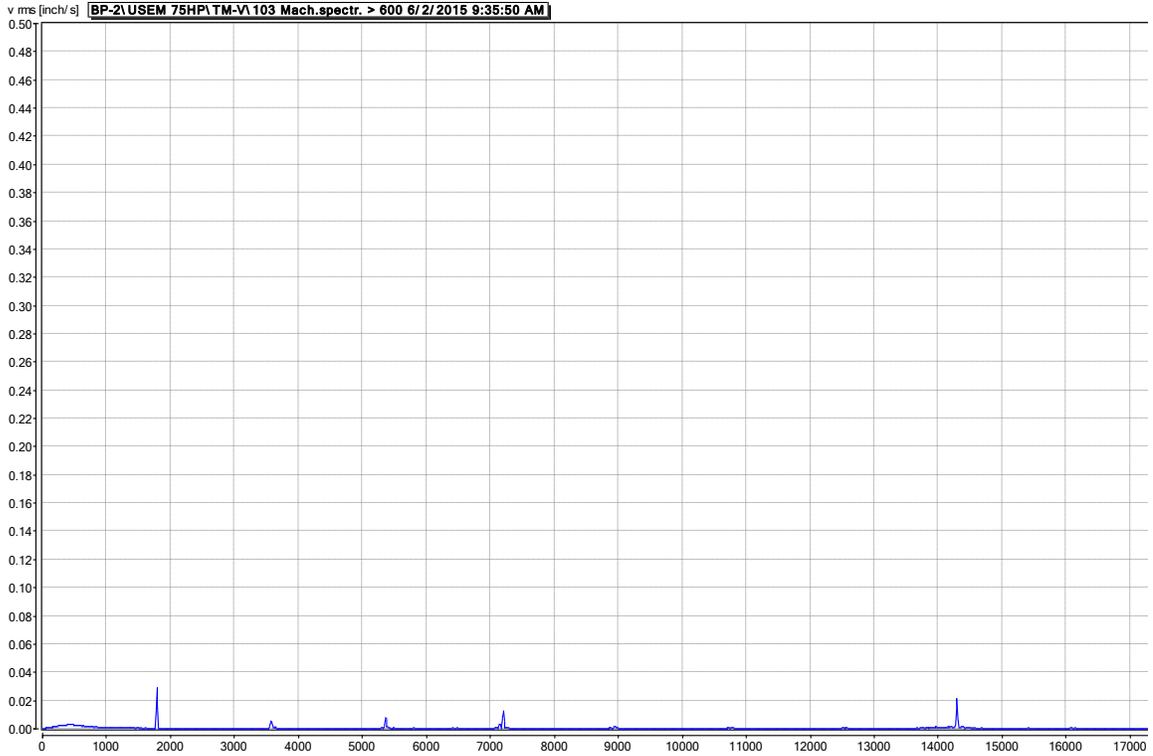
Figure 17: MT-V Filtered Vibration, highest peak is 0.029 in/sec at 1,785 cpm (1X run speed) and the next highest peak is 0.021 in/sec at 14,291 cpm (8X run speed)

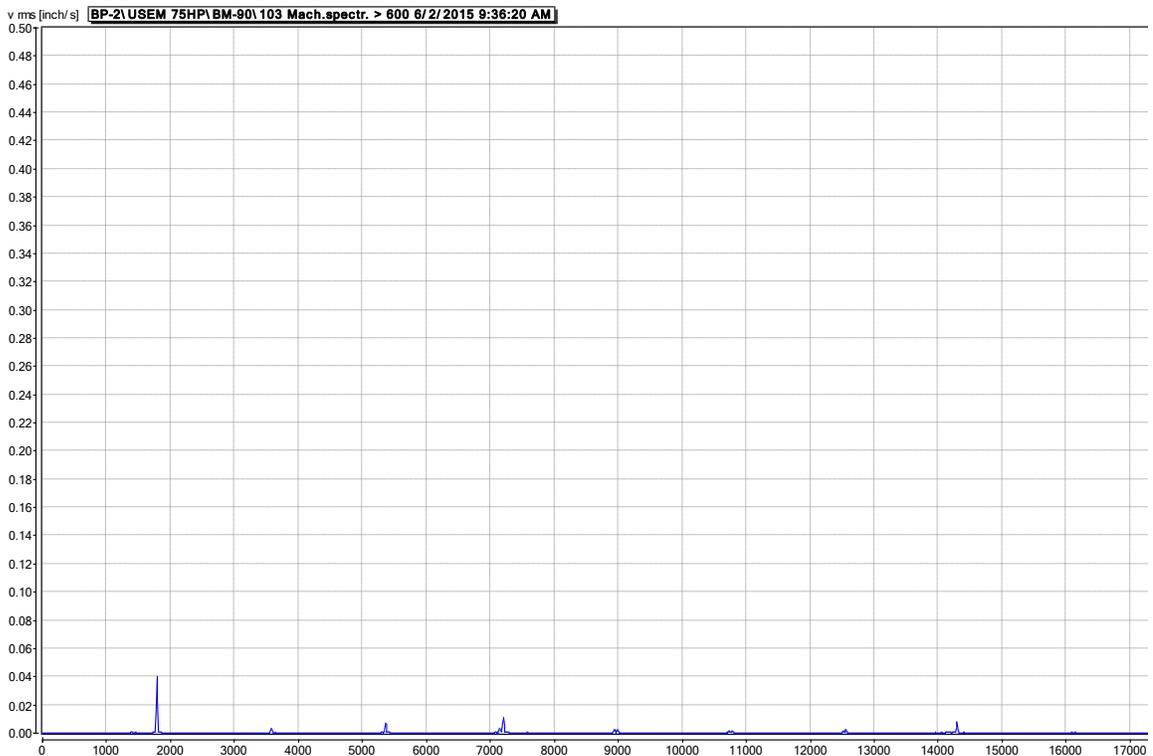
Figure 18: MB-90 Filtered Vibration, highest peak is 0.040 in/sec at 1,785 cpm (1X run speed)

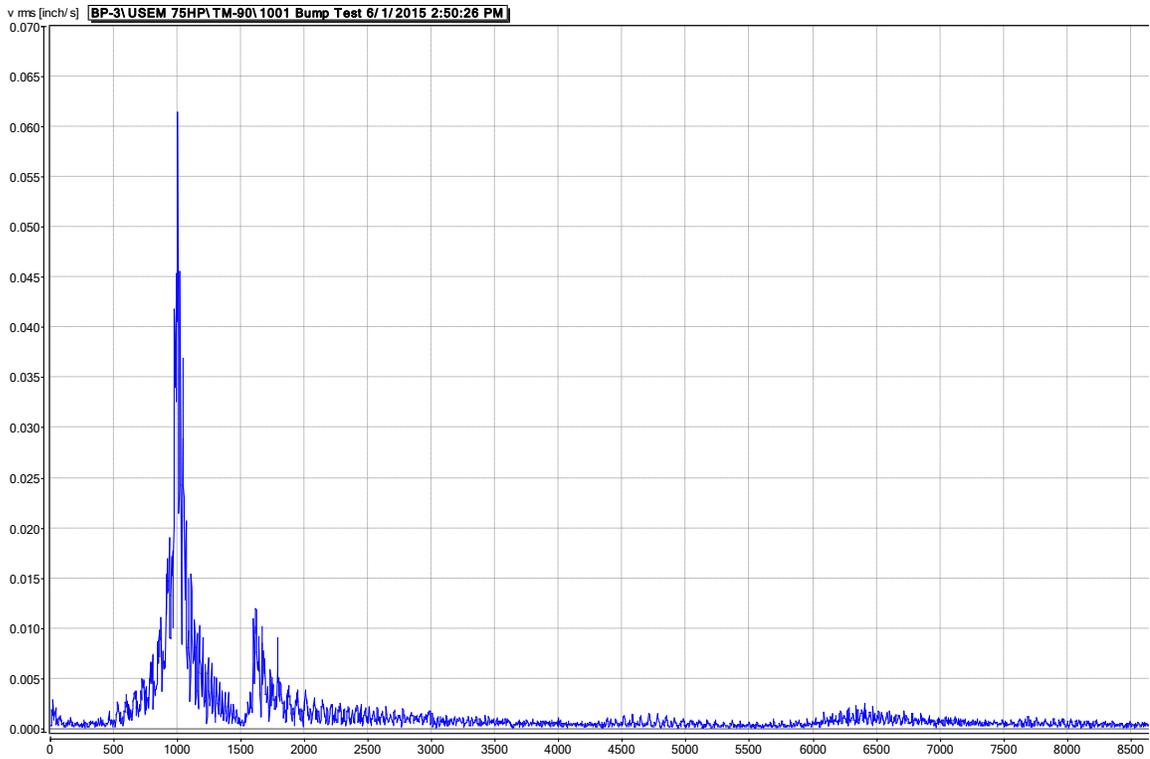
Figure 21: MT-90 Bump Test, Reed Frequency at 1,002 cpm, Motor Speed is 1,785 rpm

The reed frequency, as shown in Figures 21, is at 1,002 cpm 90 degrees to discharge which is 44% from run speed and should not cause any issues. The reed frequency, as shown in Figure 22, is at 1,291 cpm which is 28% from run speed and should not cause any issues.

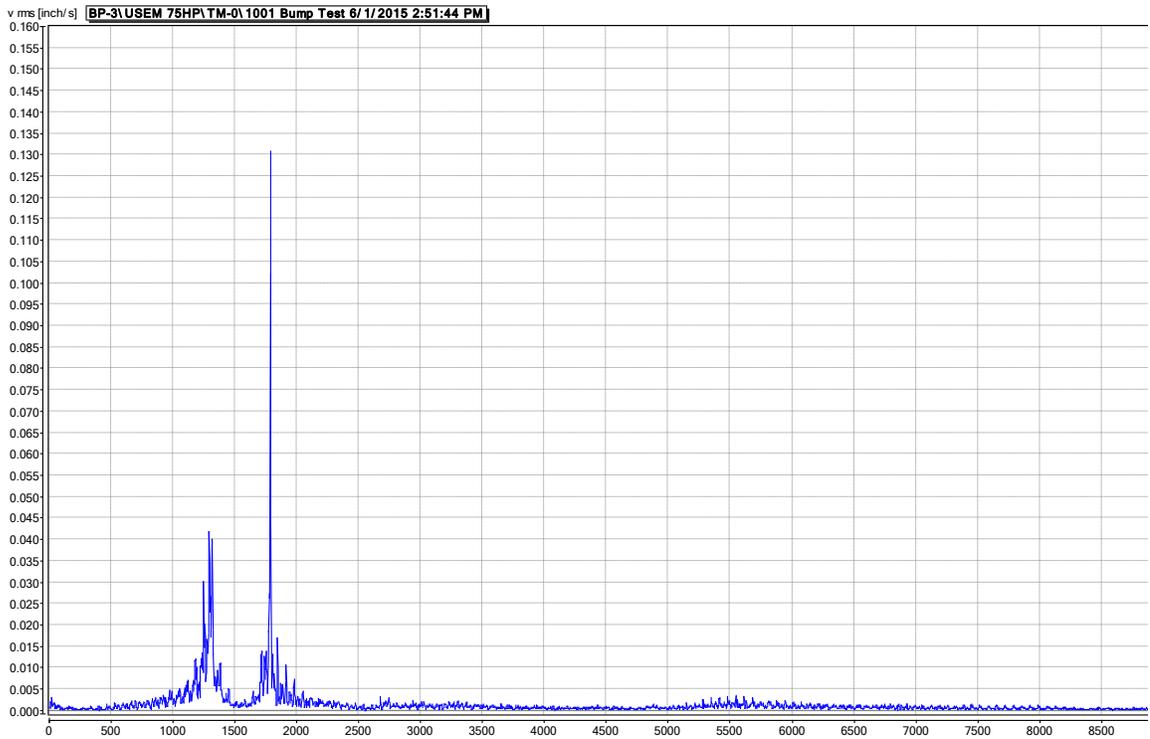
Figure 22: MT-0 Bump Test, Reed Frequency at 1,291 cpm, Motor Speed is 1,785 rpm. The highest peak is from the sister unit running while this unit was being bump tested.

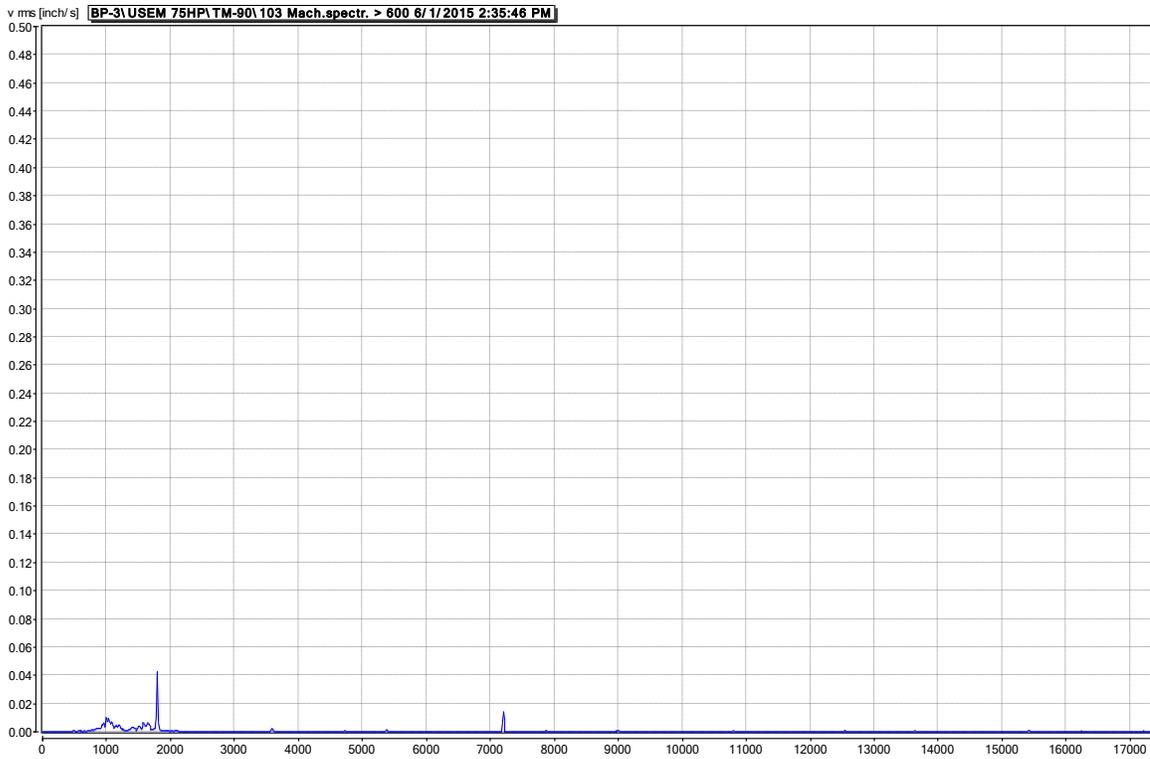
Figure 23: MT-90 Filtered Vibration, highest peak is 0.042 in/sec rms at 1,792 cpm (1X run speed)

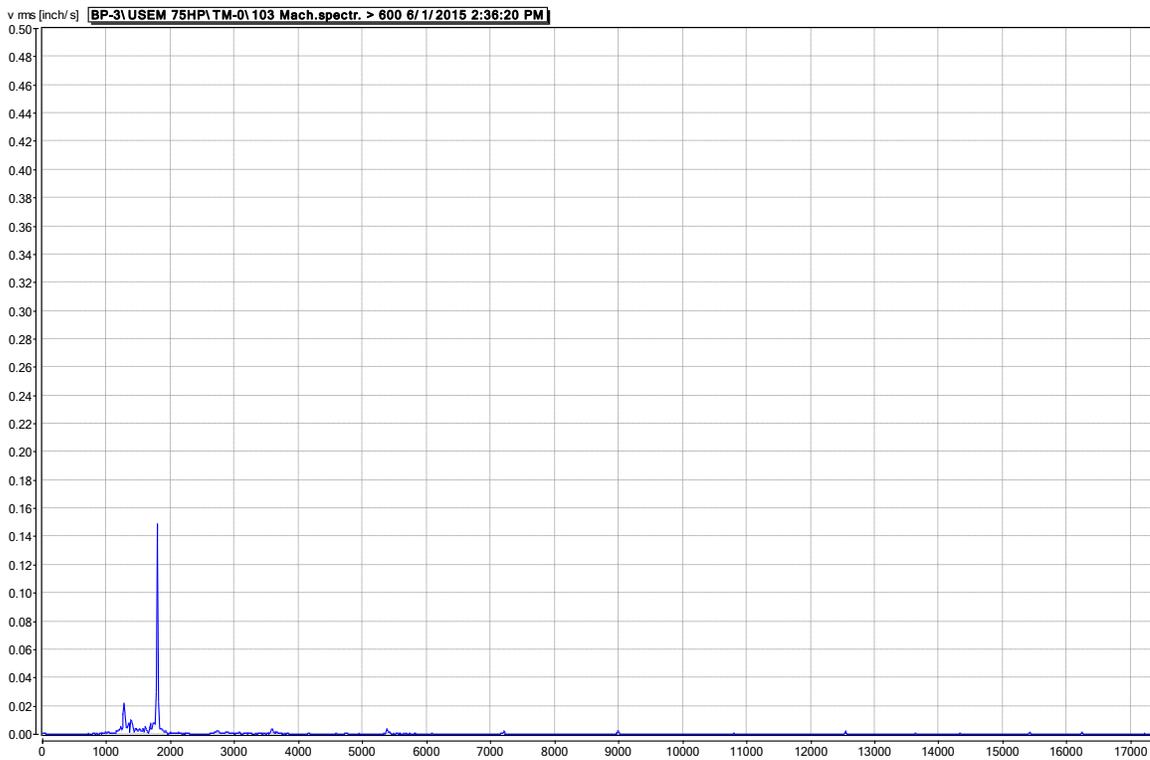
Figure 24: MT-0 Filtered Vibration, highest peak is 0.149 in/sec at 1,792 cpm (1X run speed)

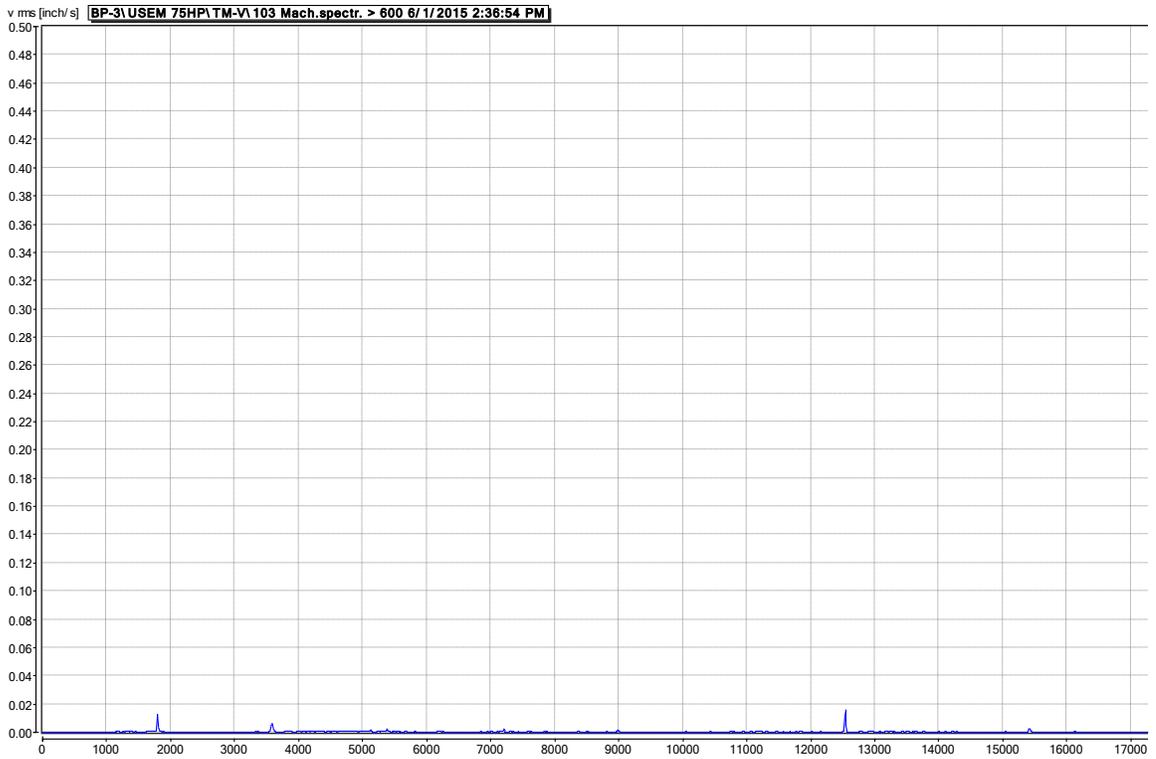
Figure 25: MT-V Filtered Vibration, all data is below 0.020 in/sec

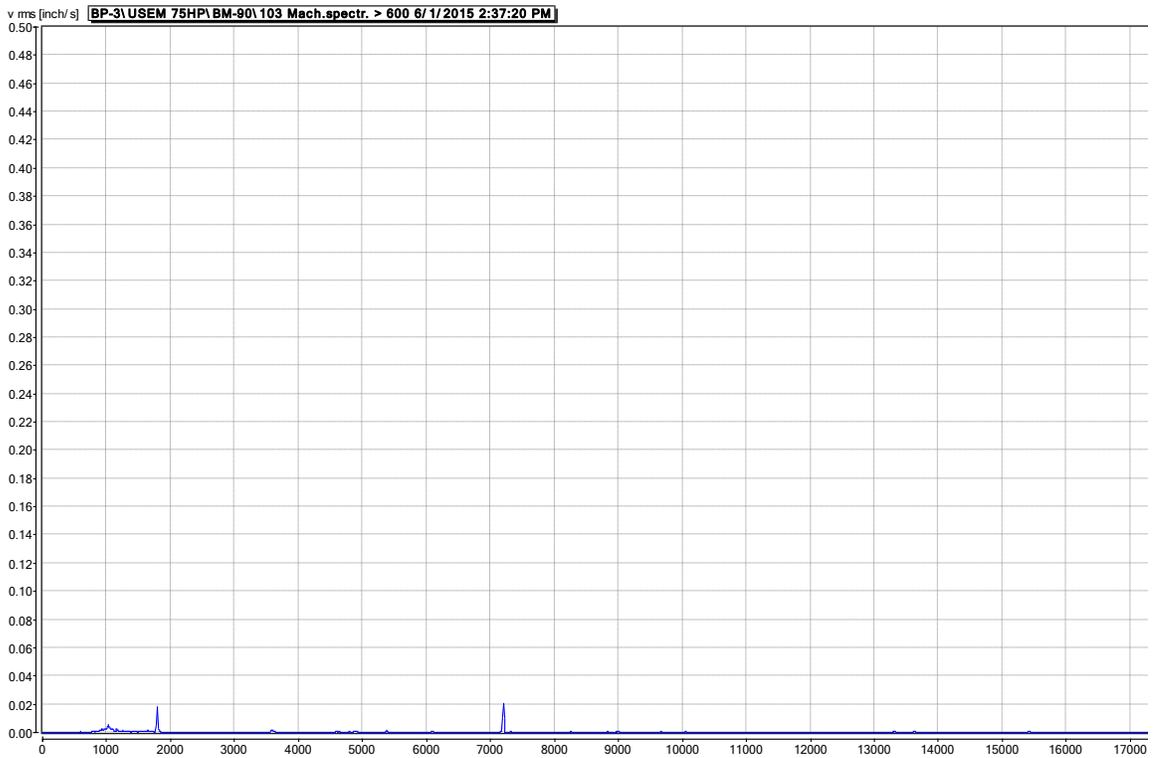
Figure 26: MB-90 Filtered Vibration, all data is below 0.020 in/sec

The vibration at all of the locations has a dominant peak at 1X run speed. This is a typical signature of rotating equipment and indicates a slight imbalance and/or misalignment or looseness. The amplitude for the most part is low but the vibration at the top of the motor in-line with the discharge is slightly above the HI limits. Field balancing would likely resolve this issue.

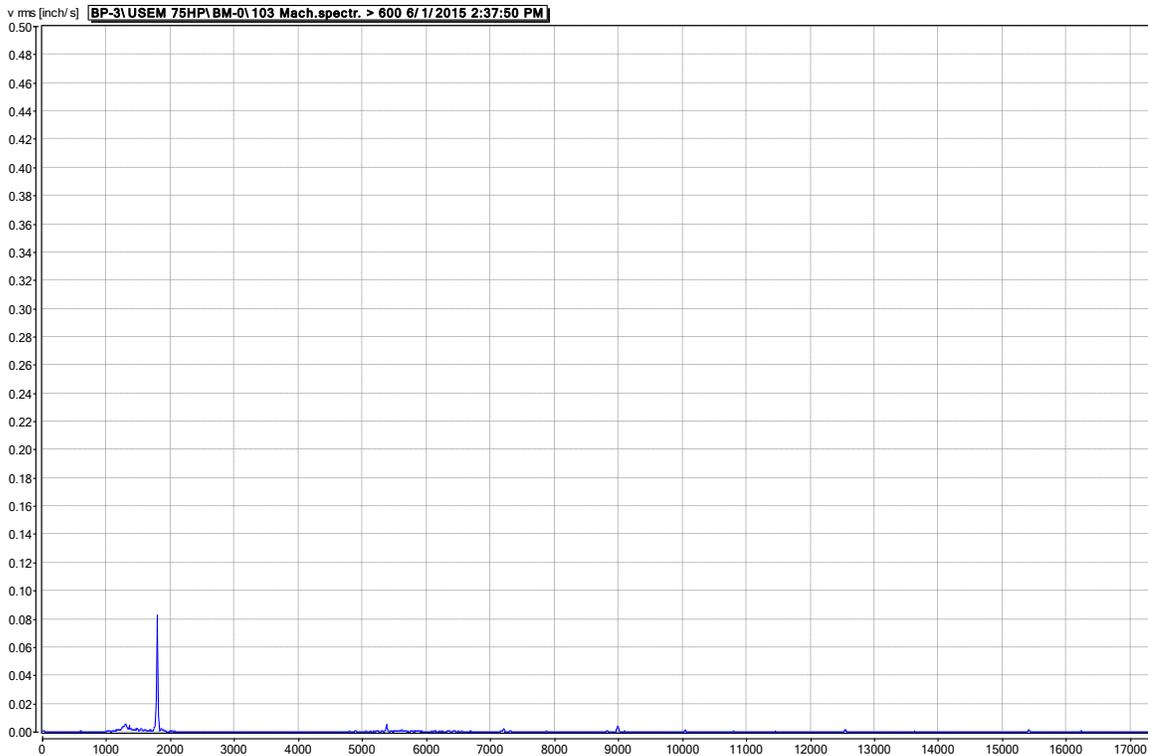
Figure 27: MB-0 Filtered Vibration, highest peak is 0.082 in/sec at 1,792 cpm (1X run speed)

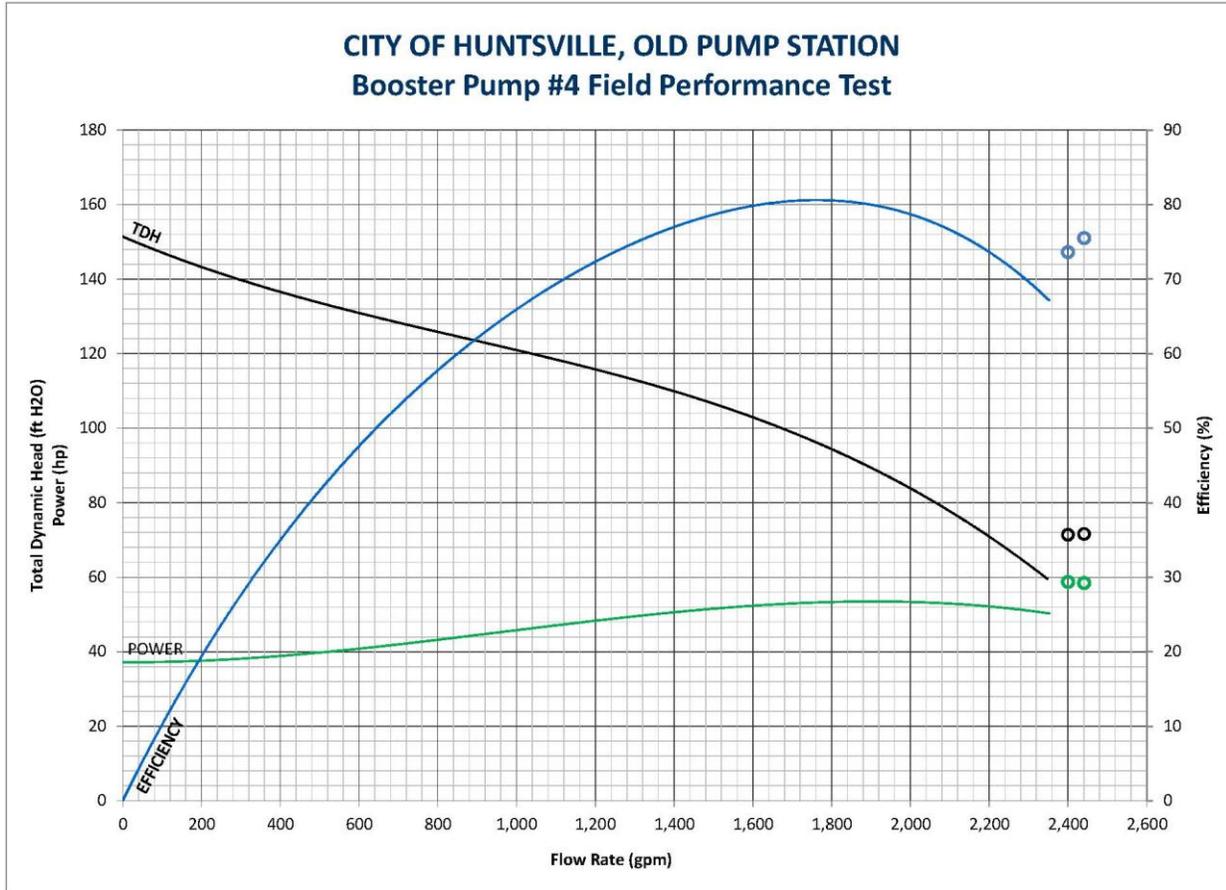
Figure 28: Old Booster Pump Station, Booster Pump #4 Field Performance Curve

- The pump appears to outperform the catalog curve provided by the city. The data points seem unrealistic when taking into account the number of years since the previous repair.

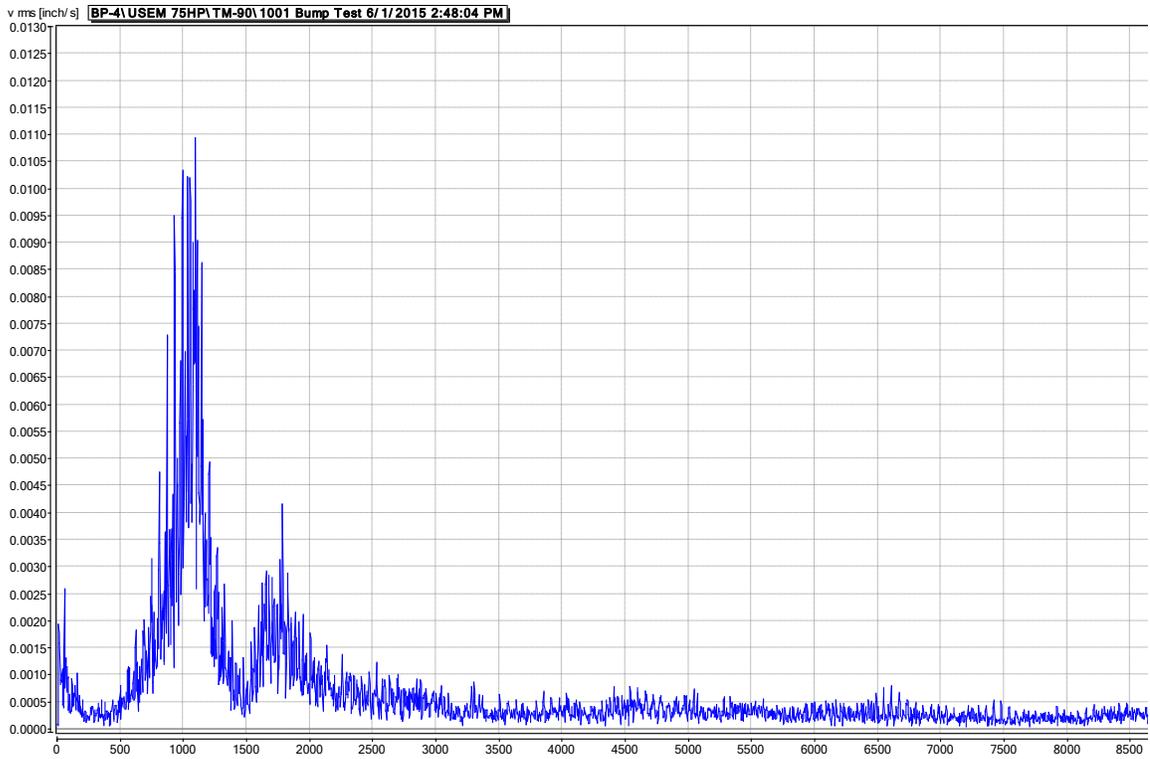
Figure 29: MT-90 Bump Test, Reed Frequency at 1,095 cpm, Motor Speed is 1,785 rpm

The reed frequency, as shown in Figures 29, is at 1,095 cpm 90 degrees to discharge which is 39% from run speed and should not cause any issues. The reed frequency, as shown in Figure 30, is at 1,243 cpm which is 30% from run speed and should not cause any issues.

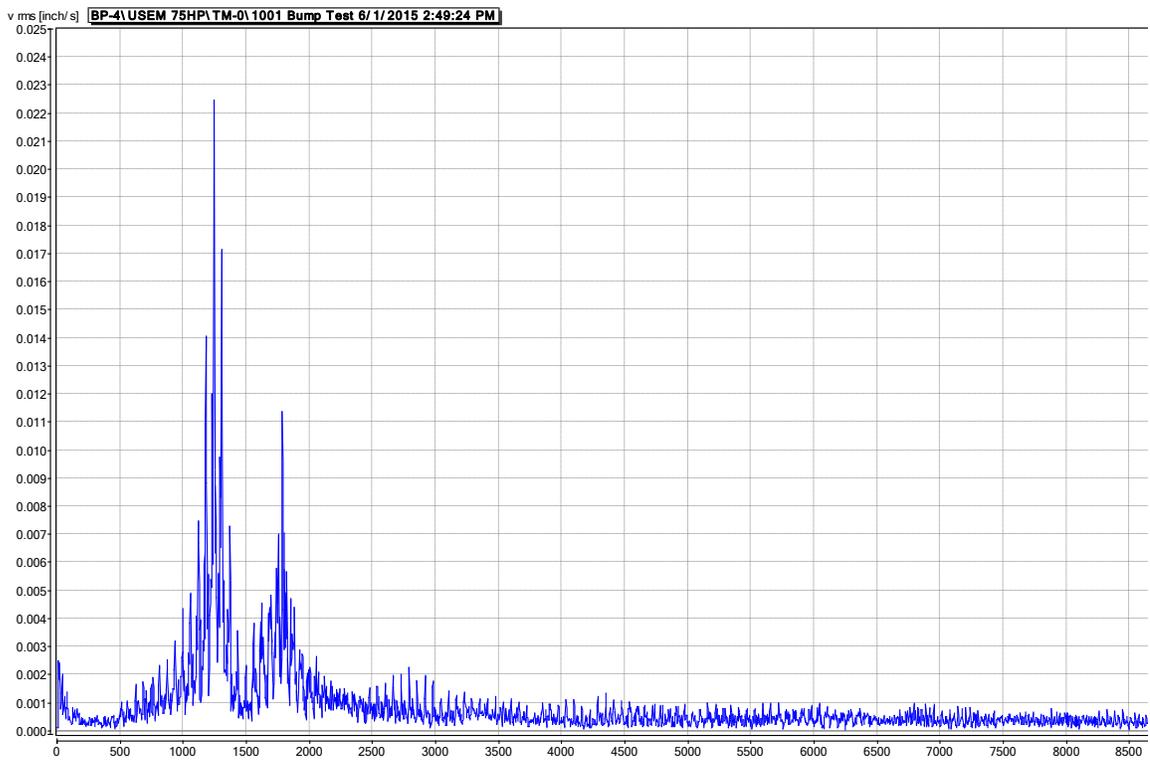
Figure 30: MT-0 Bump Test, Reed Frequency at 1,243 cpm, Motor Speed is 1,785 rpm
