PALM STREET WATER PLANT CONDITION ASSESSMENT

City of Huntsville

November 9, 2015

FREESE AND NICHOLS, INC.
11200 Broadway Street
Offices West, Suite 2332
Pearland, TX 77584
832-456-4700

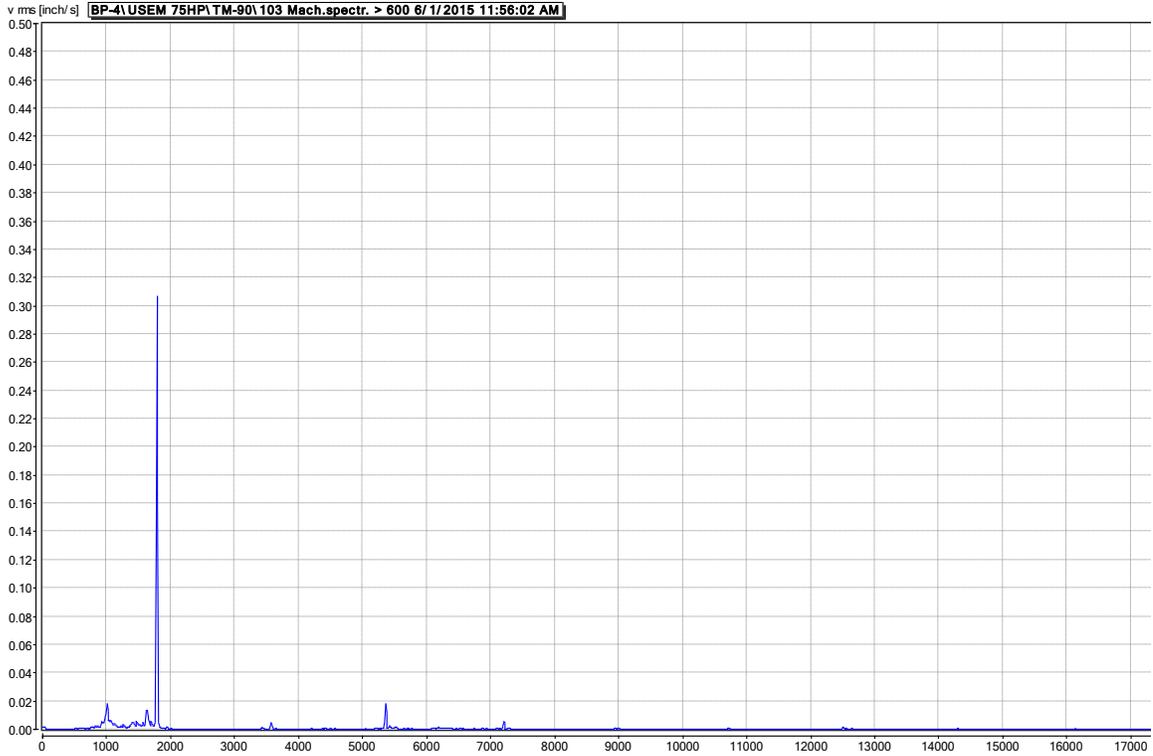
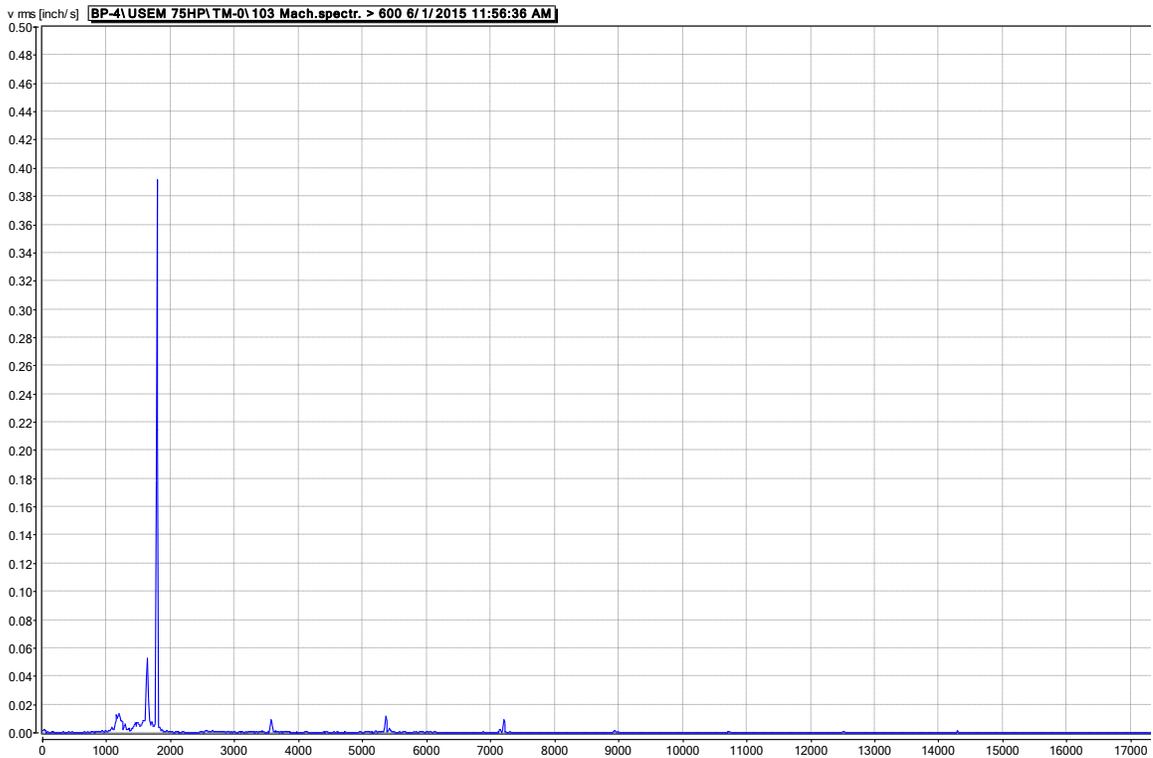
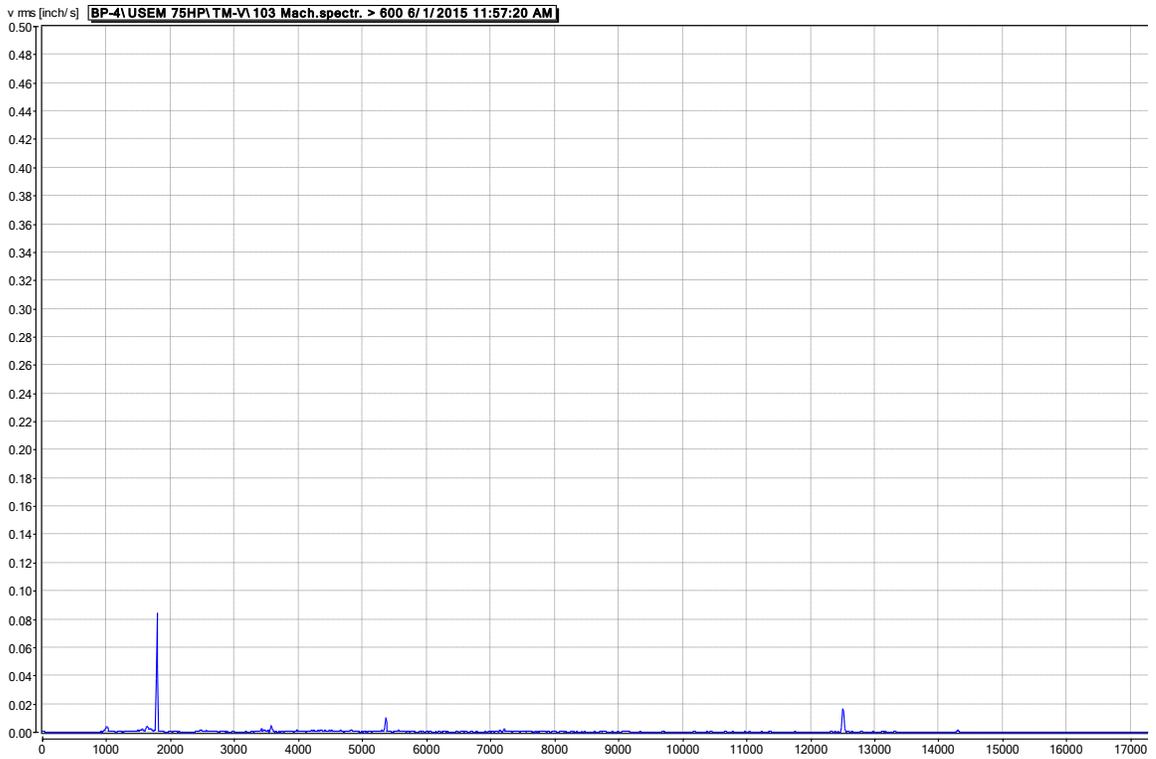
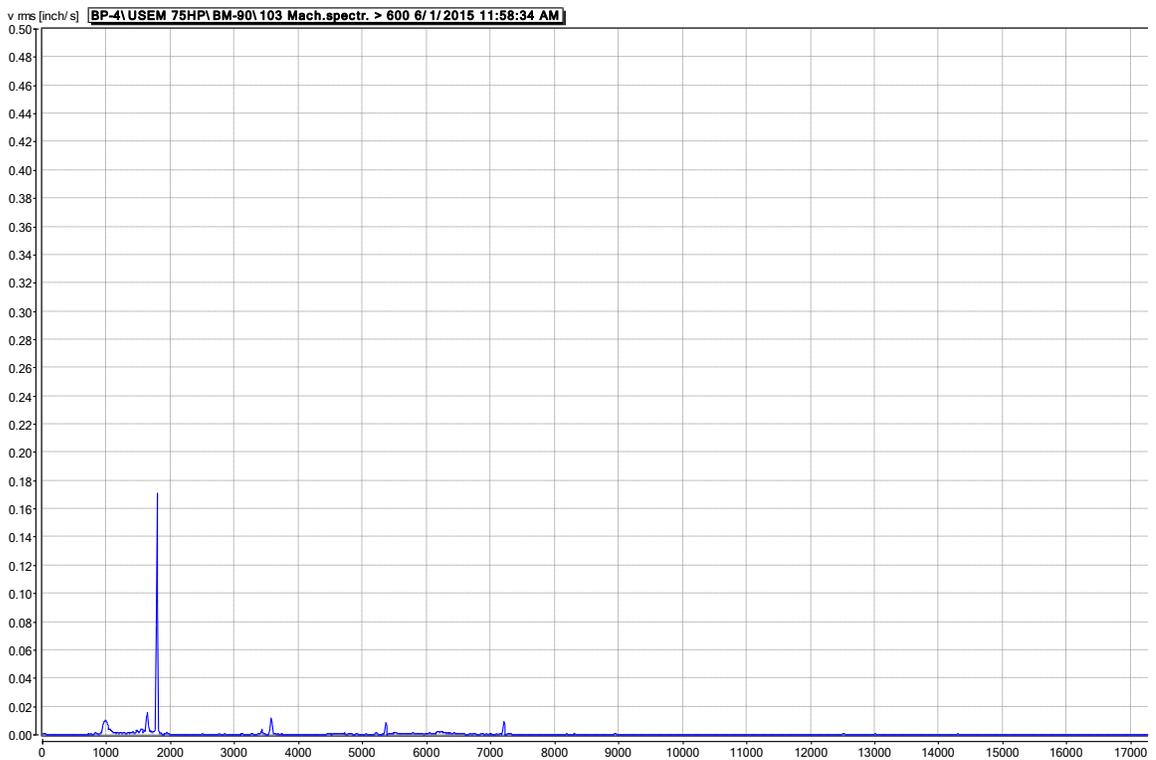
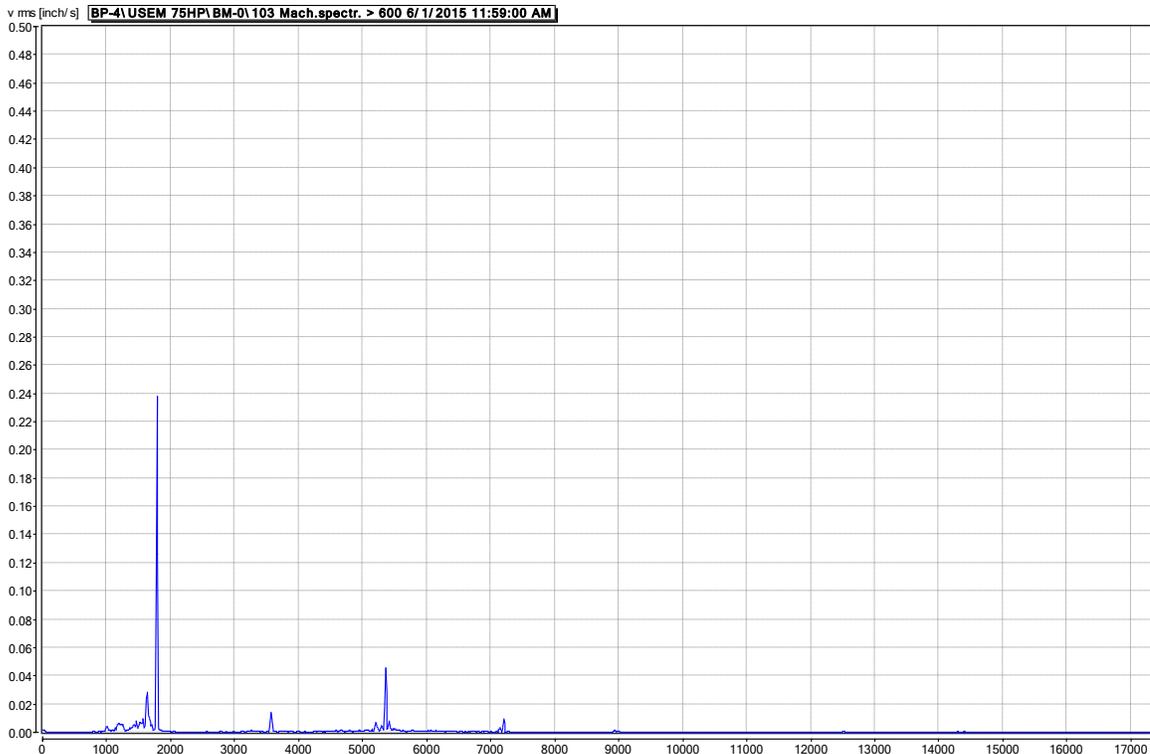
Figure 31: MT-90 Filtered Vibration, highest peak is 0.307 in/sec rms at 1,785 cpm (1X run speed)

Figure 32: MT-0 Filtered Vibration, highest peak is 0.392 in/sec at 1,785 cpm (1X run speed)

Figure 33: MT-V Filtered Vibration, highest peak is 0.084 in/sec at 1,785 cpm (1X run speed)

Figure 34: MB-90 Filtered Vibration, highest peak is 0.171 in/sec at 1,785 cpm (1X run speed)

Figure 35: MB-0 Filtered Vibration, highest peak is 0.238 in/sec at 1,785 cpm (1X run speed) and the second highest peak is 0.046 in/sec at 5,358 cpm

The vibration at all of the locations has a dominant peak at 1X run speed. This is a typical signature of rotating equipment and indicates a slight imbalance and/or misalignment or looseness. The amplitude is very high at the locations that are in-line and 90 degree to the discharge and should be corrected. Field balancing may resolve the issue but it is more likely caused by loose pump bearings which would require the pump to be pulled and repaired

- Pump vibration is well above the Hydraulic Institute Standards with the highest vibration being 0.383 in/sec rms
- This pump's runtime should be kept to a minimum

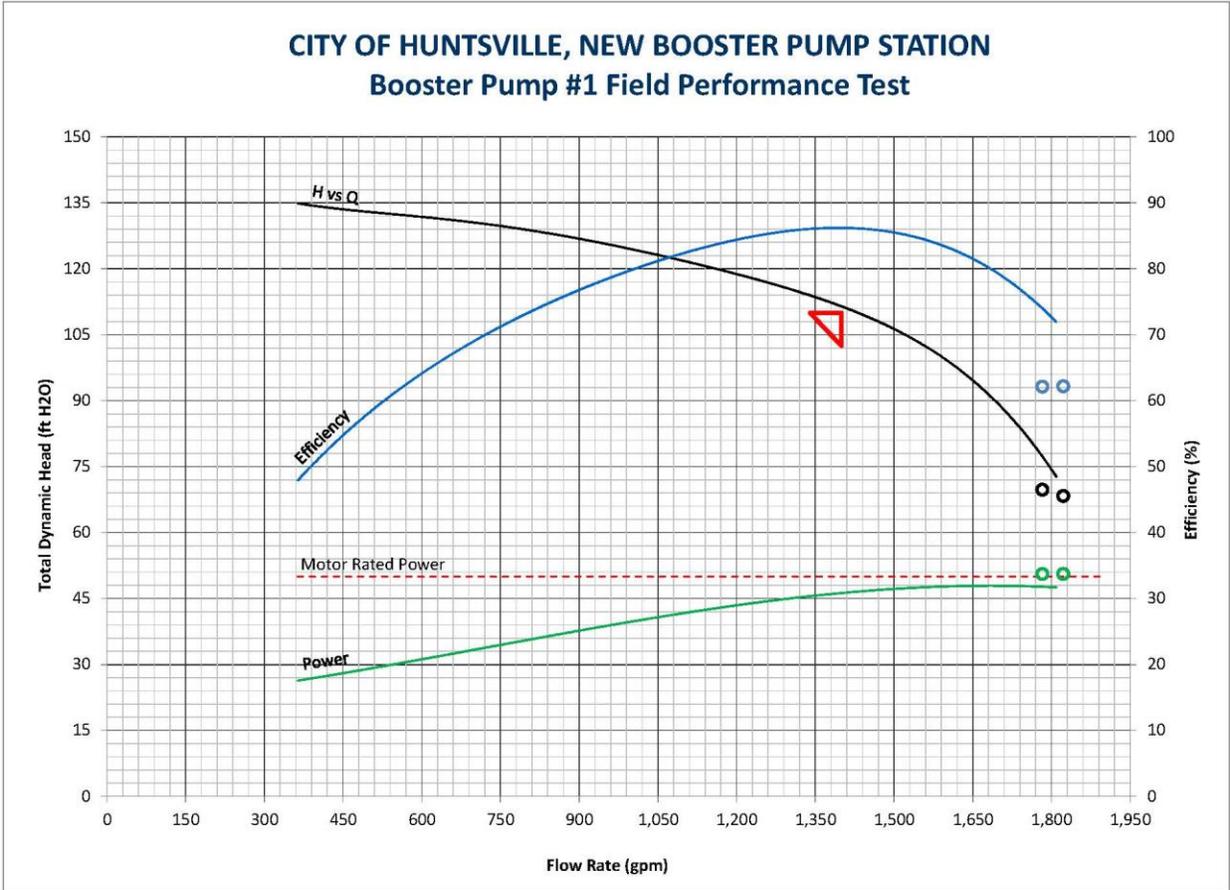
Figure 36: New Booster PS, Booster Pump #1 Field Performance Curve

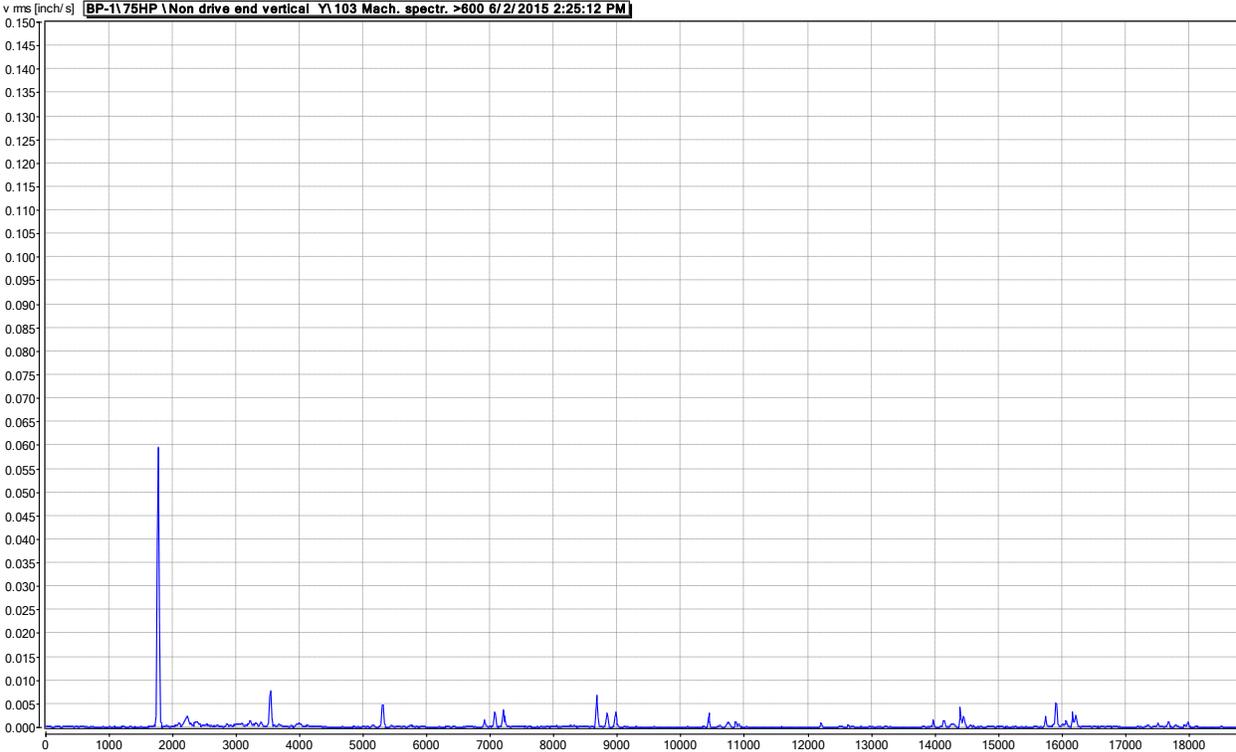
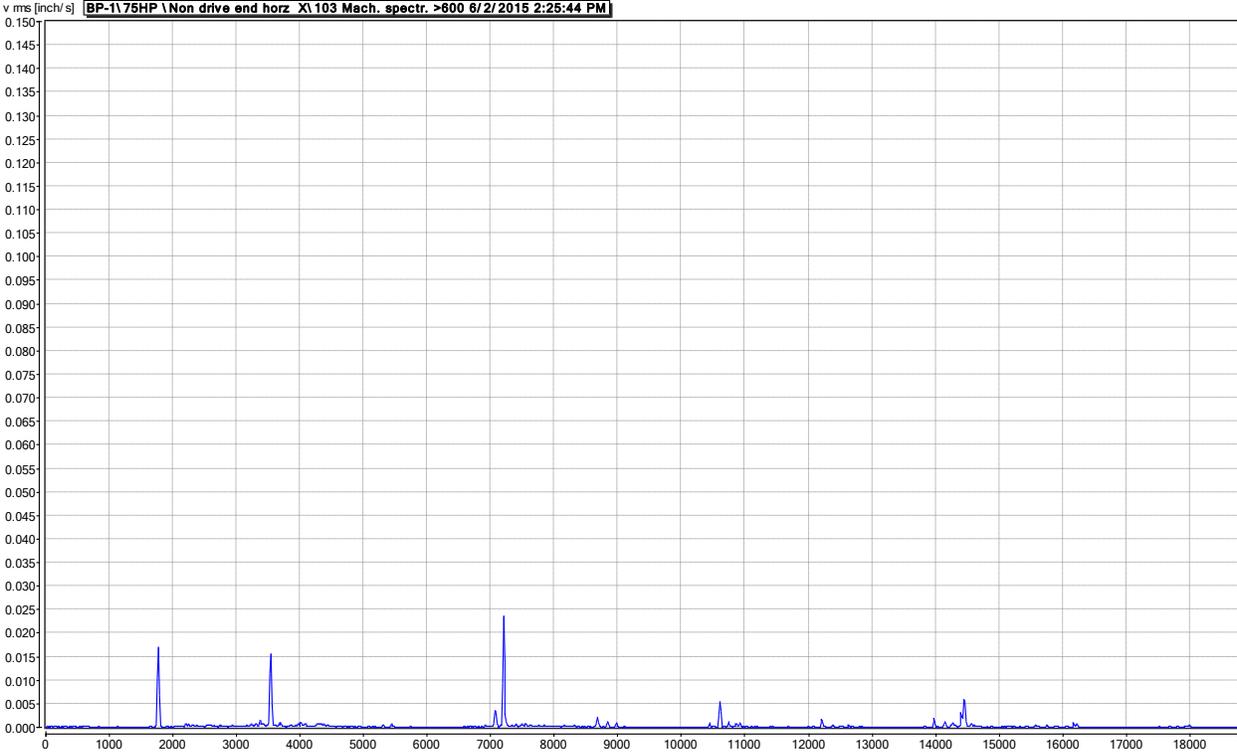
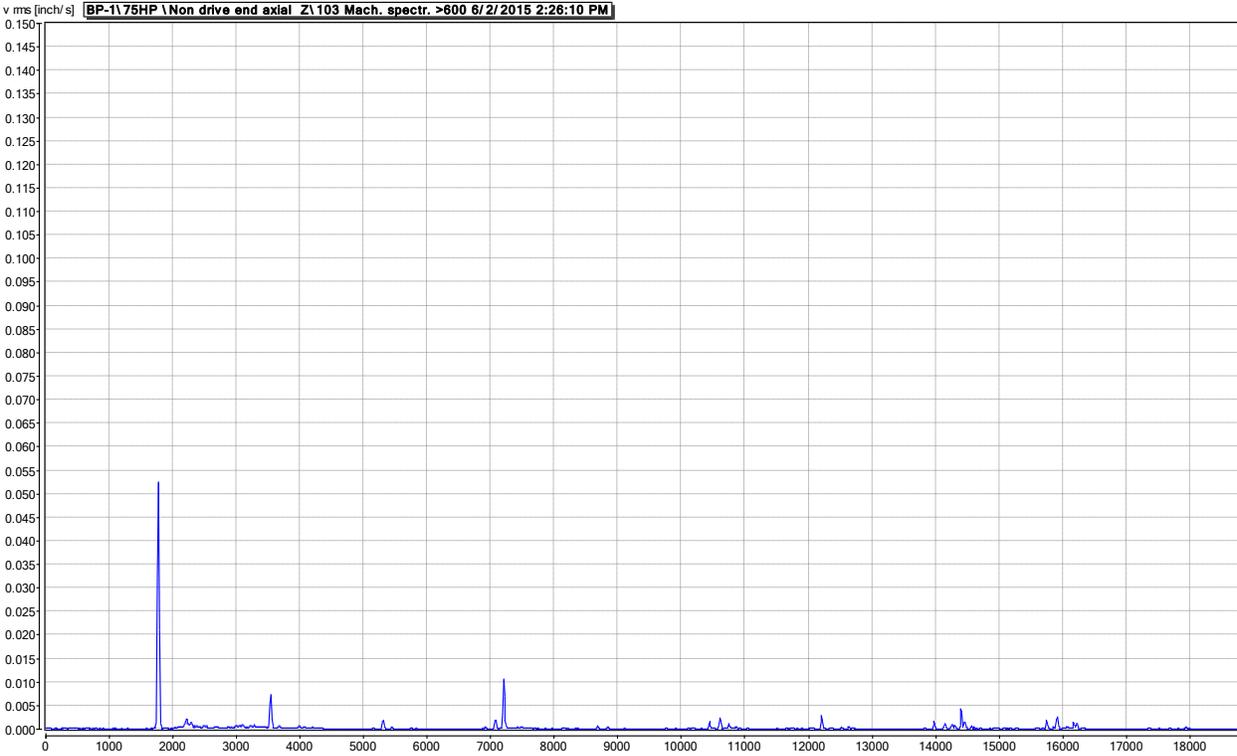
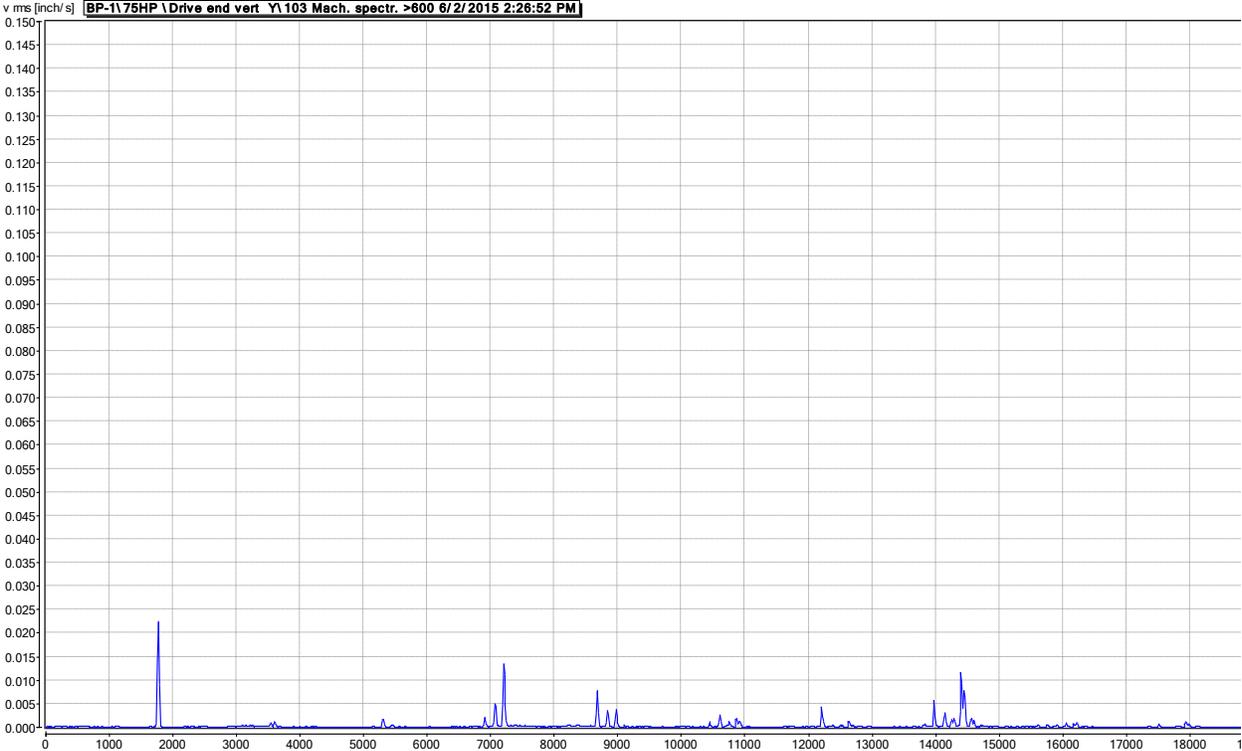
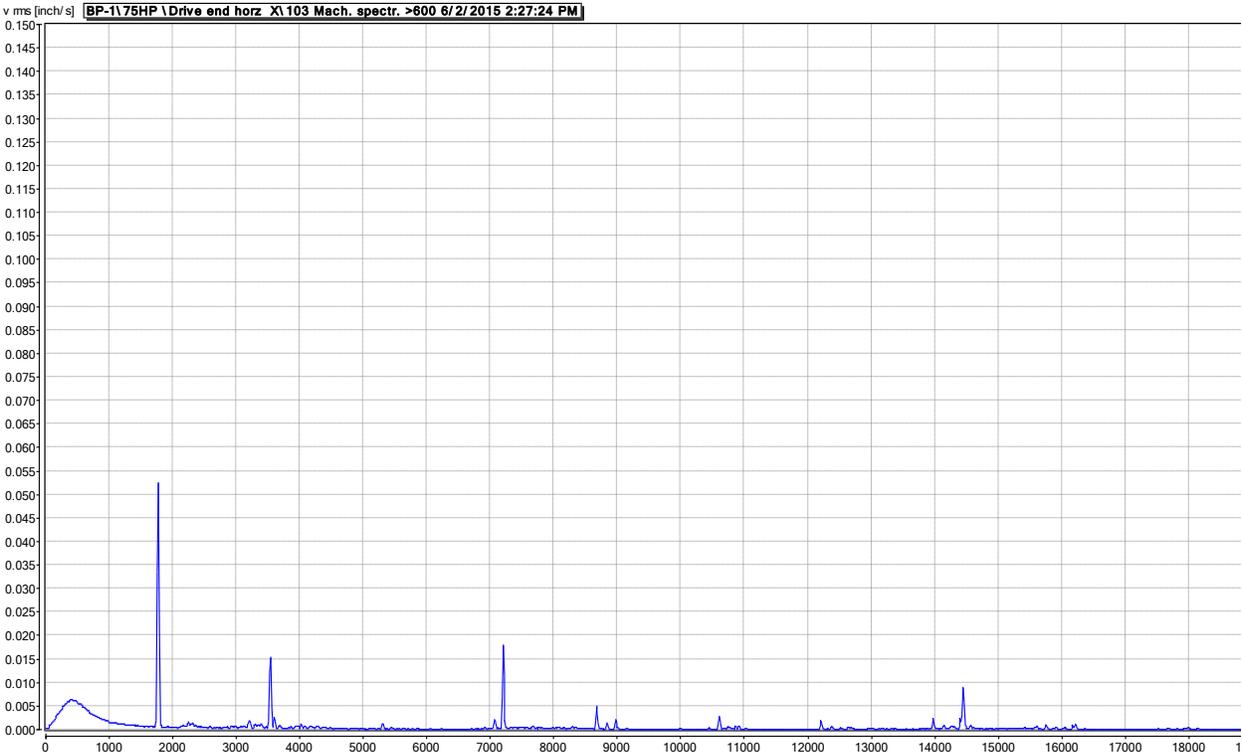
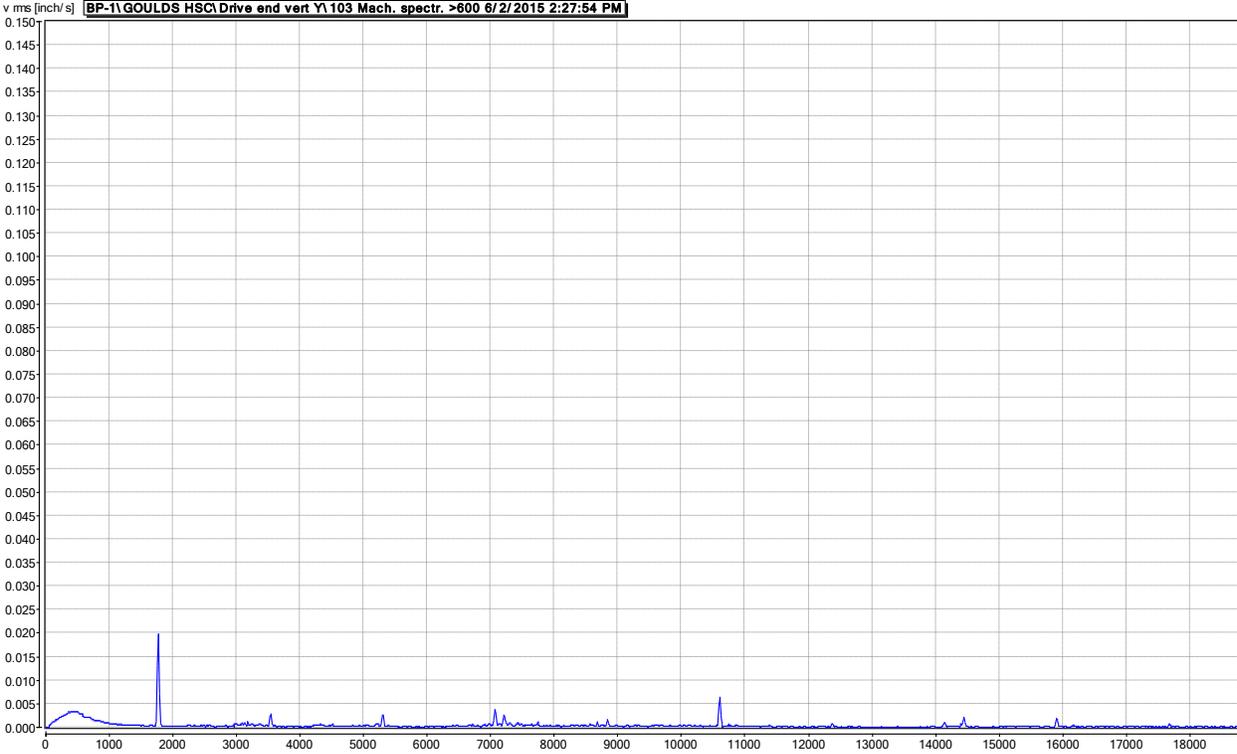
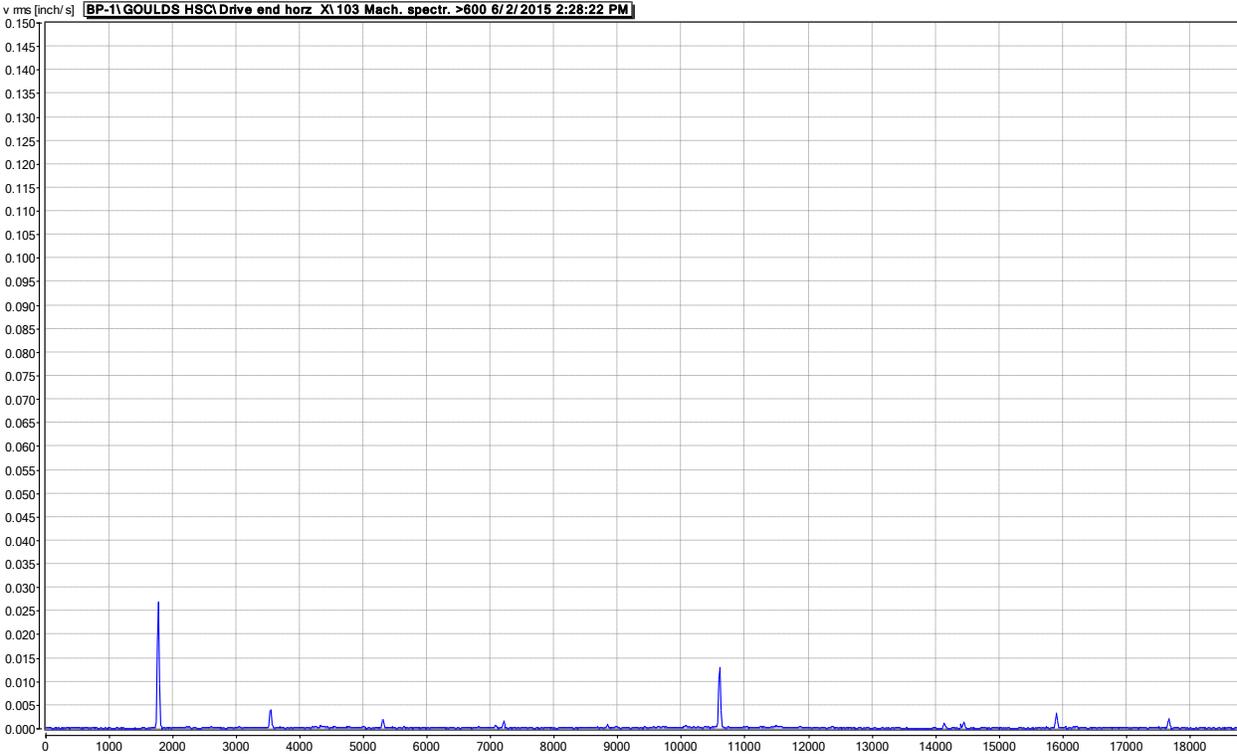
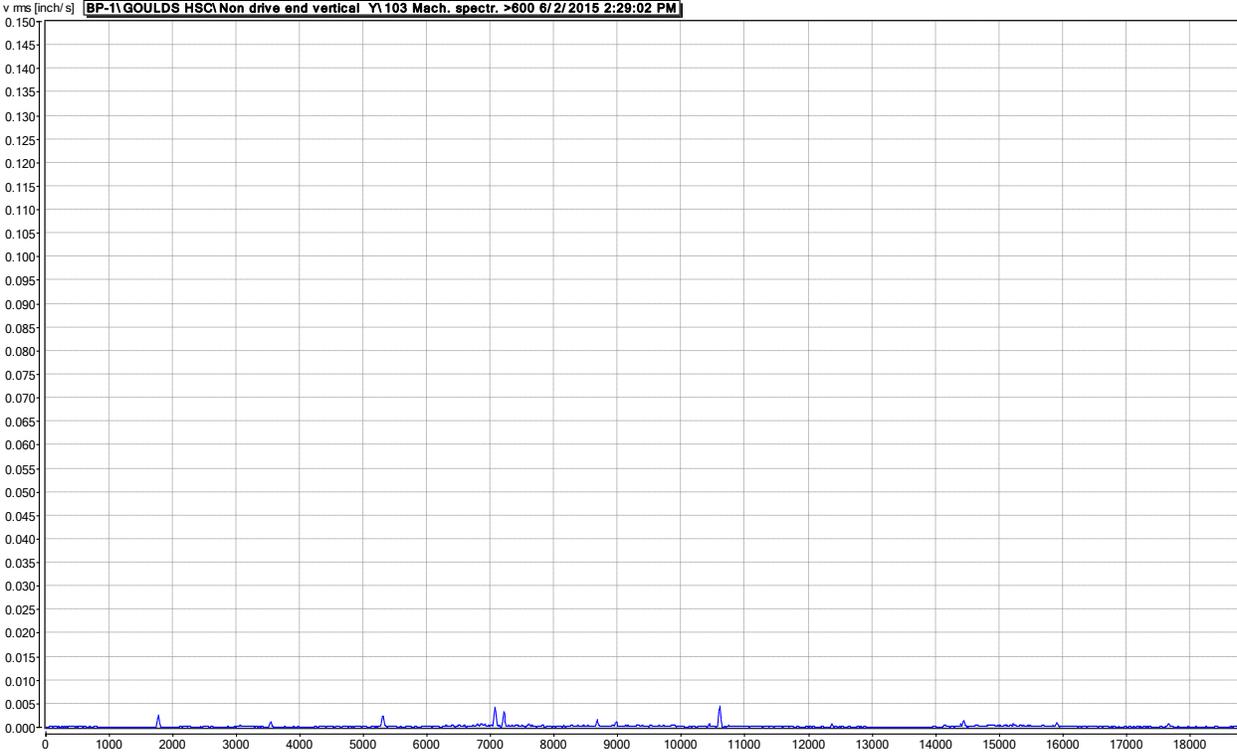
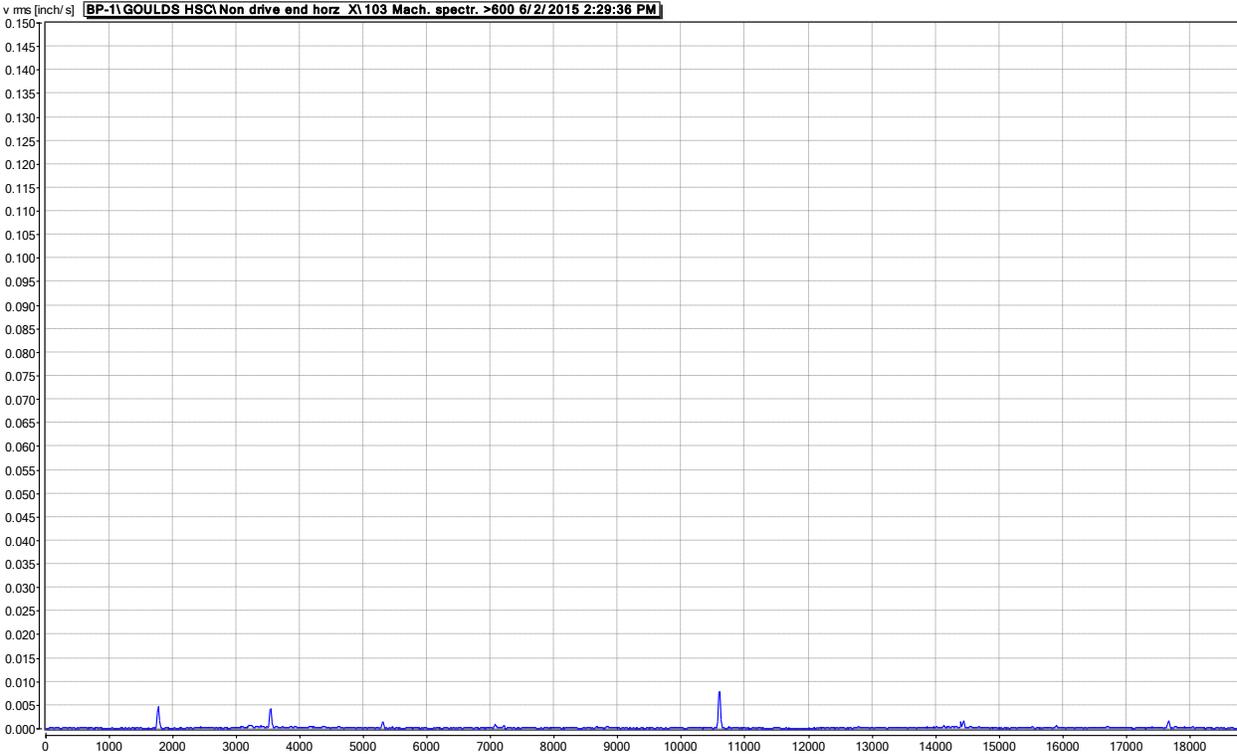
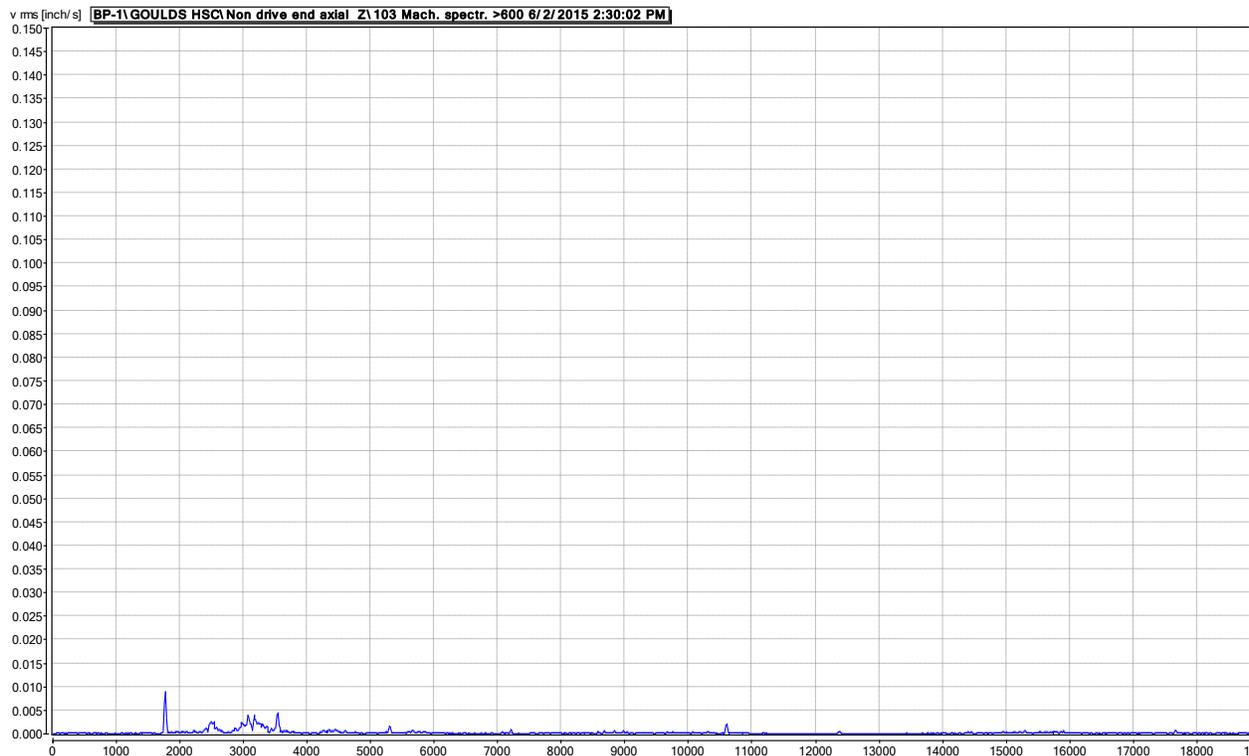
Figure 37: Motor ODE-Y Filtered Vibration, highest peak is 0.060 in/sec at 1,766 cpm (1X run speed)

Figure 38: Motor ODE-X Filtered Vibration, highest peak is 0.024 in/sec at 7,200 cpm (1X run speed) with other peaks at 1,766 cpm (1X run speed) and 3,536 cpm (2X run speed)

Figure 39: Motor ODE-Z Filtered Vibration, highest peak is 0.053 in/sec at 1,785 cpm (1X run speed)

Figure 40: Motor DE-Y Filtered Vibration, highest peak is 0.022 in/sec at 1,766 cpm (1X run speed) with a smaller peak at 7,200 cpm (electrical frequency)

Figure 41: Motor DE-X Filtered Vibration, highest peak is 0.053 in/sec at 1,766 cpm (1X run speed) with a smaller peak at 3,536 cpm (2X run speed) and 7,200 cpm (electrical frequency)

Figure 42: Pump DE-Y Filtered Vibration, highest peak is 0.020 in/sec at 1,766 cpm (1X run speed)

Figure 43: Pump DE-X Filtered Vibration, highest peak is 0.027 in/sec at 1,766 cpm (1X run speed) with a smaller peak at 10,601 cpm (6X run speed)

Figure 44: Pump ODE-Y Filtered Vibration, all peaks are below 0.005 in/sec

Figure 45: Pump ODE-X Filtered Vibration, all peaks are below 0.010 in/sec

Figure 46: Pump ODE-Z Filtered Vibration, all peaks are below 0.010 in/sec

The motor and pump vibration are very low at all locations.
