PALM STREET WATER PLANT CONDITION ASSESSMENT

City of Huntsville

November 9, 2015

FREESE AND NICHOLS, INC.
11200 Broadway Street
Offices West, Suite 2332
Pearland, TX 77584
832-456-4700

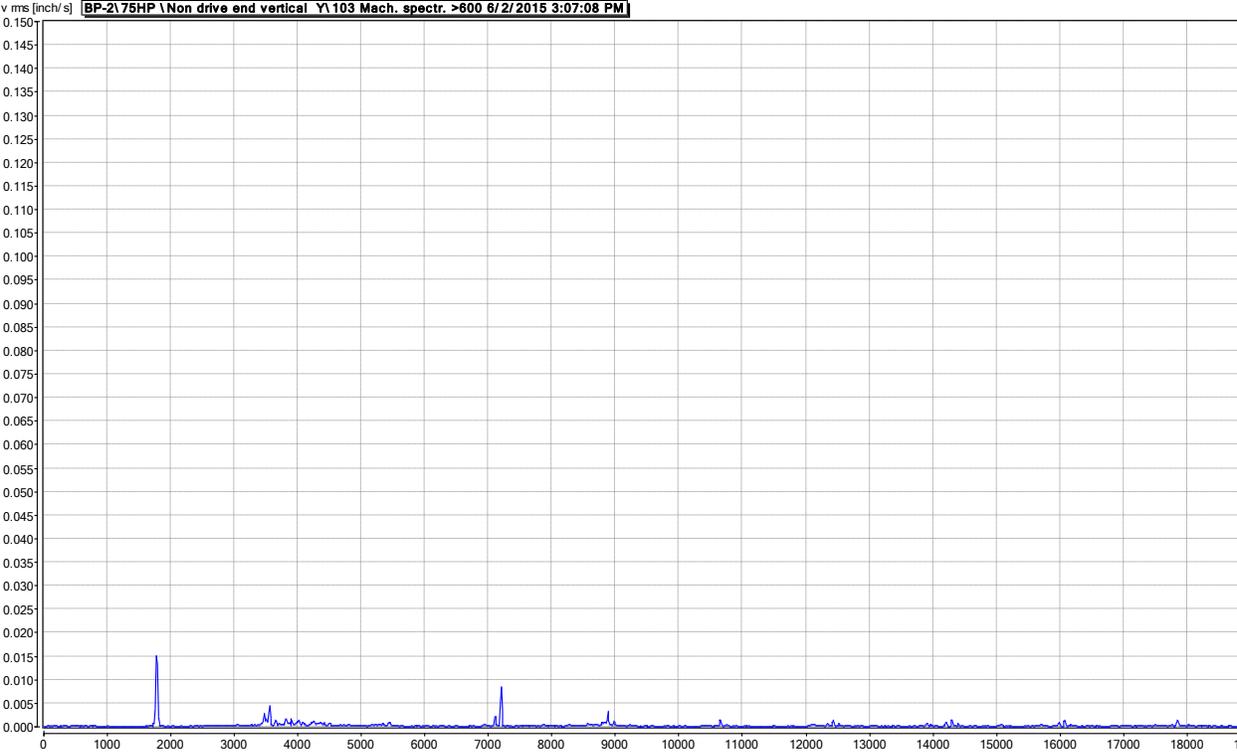
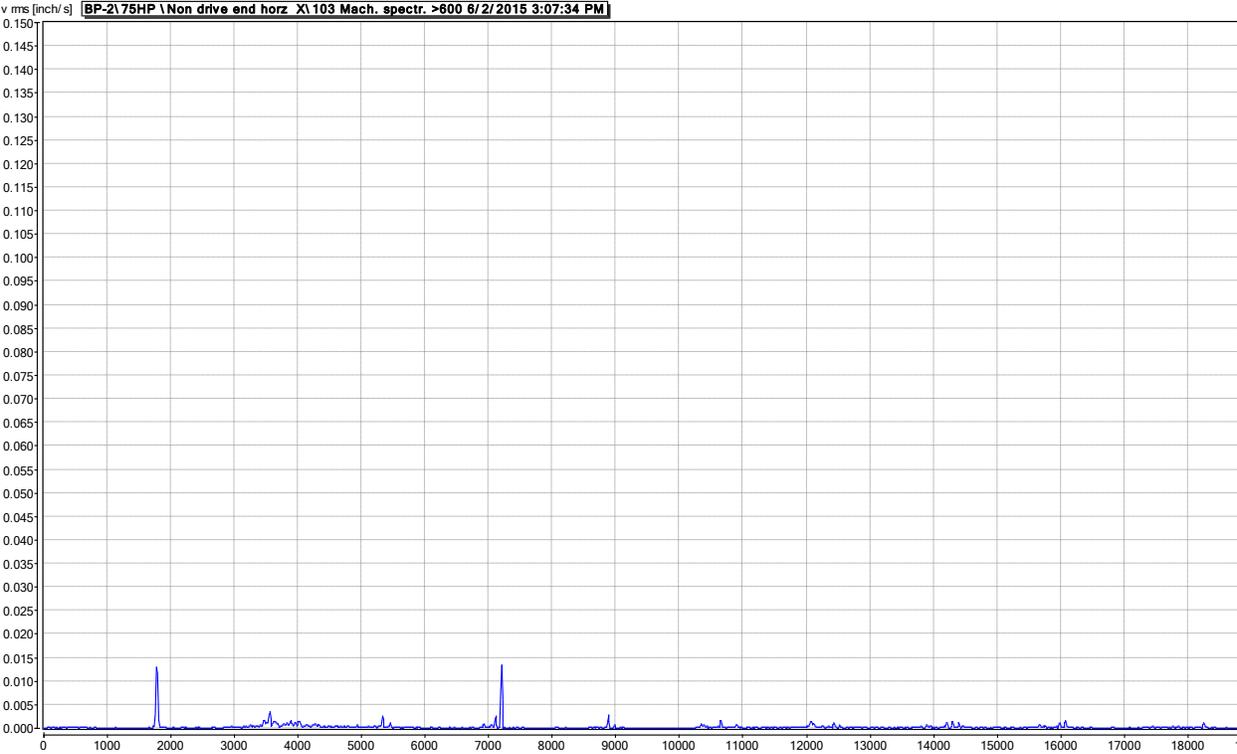
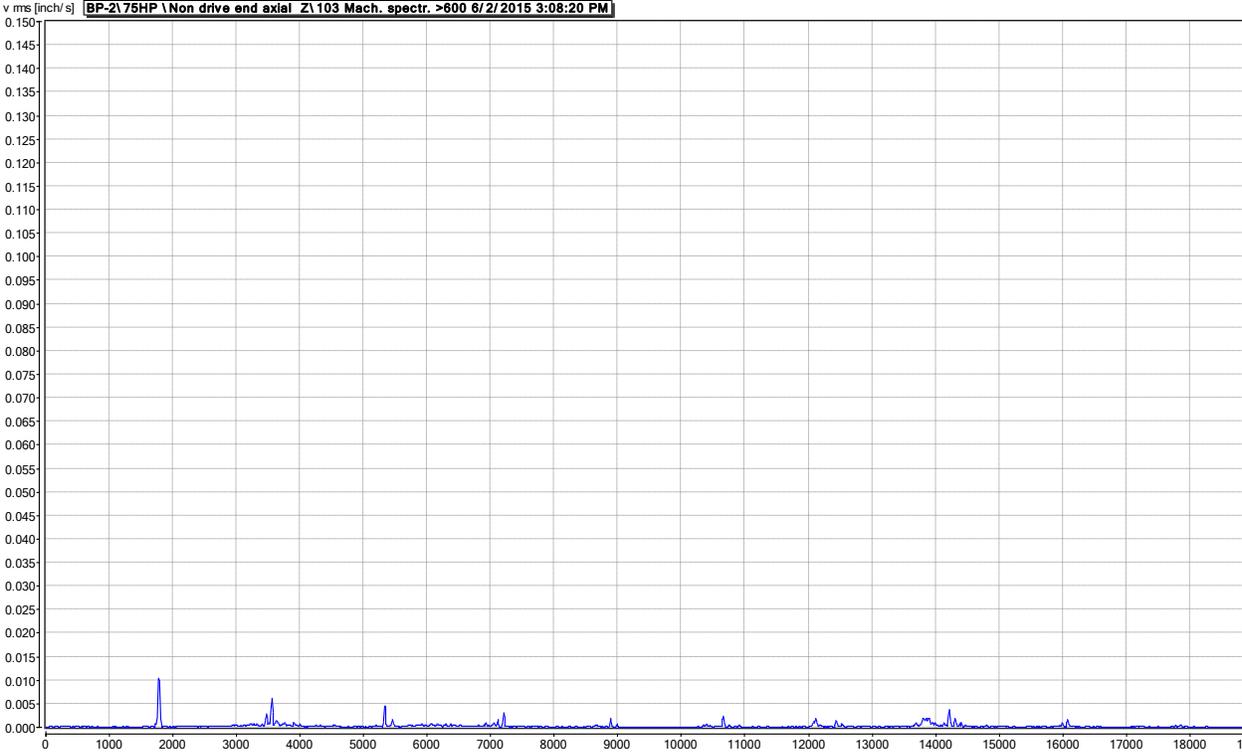
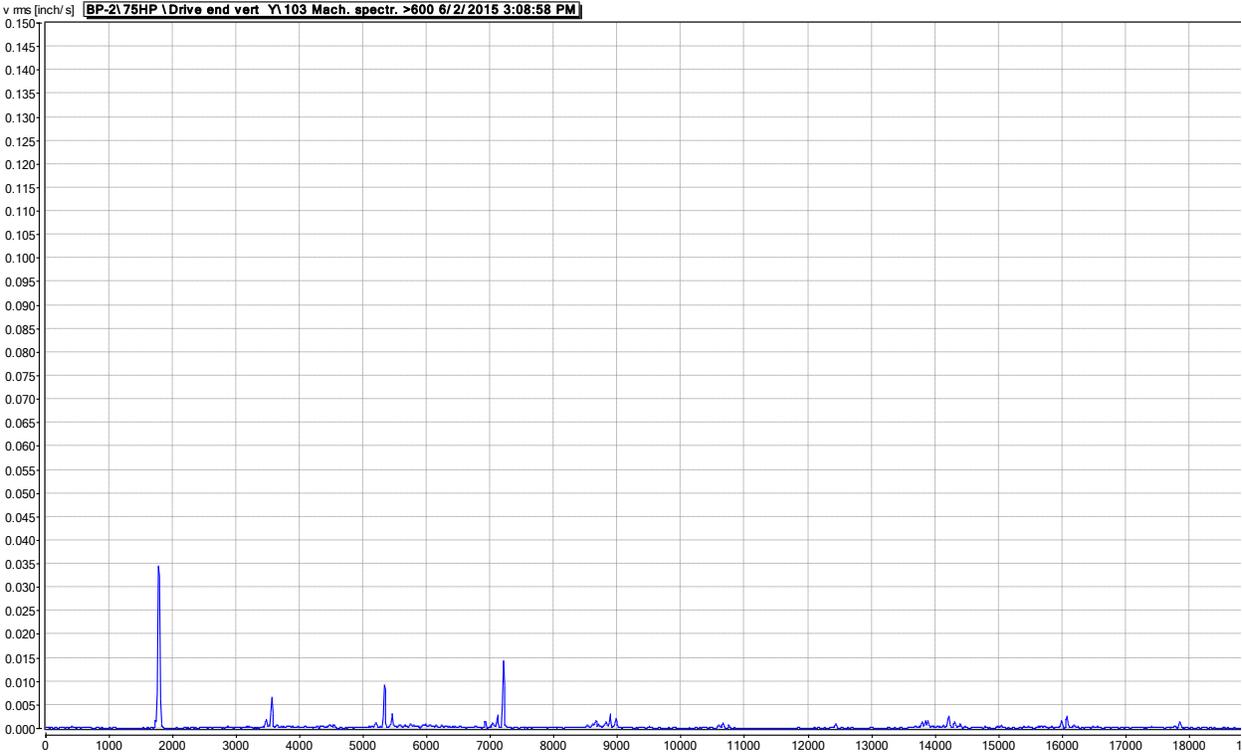
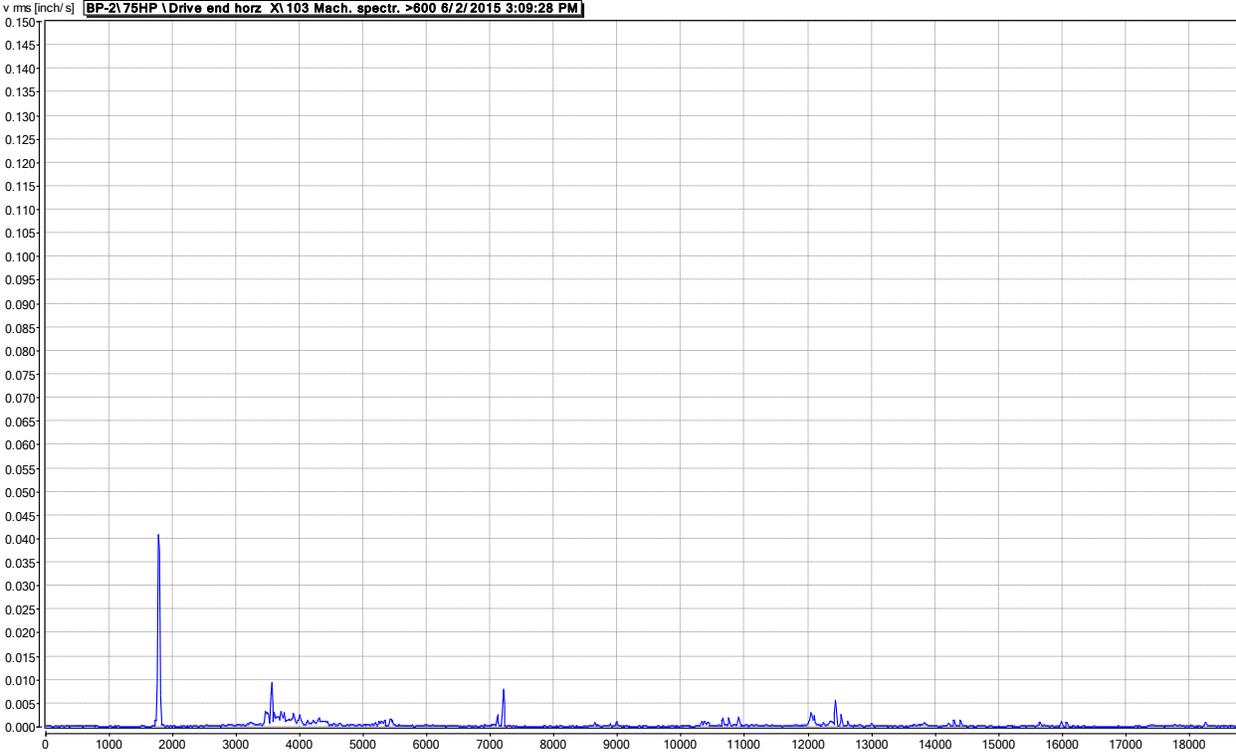
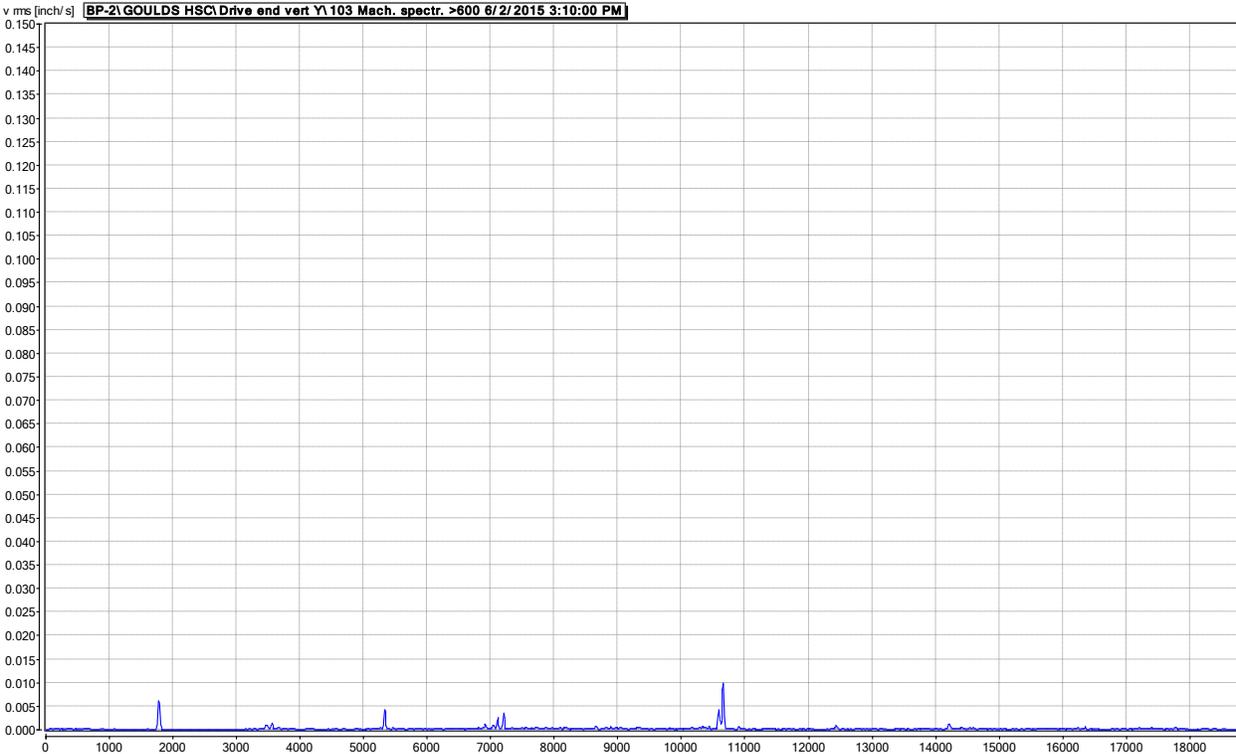
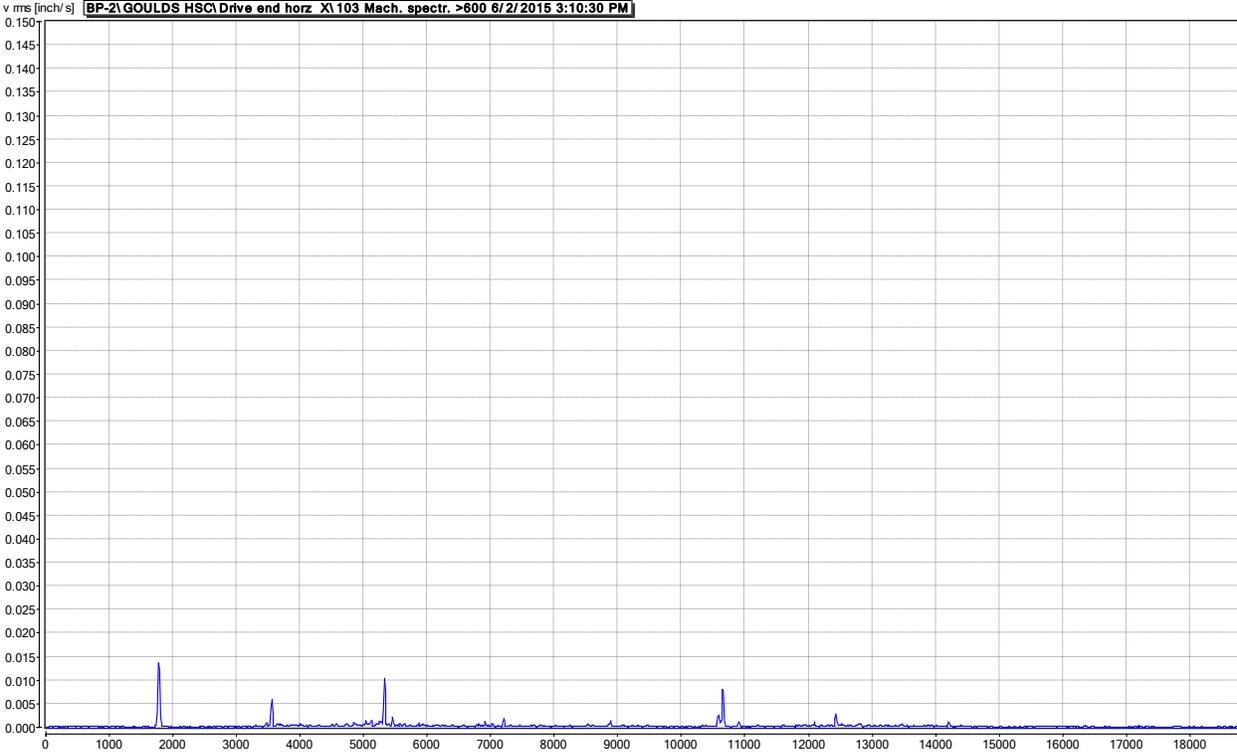
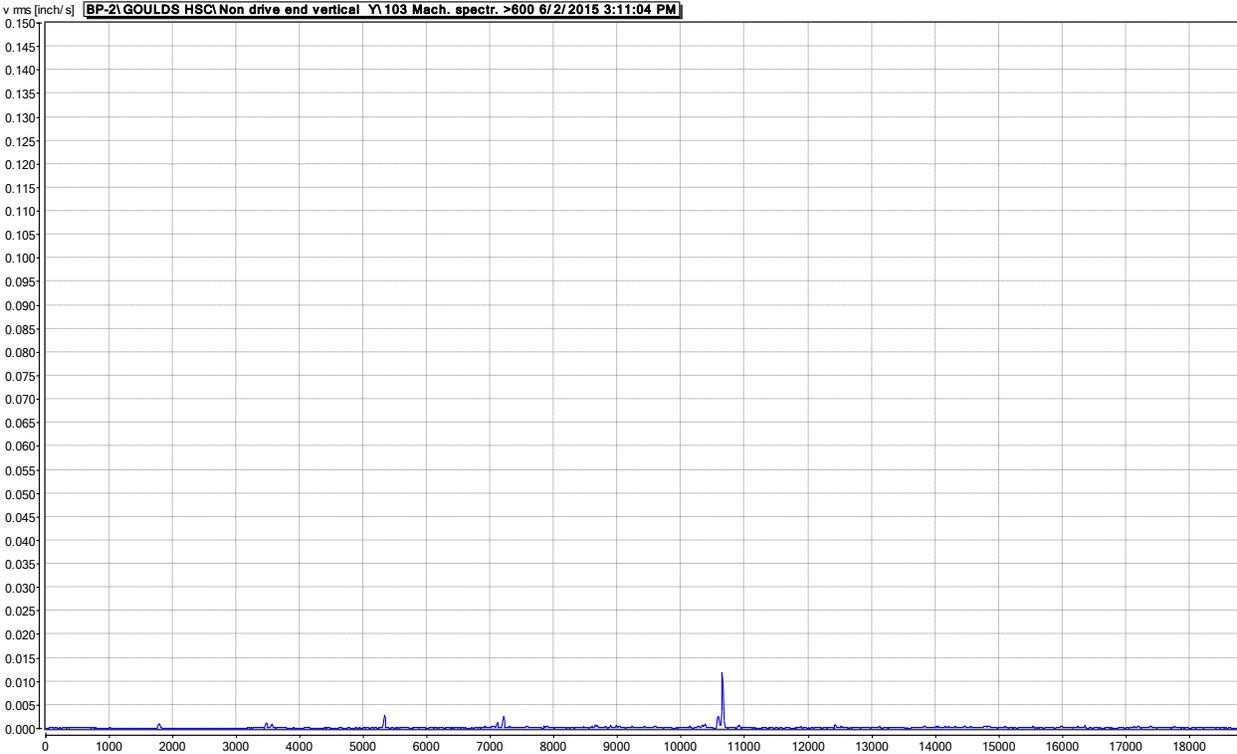
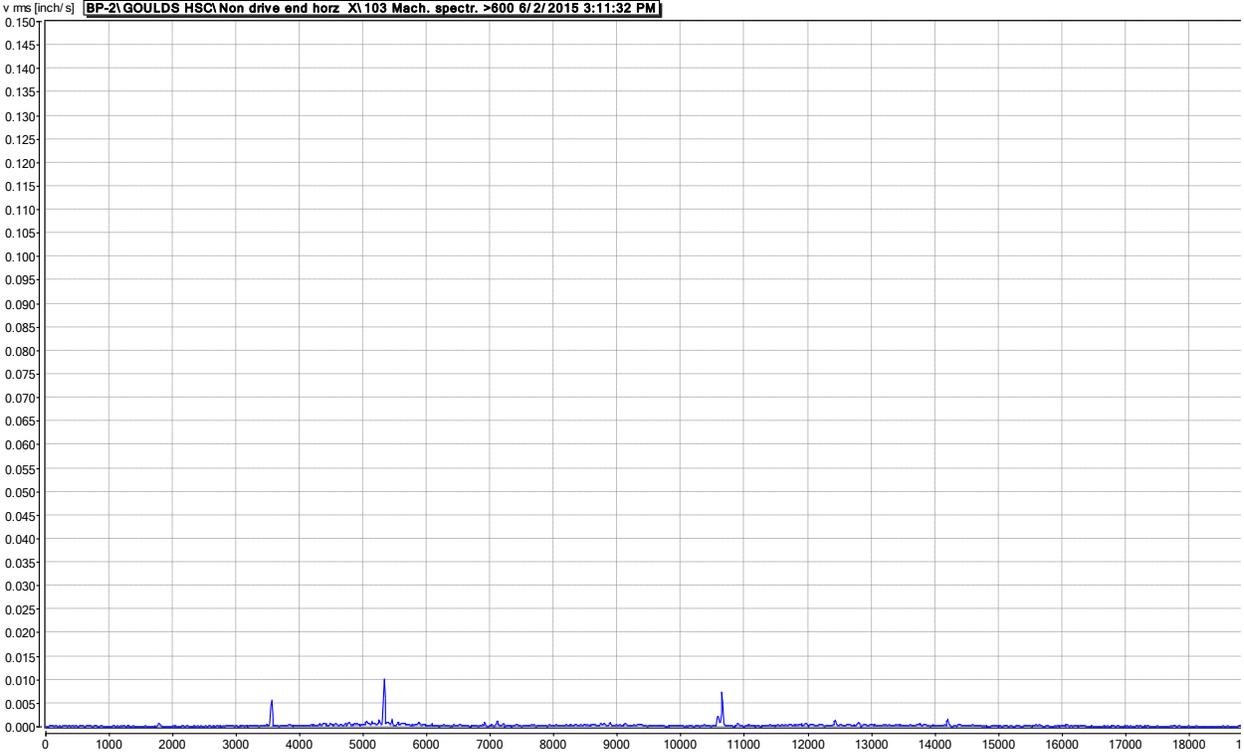
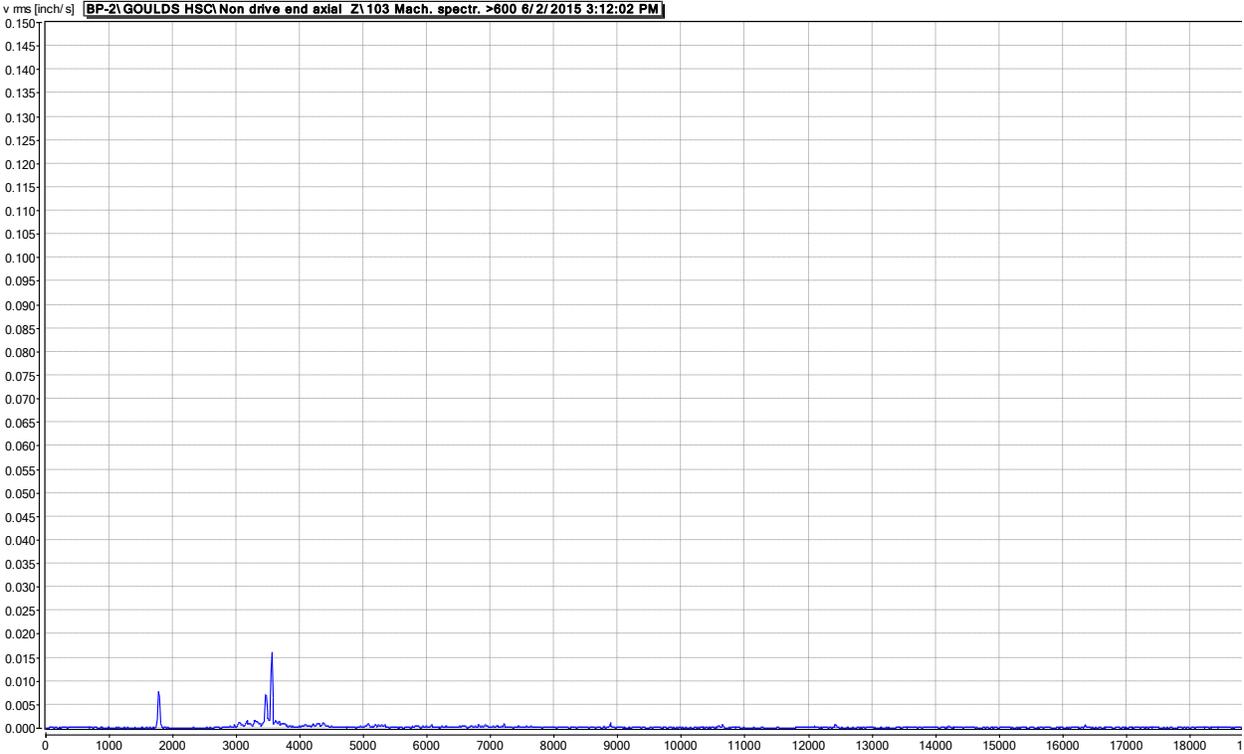
Figure 48: Motor ODE-Y Filtered Vibration, all peaks are below 0.015 in/sec

Figure 49: Motor ODE-X Filtered Vibration, all peaks are below 0.015 in/sec

Figure 50: Motor ODE-Z Filtered Vibration, all peaks are below 0.010 in/sec

Figure 51: Motor DE-Y Filtered Vibration, highest peak is 0.034 in/sec at 1,778 cpm (1X run speed) with the remaining peaks below 0.015 in/sec

Figure 52: Motor DE-X Filtered Vibration, highest peak is 0.041 in/sec at 1,778 cpm (1X run speed) with the remaining peaks below 0.010 in/sec

Figure 53: Pump DE-Y Filtered Vibration, all peaks are below 0.010 in/sec

Figure 54: Pump DE-X Filtered Vibration, all peaks are below 0.010 in/sec

Figure 55: Pump ODE-Y Filtered Vibration, all peaks are below 0.015 in/sec

Figure 56: Pump ODE-X Filtered Vibration, all peaks are below 0.010 in/sec

Figure 57: Pump ODE-Z Filtered Vibration, the highest peak is 0.016 in/sec at 3,551 cpm (2X run speed)

The motor and pump vibration are very low at all locations.

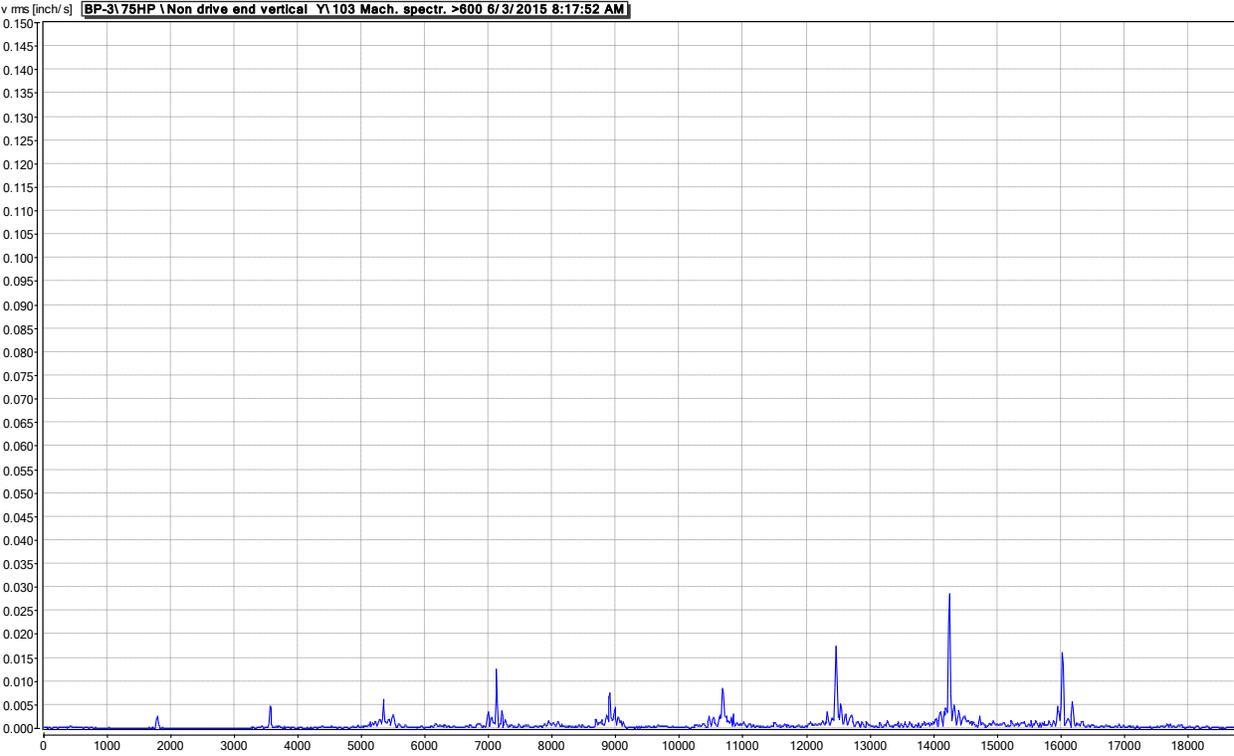
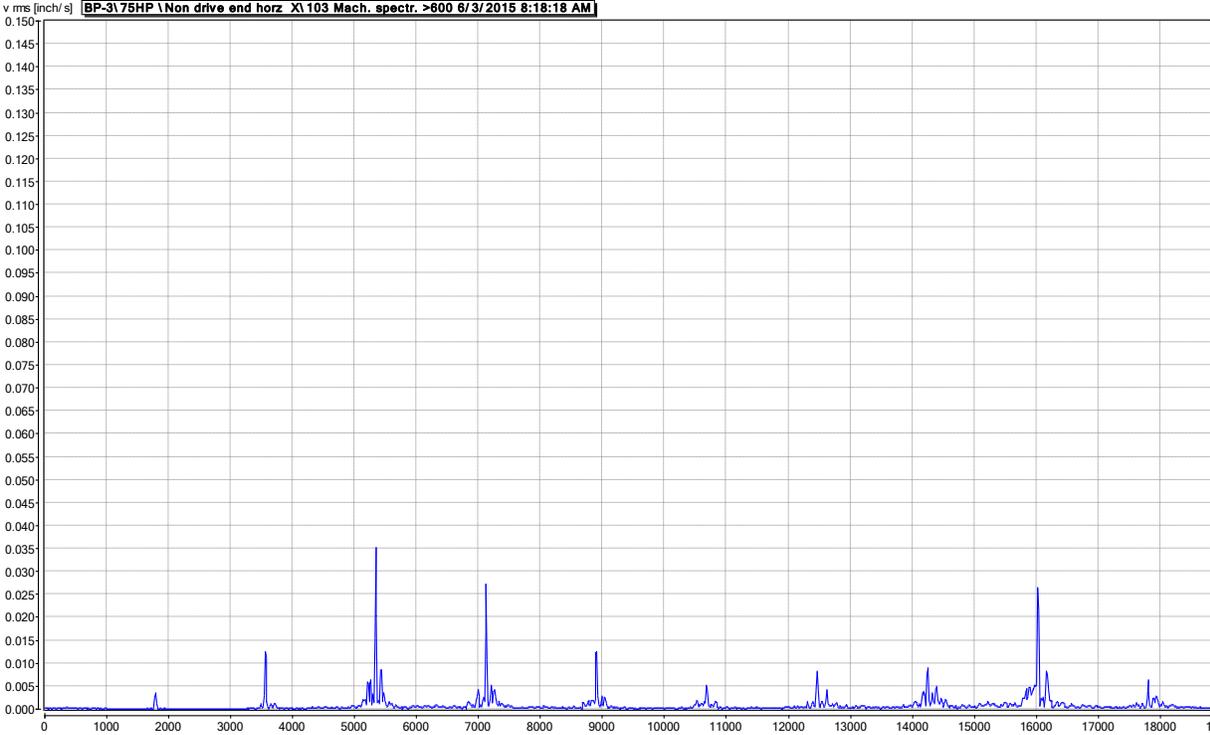
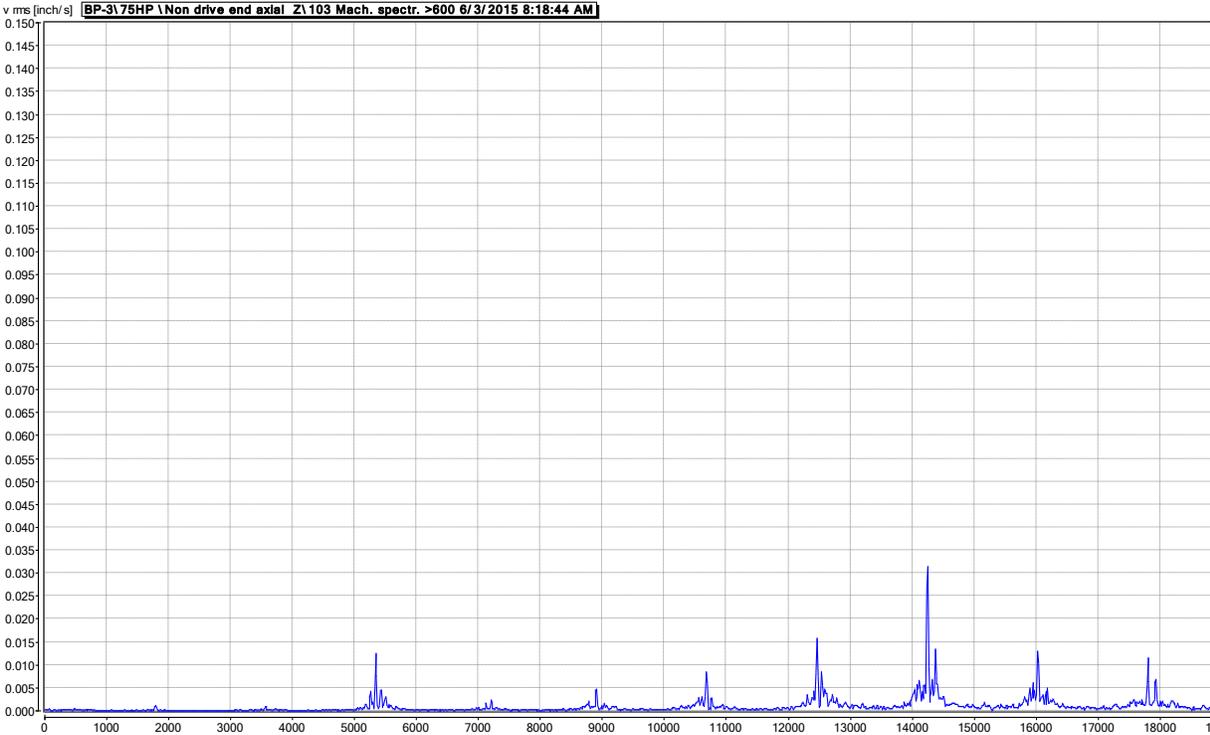
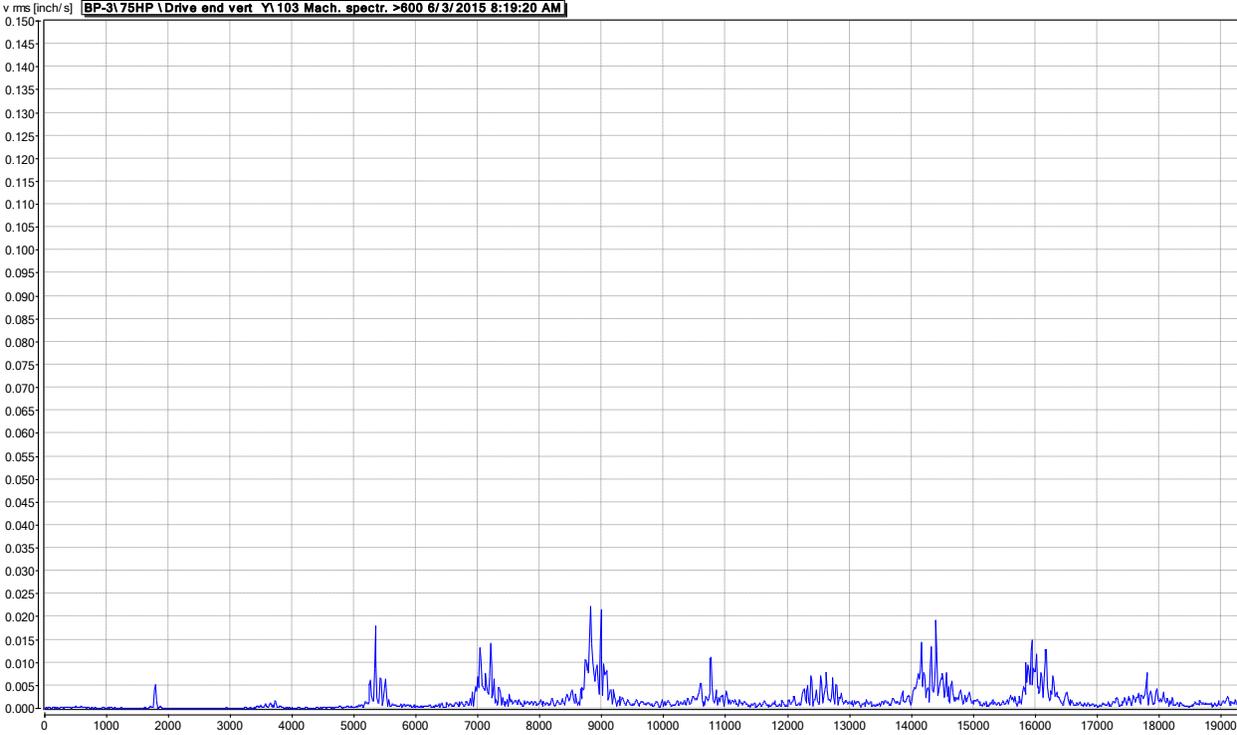
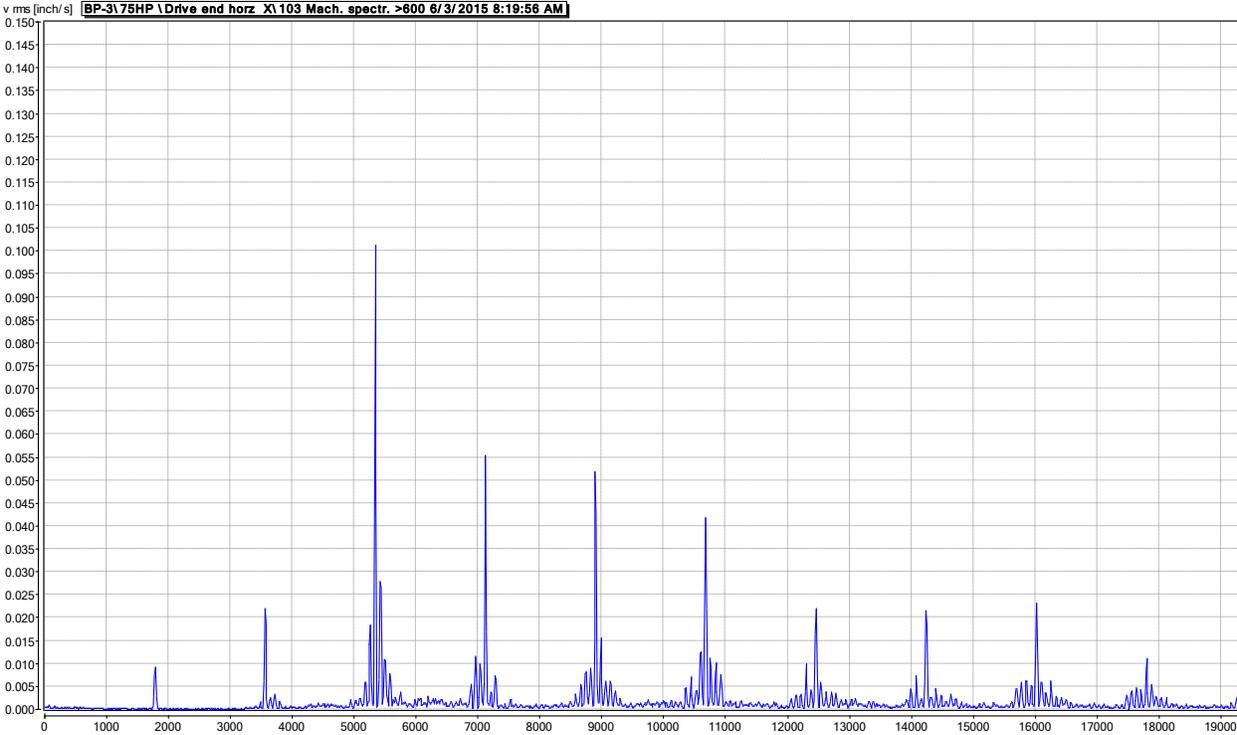
Figure 58: Motor ODE-Y Filtered Vibration, the highest peak is 0.029 in/sec at 14,246 cpm (8X run speed) with other peaks at 1X, 2X, 3X, 4X, 5X, 6X, 7X, and 9X

Figure 59: Motor ODE-X Filtered Vibration, the highest peak is 0.035 in/sec at 5,340 cpm (3X run speed) with other peaks at 1X, 2X, 4X, 5X, 6X, 7X, 8X, and 9X

Figure 60: Motor ODE-Z Filtered Vibration, the highest peak is 0.032 in/sec at 14,242 cpm (8X run speed) with other peaks at 3X, 6X, 7X, 8X, 9X, 10X, 11X, and 12X

Figure 61: Motor DE-Y Filtered Vibration, highest peak is 0.022 in/sec at 8,816cpm (4.9X run speed) with other peaks at 1X, 3X, 4X, 6X, 7X, 8X, and 9X

Figure 62: Motor DE-X Filtered Vibration, highest peak is 0.101 in/sec at 5,340 cpm (3X run speed) with other peaks at 1X, 2X, 4X, 5X, 6X, 7X, 8X, 9X, 10X, 11X, and 12X

The motor vibration has peaks at 1X up to 12X consistently. This is an indication of looseness in the motor or bearings. The motor should be inspected soon.

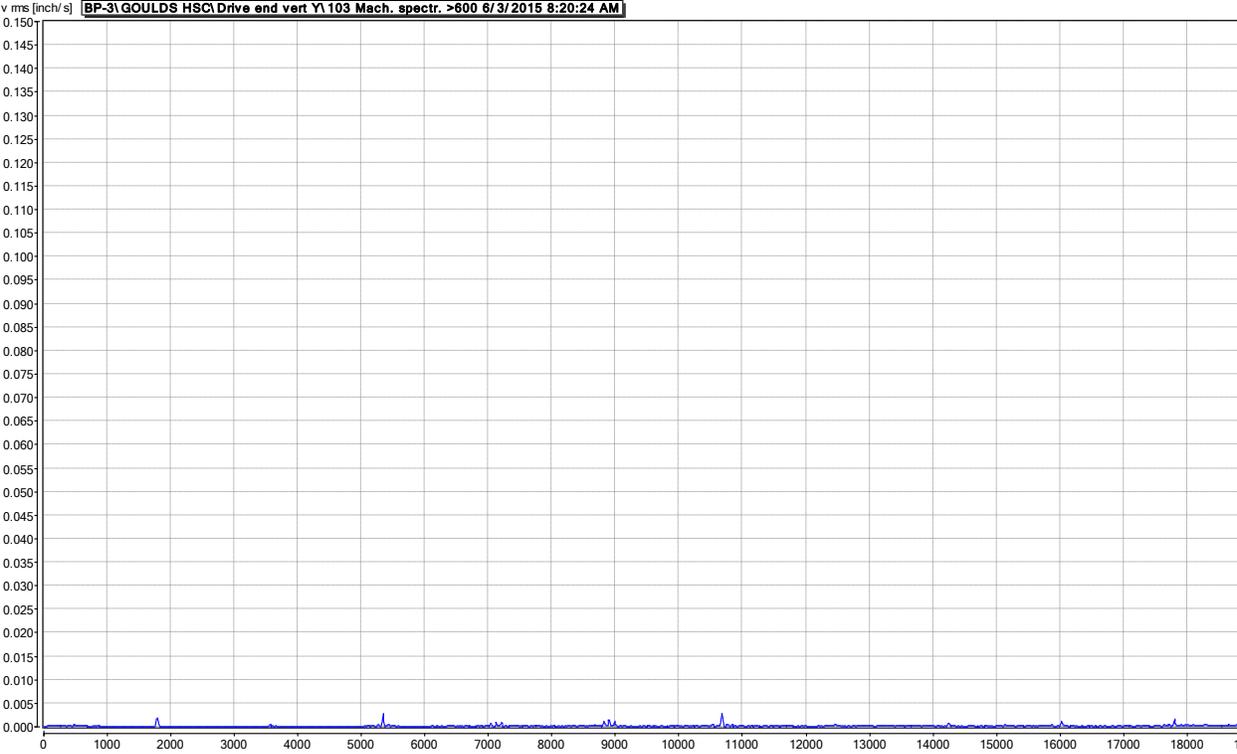
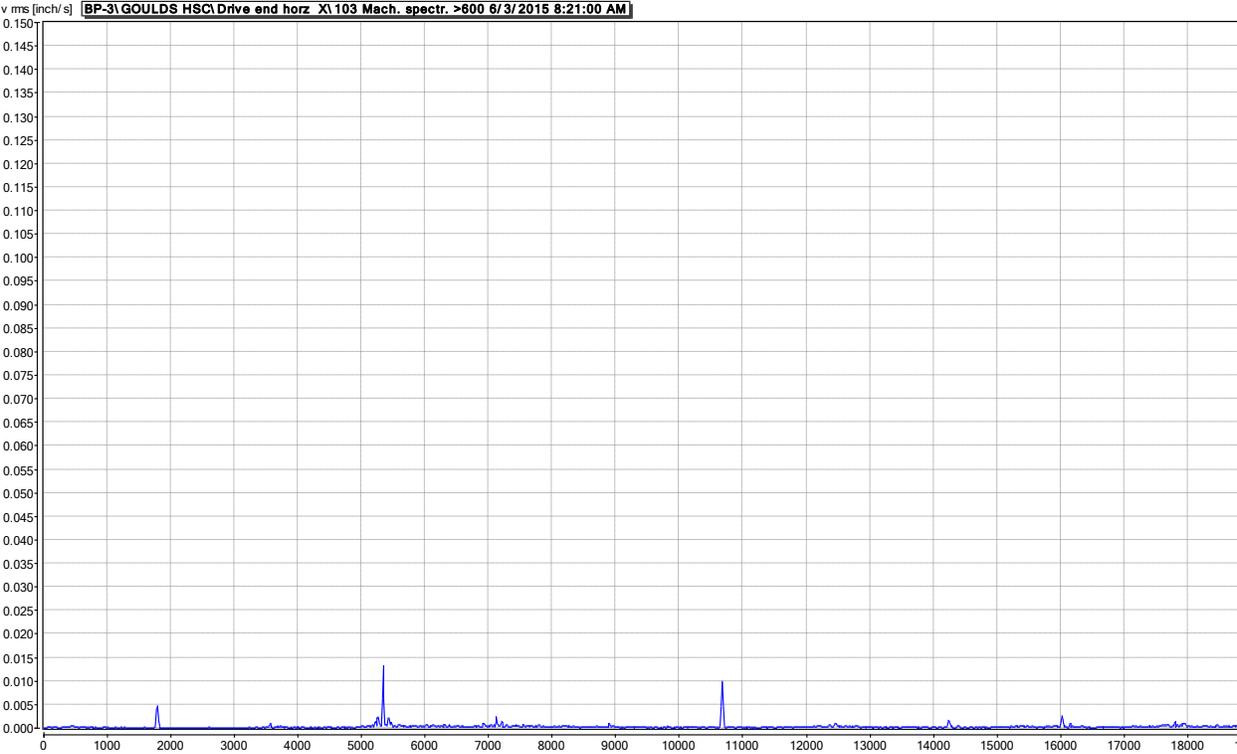
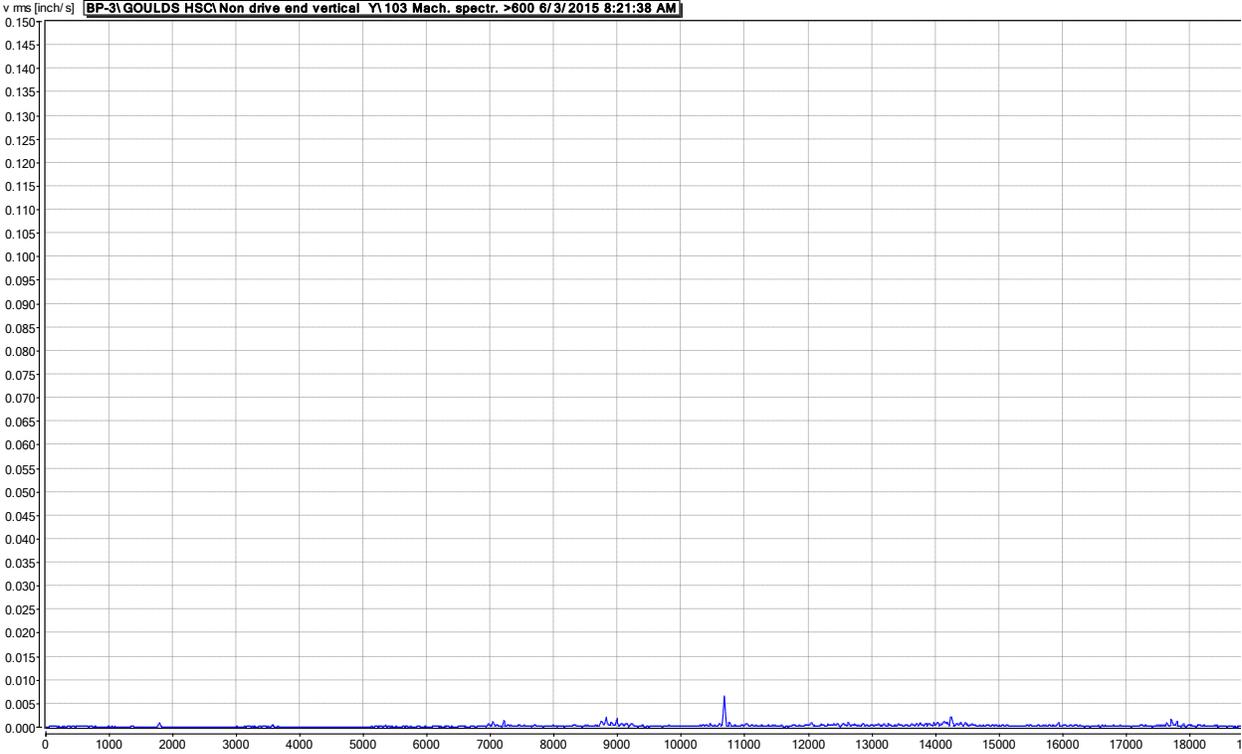
Figure 63: Pump DE-Y Filtered Vibration, all peaks are below 0.005 in/sec

Figure 64: Pump DE-X Filtered Vibration, all peaks are below 0.015 in/sec

Figure 65: Pump ODE-Y Filtered Vibration, all peaks are below 0.010 in/sec

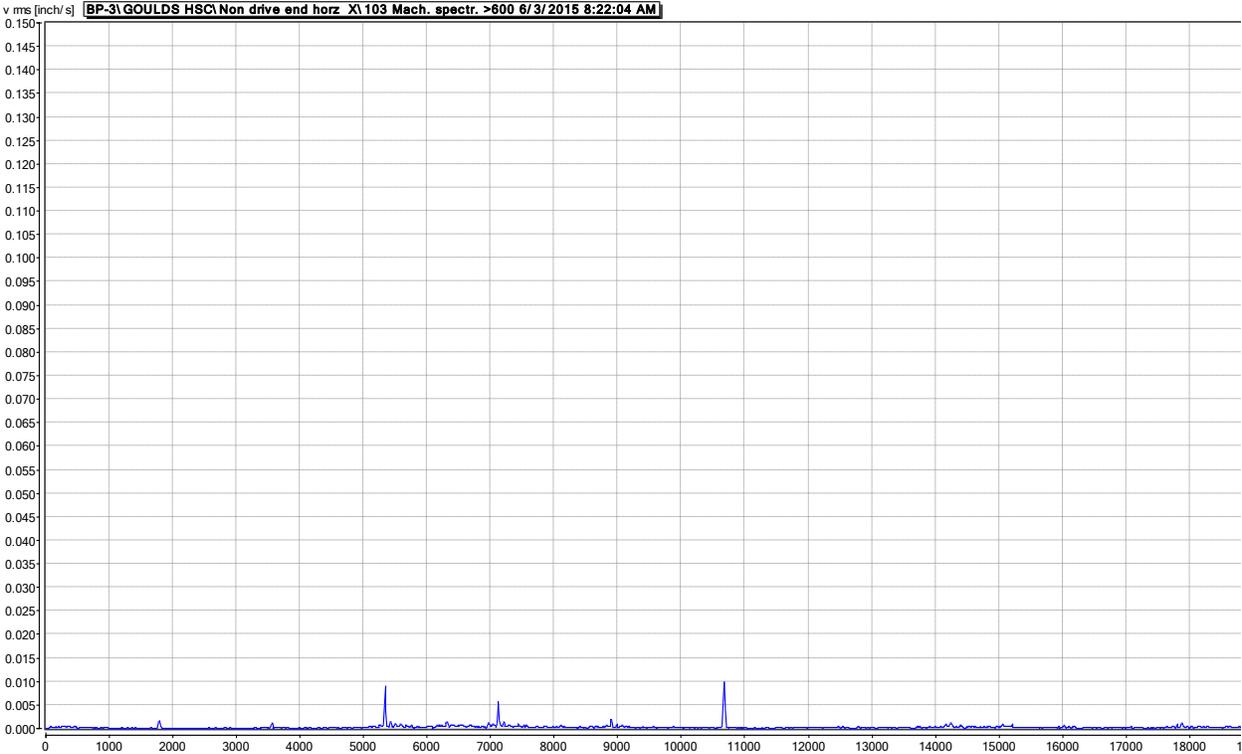
Figure 66: Pump ODE-X Filtered Vibration, all peaks are below 0.010 in/sec

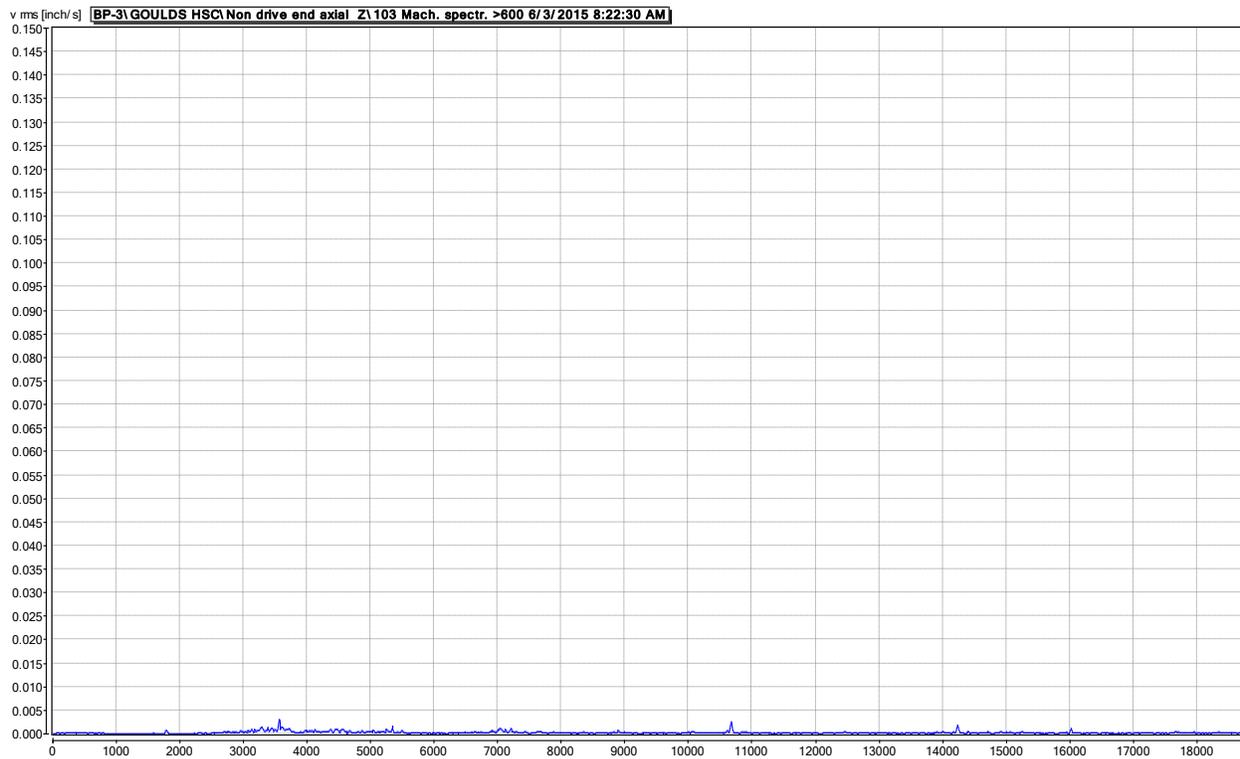
Figure 67: Pump ODE-Z Filtered Vibration, all peaks are below 0.005 in/sec

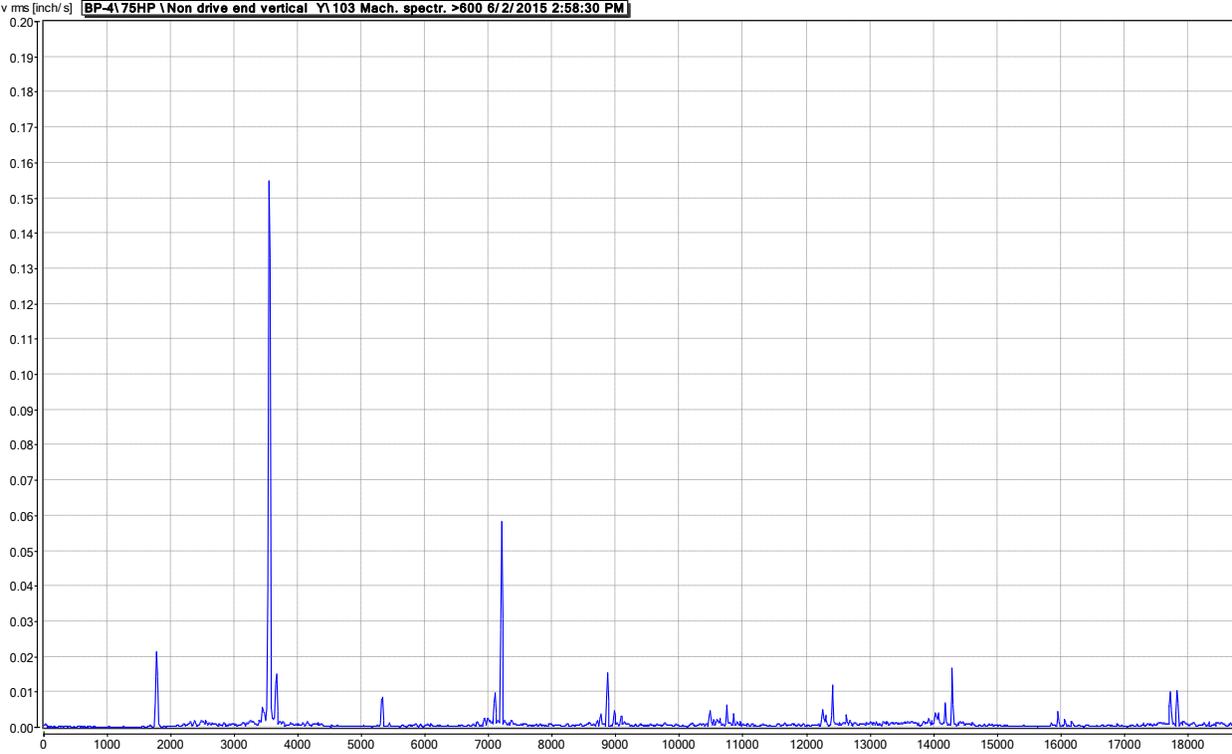
Figure 68: Motor ODE-Y Filtered Vibration, the highest peak is 0.155 in/sec at 3,548 cpm (2X run speed) with other peaks at 1X, 3X, 4X, 5X, 7X, and 8X

The motor vibration has peaks at 1X up to 7X consistently. This is an indication of looseness in the motor or bearings. The motor should be inspected soon.

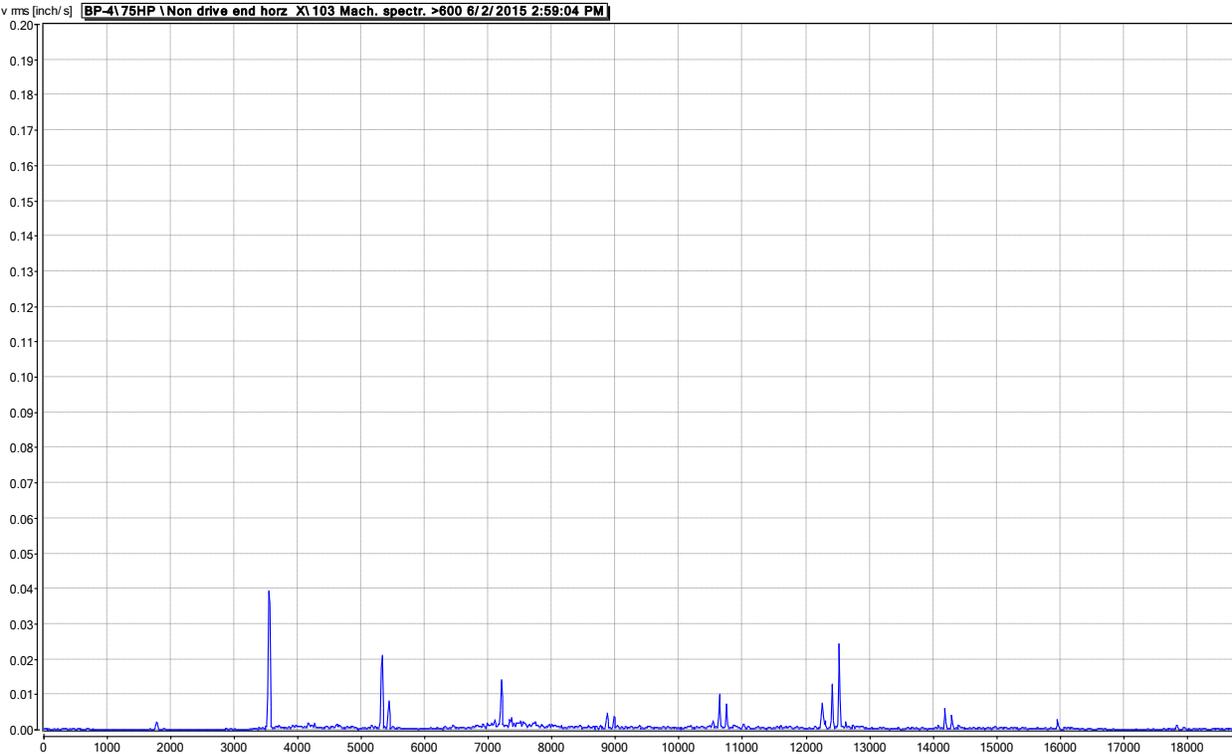
Figure 69: Motor ODE-X Filtered Vibration, the highest peak is 0.039 in/sec at 3,548 cpm (2X run speed) with other peaks at 3X, 4X, 6X, and 7X

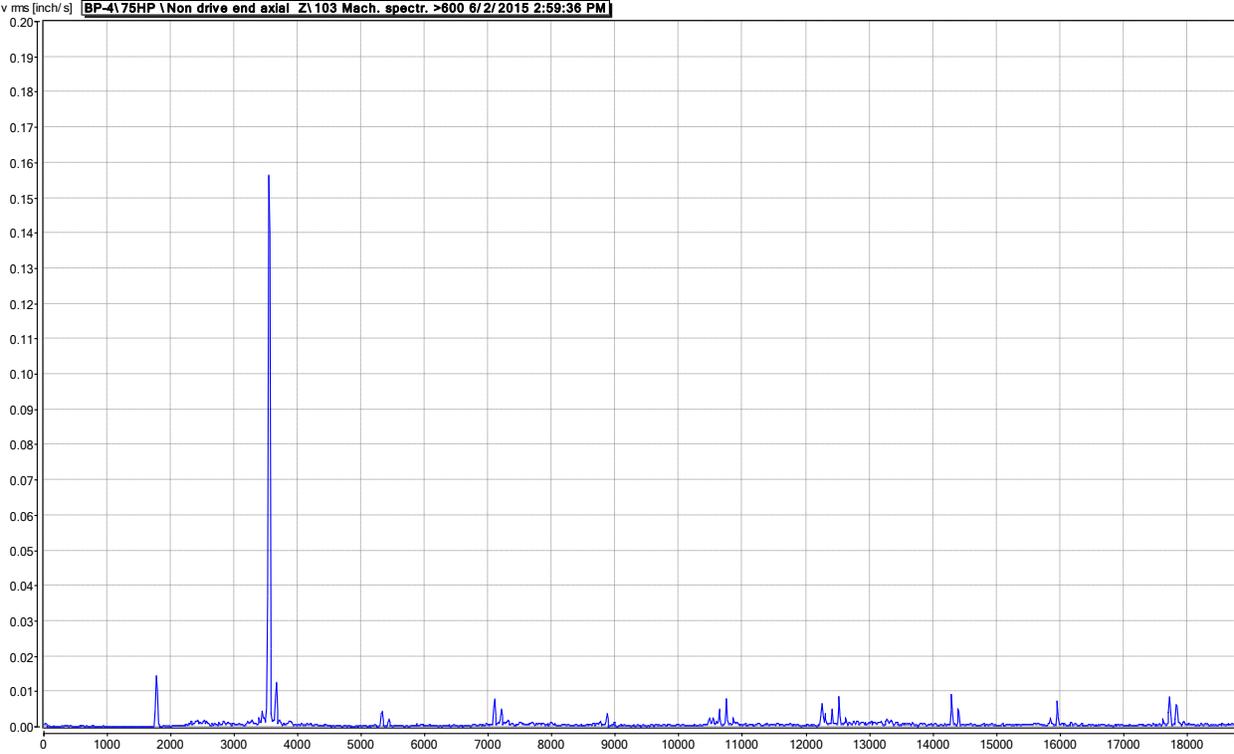
Figure 70: Motor ODE-Z Filtered Vibration, the highest peak is 0.157 in/sec at 3,548 cpm (2X run speed) with other peak at 1X

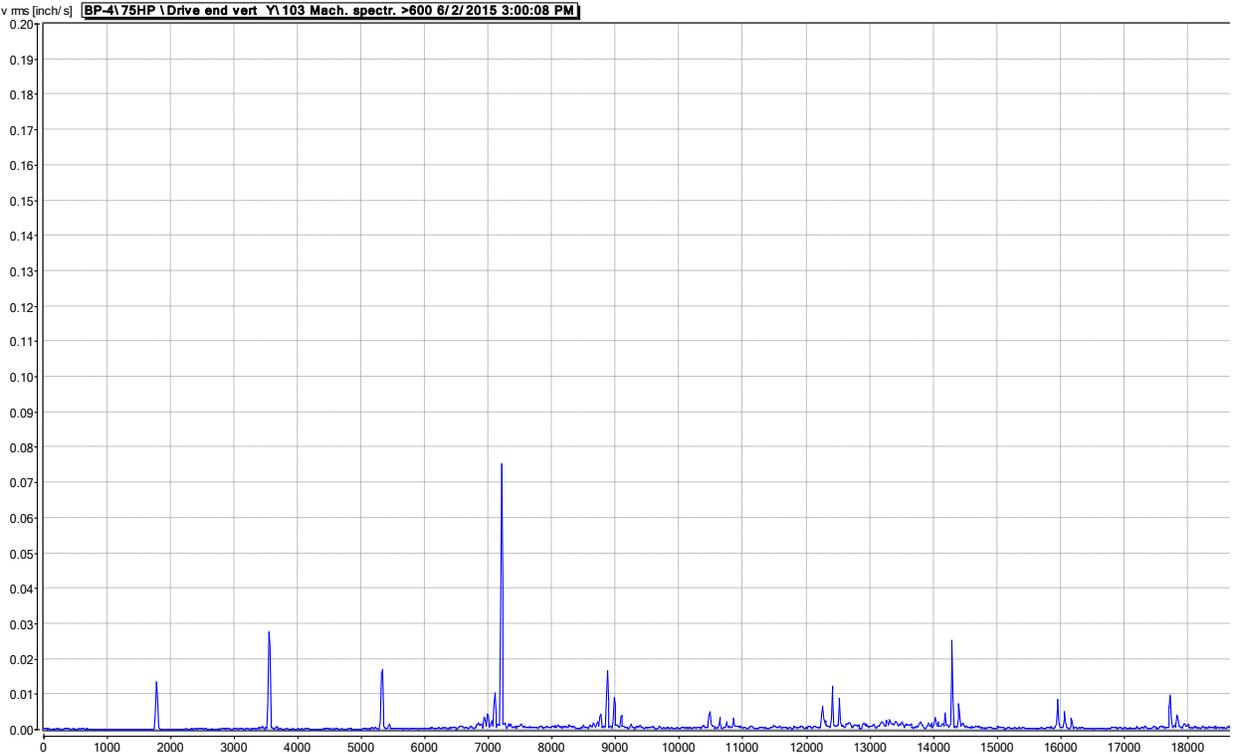
Figure 71: Motor DE-Y Filtered Vibration, highest peak is 0.075 in/sec at 7,200 cpm (4X run speed) with other peaks at 1X, 2X, 3X, 5X, 7X, and 8X
