PALM STREET WATER PLANT CONDITION ASSESSMENT

City of Huntsville

November 9, 2015

FREESE AND NICHOLS, INC.
11200 Broadway Street
Offices West, Suite 2332
Pearland, TX 77584
832-456-4700

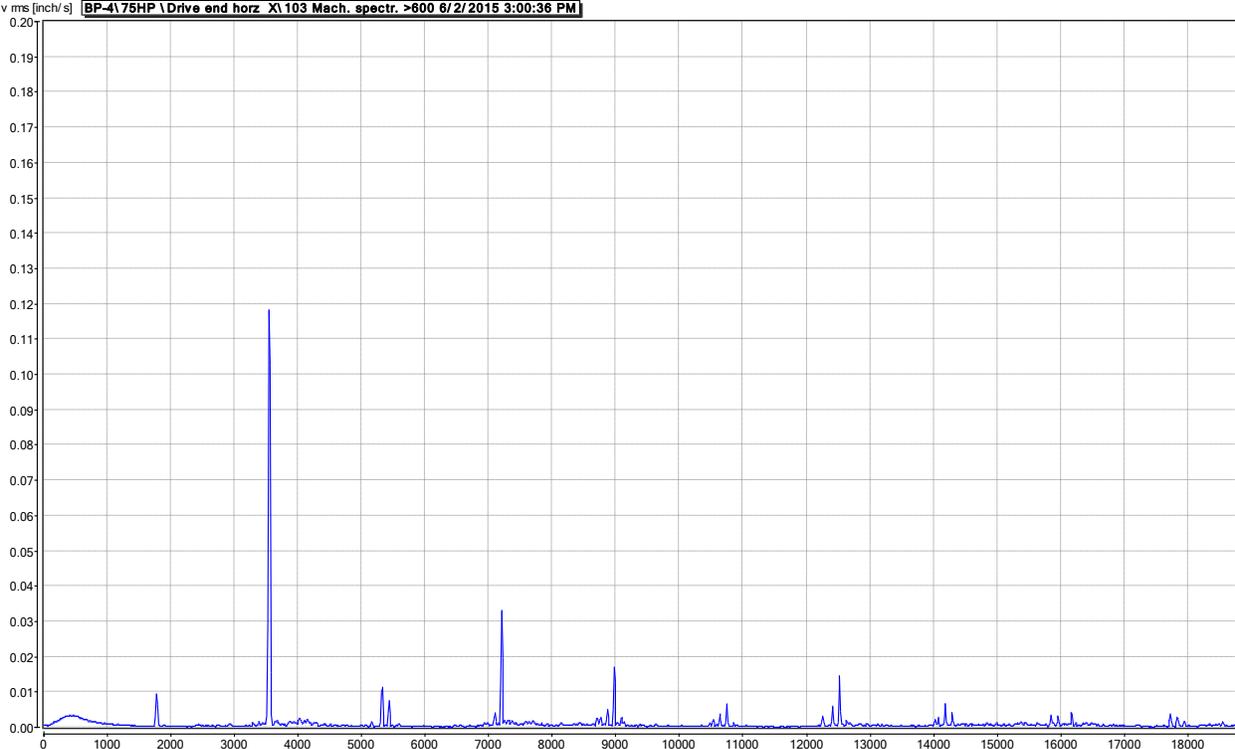
Figure 72: Motor DE-X Filtered Vibration, highest peak is 0.118 in/sec at 3,548 cpm (2X run speed) with other peaks at 1X, 3X, 4X, 5X, and 7X

The motor vibration has peaks at 1X up to 7X consistently. This is an indication of looseness in the motor or bearings. The motor should be inspected soon.

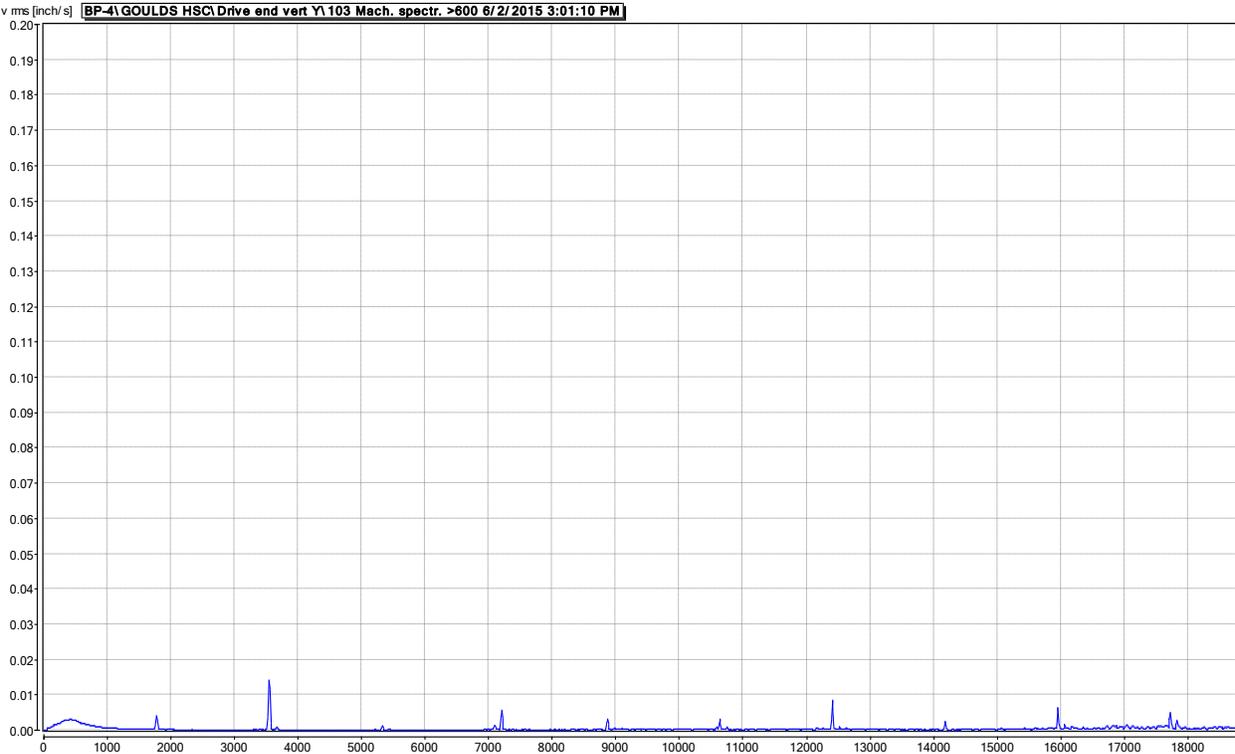
Figure 73: Pump DE-Y Filtered Vibration, all peaks are below 0.015 in/sec

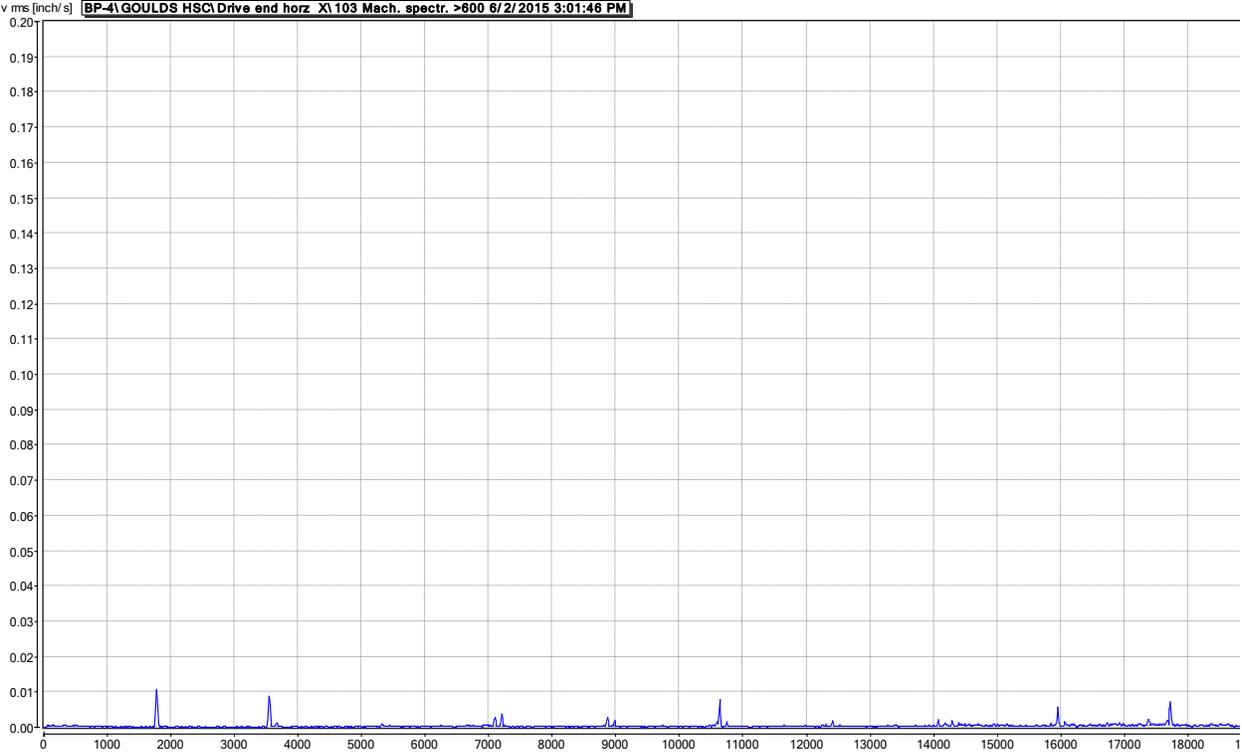
Figure 74: Pump DE-X Filtered Vibration, all peaks are below 0.015 in/sec

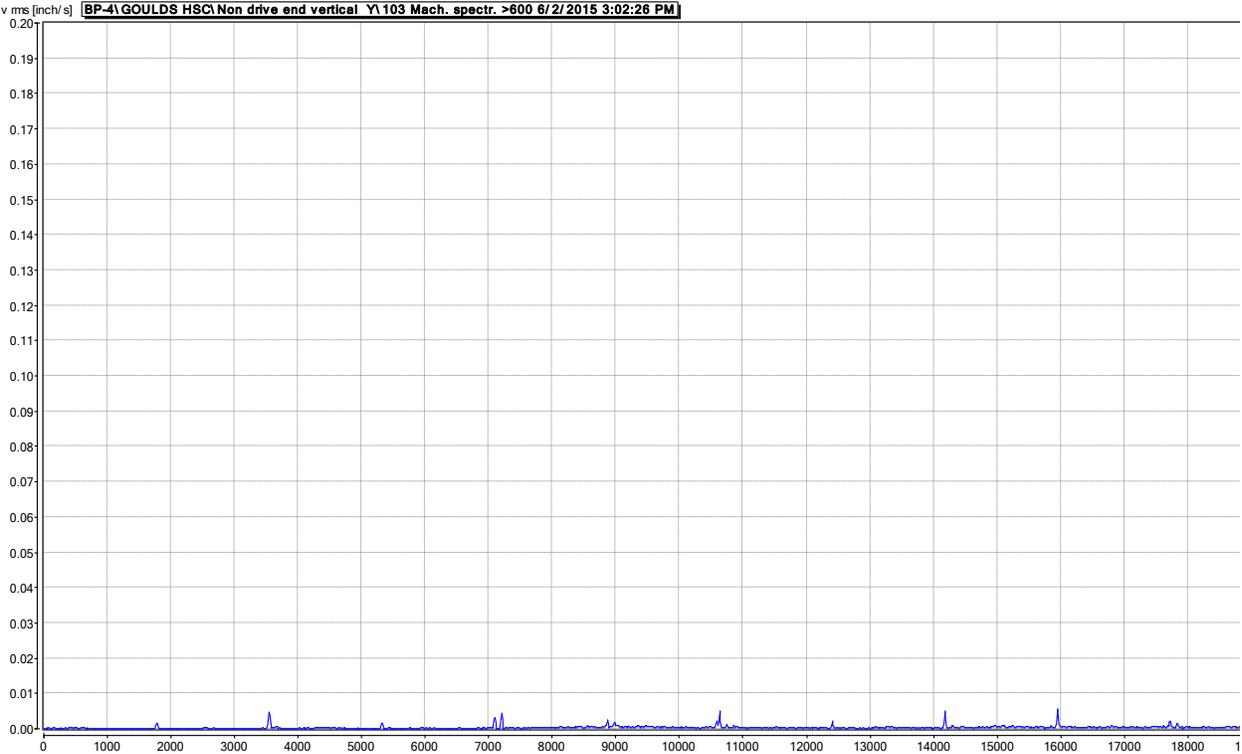
Figure 75: Pump ODE-Y Filtered Vibration, all peaks are below 0.010 in/sec

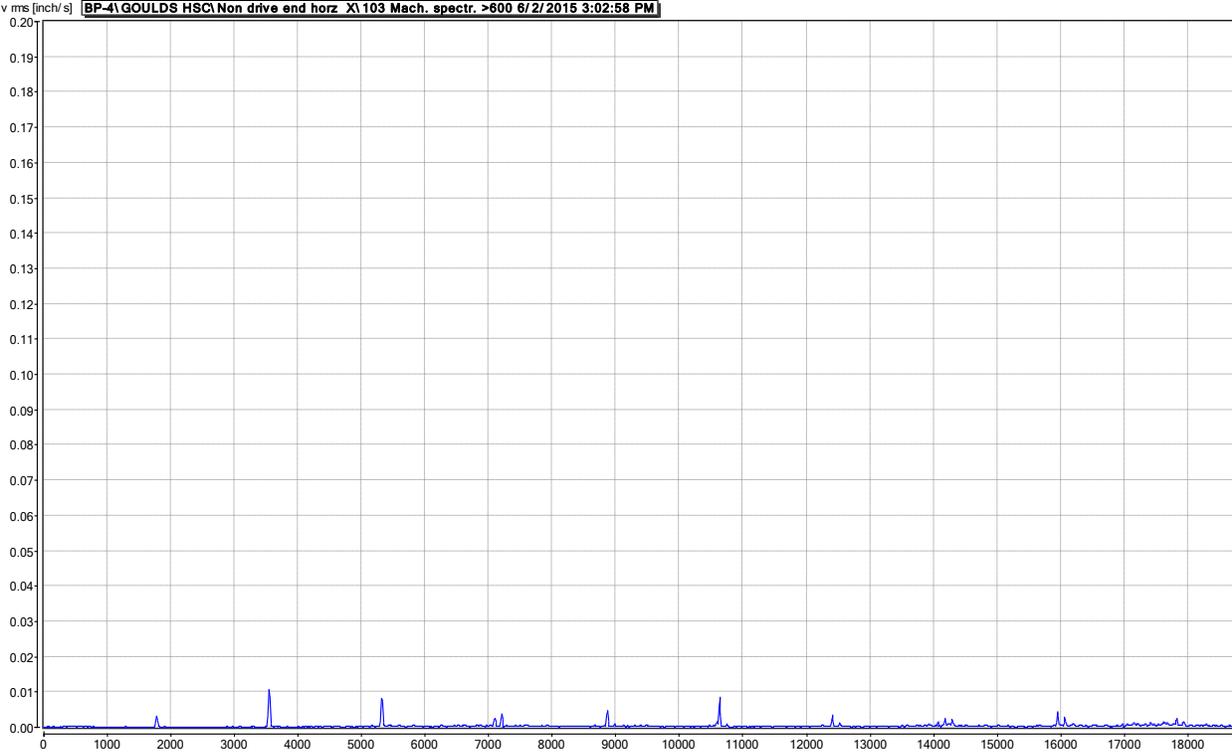
Figure 76: Pump ODE-X Filtered Vibration, all peaks are below 0.015 in/sec

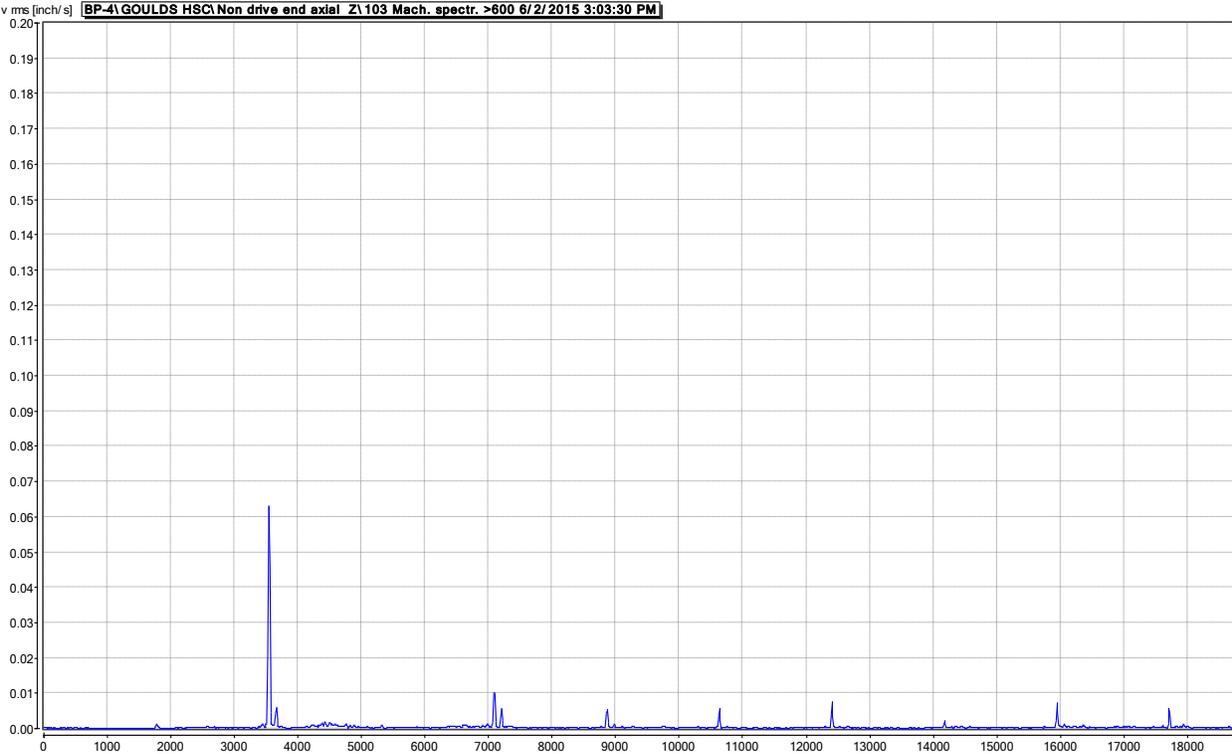
Figure 77: Pump ODE-Z Filtered Vibration, the highest peak is 0.063 in/sec at 3,548 cpm (2X run speed)

The pump vibration is low and has a consistent vibration at 2X which is likely caused parallel and angular misalignment.
