## **APPENDIX C**

### **Water System Field Testing Results**

**PROJECT:** Water and Wastewater Condition and Capacity Assessment Studies  
Spring Lake Water Plant Pump Testing

### Water and Wastewater System Condition and Capacity Studies

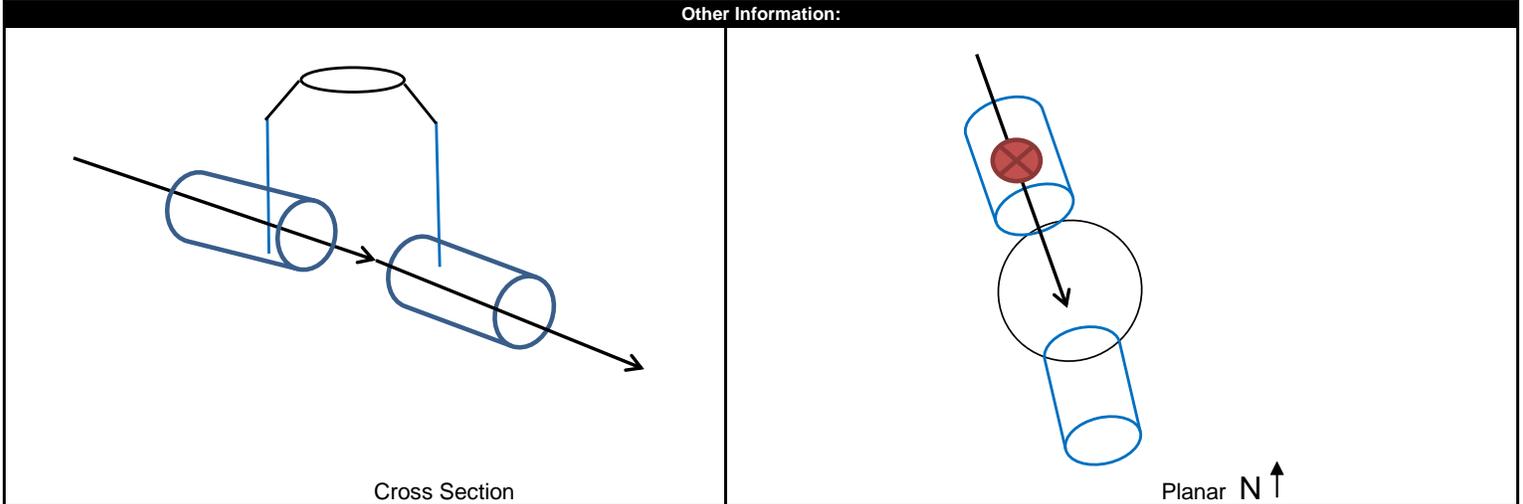
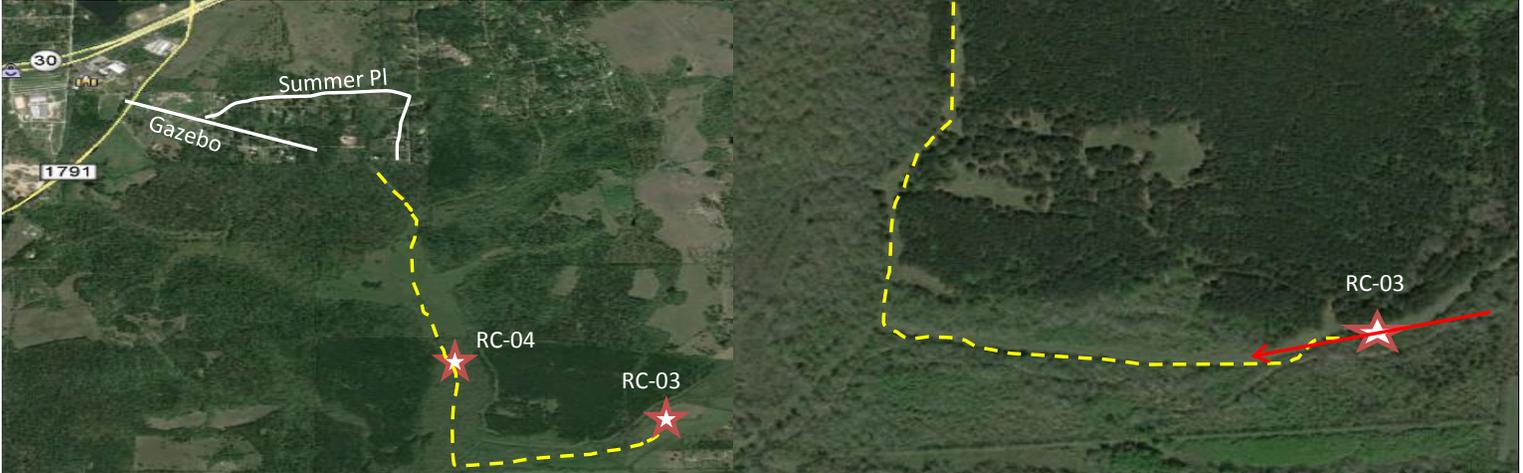
Installation Information		Backup	Yes	No	?	Distance
Installation Type:	Ring Crank	Trunk		X		
Sensors / Devices:	IJVP	Lift/Pump Station		X		
Surcharge Height:	4 Feet	WWTP		X		
Rain Gauge Zone:		Other		X

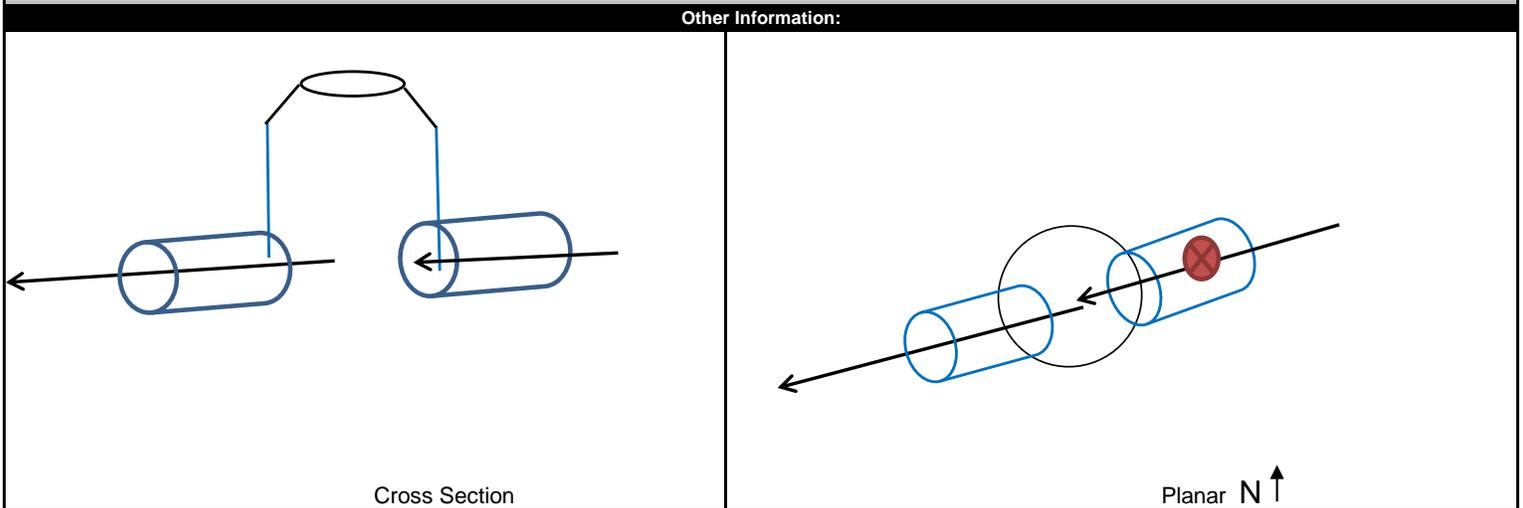
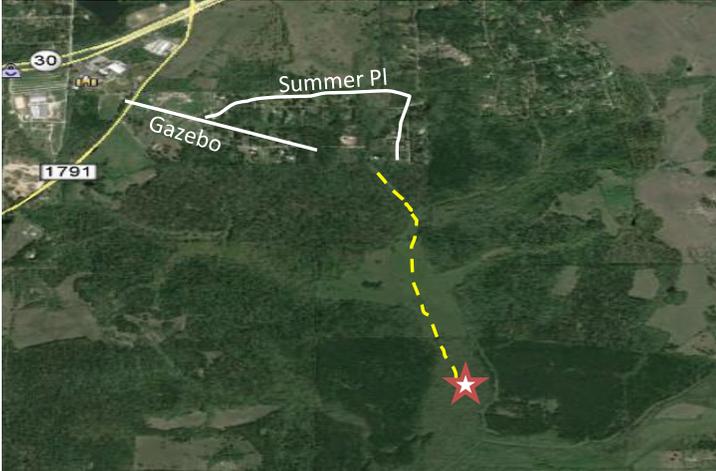
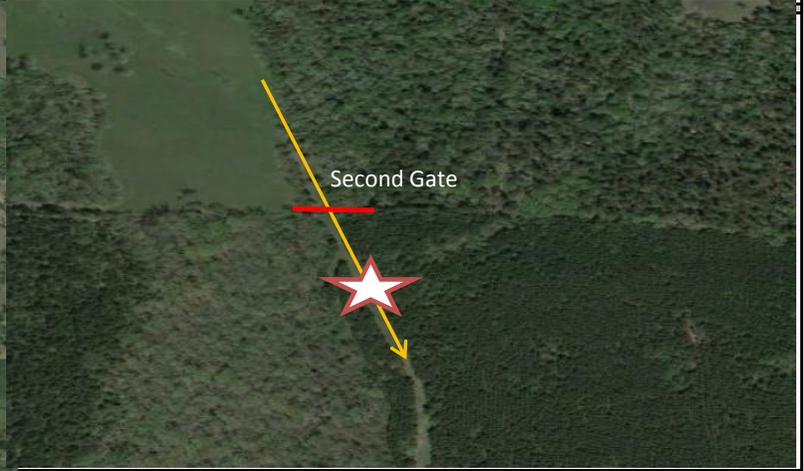
Installation Information		Backup	Yes	No	?	Distance
Installation Type:	Ring Crank	Trunk			X	1500
Sensors / Devices:	IJVP	Lift/Pump Station		X		
Surcharge Height:	12 Feet	WWTP		X		
Rain Gauge Zone:		Other		X

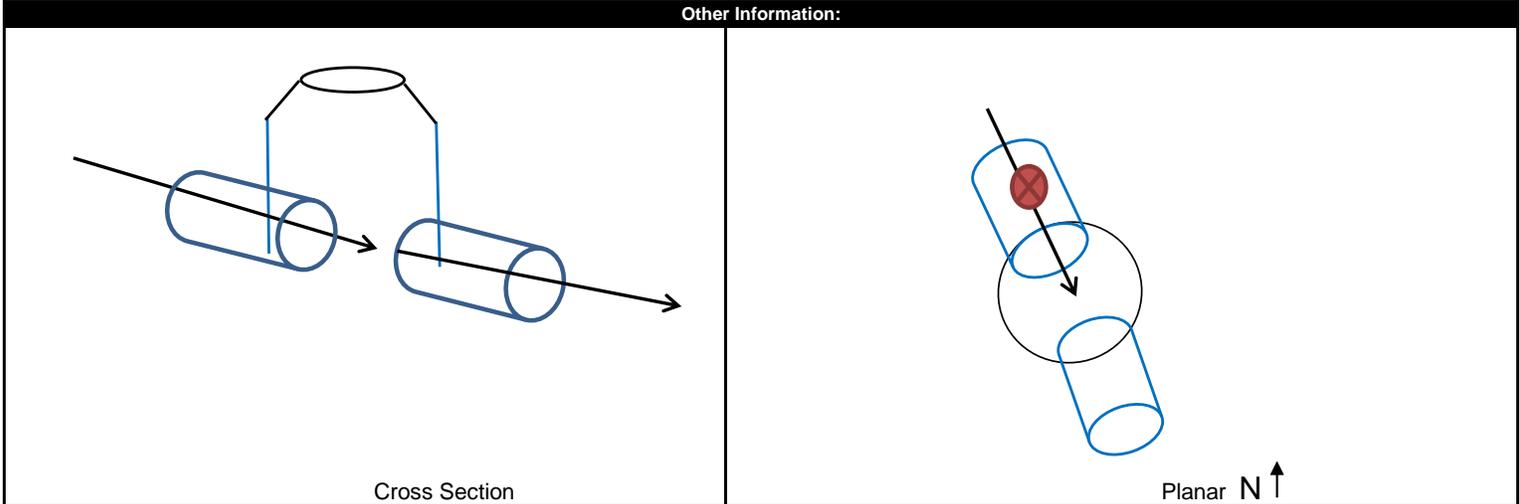
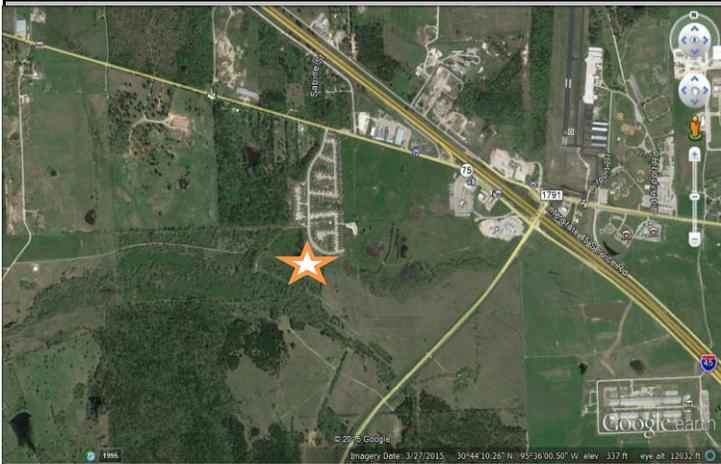
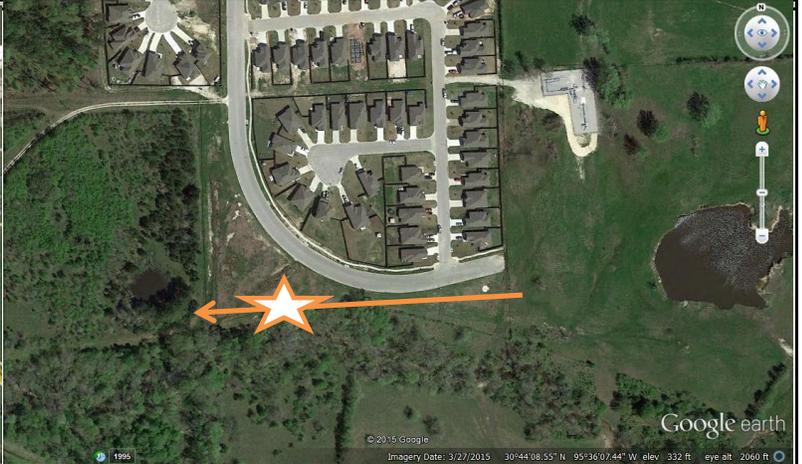
Installation Information		Backup	Yes	No	?	Distance
Installation Type:	Ring Crank	Trunk		X		
Sensors / Devices:	IJVP	Lift/Pump Station		X		
Surcharge Height:	12 Feet	WWTP			X	3000'
Rain Gauge Zone:		Other		X

GPS: N30°44'39.60" W095°32'45.08" Need key for locked gates

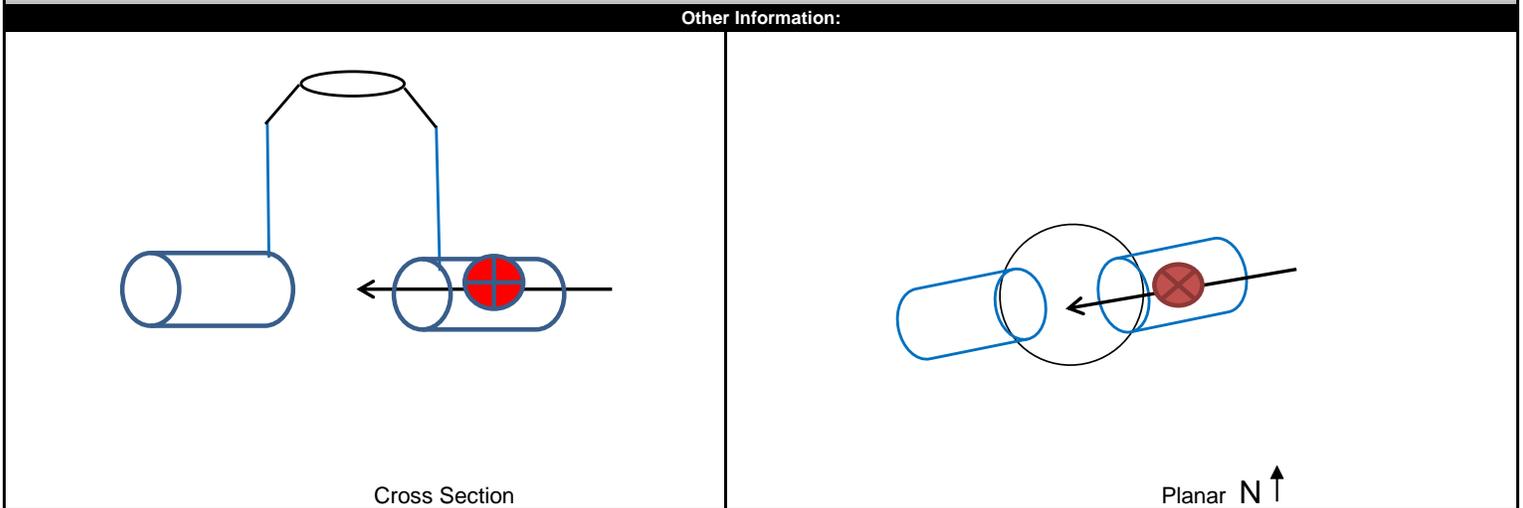
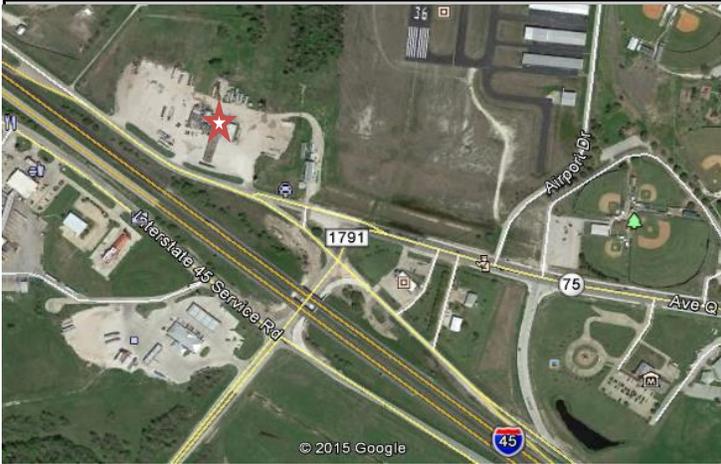
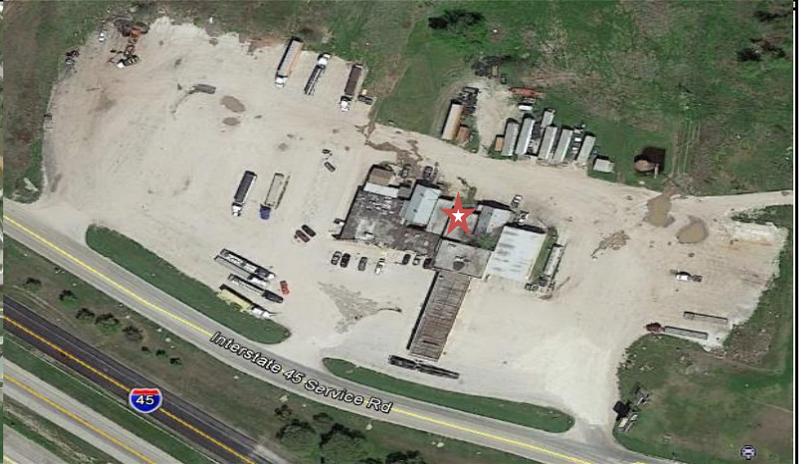
Installation Information		Backup	Yes	No	?	Distance
Installation Type:	Ring Crank	Trunk			X	1500'
Sensors / Devices:	IJVP	Lift/Pump Station		X		
Surcharge Height:	4 Feet	WWTP		X		
Rain Gauge Zone:		Other		X

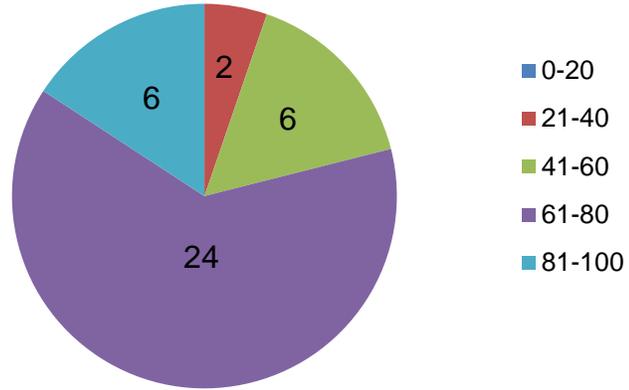
The individual scores and defects for each manhole are provided in the attached appendix. The highest priority manholes are Manholes 0087, 0364, 0366, 0104, and 0369. Manholes are scored on a 0 (best) to 100 (worst) system. Figure 1 displays the number of manholes within each score range.

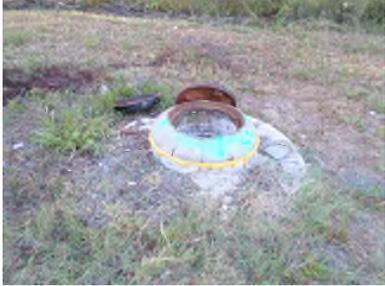
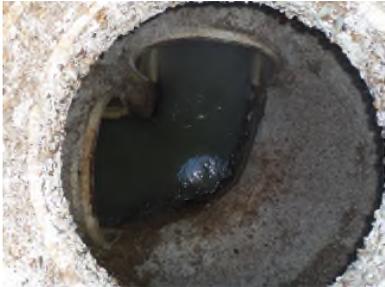
<p>Defects</p> <p>Chimney corrosion minor</p> <p>Frame corrosion moderate</p> <p>Grade ring crack moderate</p> <p>Cone corrosion moderate</p> <p>Bench corrosion moderate</p> <p>Channel corrosion moderate</p> <p>Wall corrosion minor</p> <p style="text-align: right;"><i>Overall Score</i></p> <p style="text-align: right;">Total <b>68</b></p>
--	---

Comments  
Concrete around the frame of the manhole has minor cracks

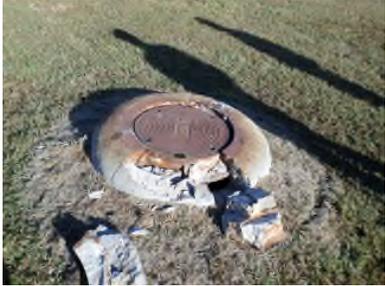
GPS Verified? N/A	MH On Map? Yes	MH Located? Yes	MH Inspected? No, CNA	Surface Cover	Surface Material
----------------------	-------------------	--------------------	--------------------------	---------------	------------------

A total of 43 manhole inspections were assigned, and 42 manhole inspections were completed in the Robinson Creek Basin. Manhole 0003 was not accessible for inspection due to the poor condition of the manhole. This manhole needs a frame and cover replacement, the frame is in danger of falling into the manhole if disturbed.

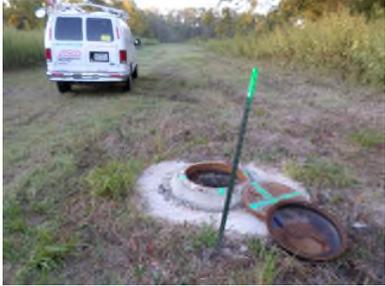
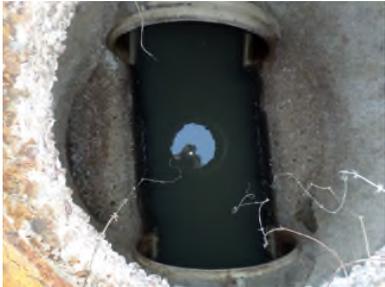
<p>Defects</p> <p>Grade ring crack minor</p> <p>Cone corrosion minor</p> <p>Bench corrosion minor</p> <p>Channel corrosion minor</p> <p>Pipe seal I/I evidence major</p> <p>Wall corrosion minor</p> <p style="text-align: right;"><i>Overall Score</i></p> <p style="text-align: right;">Total        <b>76</b></p>
--	---

Flow monitor RCO1 from the 2015 Temporary Inflow and Infiltration study. This location contains an inflow dish. oncrete around the frame of the manhole has minor cracks

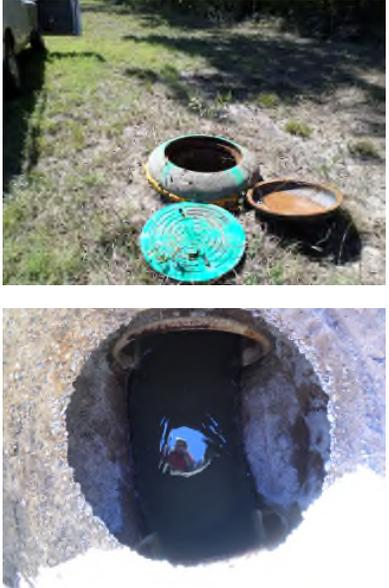
<p>Defects</p> <p>Chimney corrosion moderate</p> <p>Frame corrosion moderate</p> <p>Cone corrosion moderate</p> <p>Bench corrosion moderate</p> <p>Channel corrosion moderate</p> <p>Wall corrosion moderate</p>
--	--

*Overall Score*  
Total **67**

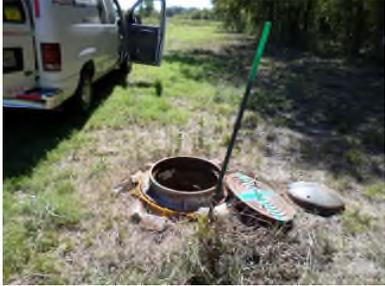
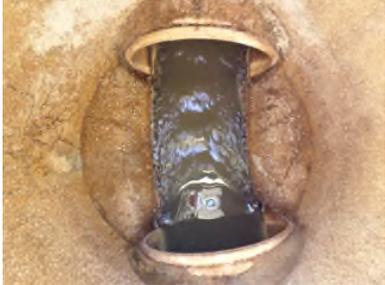
<table><tr> <td style="width: 70%;">Chimney corrosion minor</td> <td style="width: 30%; text-align: right;"><i>Overall Score</i></td> </tr><tr> <td>Frame base seal crack moderate</td> <td style="text-align: right;">Total <b>46</b></td> </tr><tr> <td>Frame base seal corrosion minor</td> <td></td> </tr><tr> <td>Frame corrosion moderate</td> <td></td> </tr><tr> <td>Grade ring crack major</td> <td></td> </tr><tr> <td>Cone corrosion minor</td> <td></td> </tr><tr> <td>Bench corrosion minor</td> <td></td> </tr><tr> <td>Channel corrosion minor</td> <td></td> </tr><tr> <td>Wall corrosion minor</td> <td></td> </tr></table>

The concrete around the frame has broken away from the frame and is offset slightly. This location contains an inflow dish.

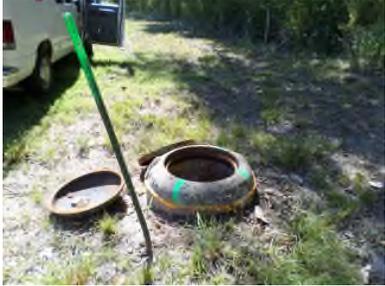
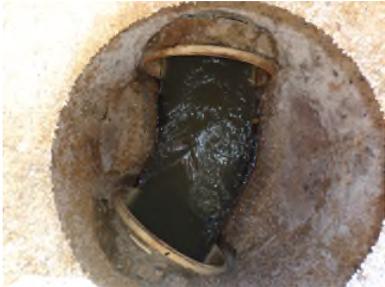
<p>Defects</p> <p>Chimney corrosion moderate</p> <p>Riser ring corrosion moderate</p> <p>Cone corrosion moderate</p> <p>Bench corrosion moderate</p> <p>Channel corrosion moderate</p> <p>Wall corrosion moderate</p> <p style="text-align: right;"><i>Overall Score</i></p> <p style="text-align: right;">Total        <b>66</b></p>
--	--

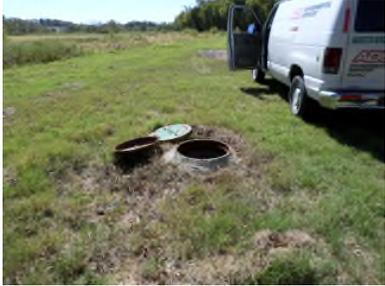
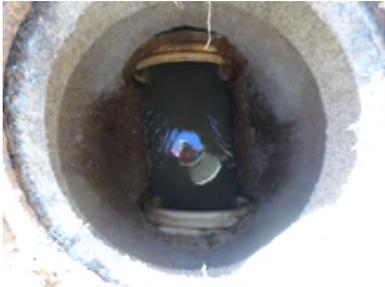
<p>Defects</p> <p>Chimney corrosion minor</p> <p>Cone corrosion minor</p> <p>Bench corrosion minor</p> <p>Channel corrosion minor</p> <p>Wall corrosion minor</p> <p style="text-align: right;"><i>Overall Score</i></p> <p style="text-align: right;">Total <b>46</b></p>
--	---

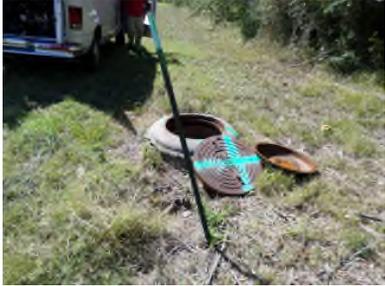
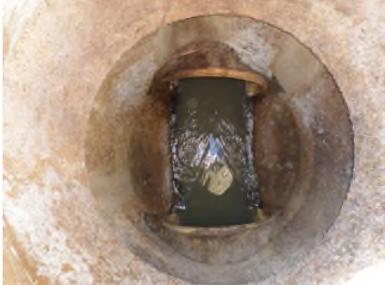
<p>Defects</p> <p>Chimney corrosion minor</p> <p>Frame base seal corrosion minor</p> <p>Cone corrosion minor</p> <p>Bench corrosion minor</p> <p>Channel corrosion minor</p> <p>Wall corrosion minor</p> <table style="width: 100%;"> <tr> <td style="text-align: right;"><i>Overall Score</i></td> <td></td> </tr> <tr> <td style="text-align: right;">Total</td> <td style="text-align: right;"><b>46</b></td> </tr> </table>	<i>Overall Score</i>		Total	<b>46</b>
<i>Overall Score</i>					
Total	<b>46</b>

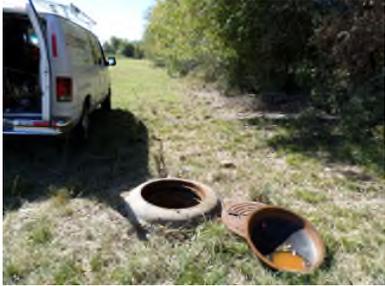
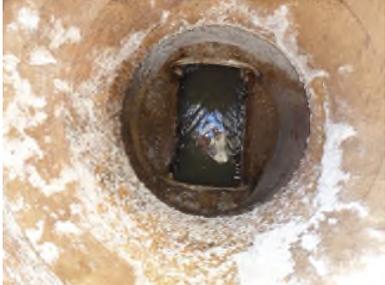
<table><tr> <td>Chimney corrosion moderate</td> <td style="text-align: right;"><i>Overall Score</i></td> </tr><tr> <td>Frame base seal corrosion minor</td> <td style="text-align: right;">Total <b>69</b></td> </tr><tr> <td>Frame corrosion minor</td> <td></td> </tr><tr> <td>Cone corrosion moderate</td> <td></td> </tr><tr> <td>Bench corrosion minor</td> <td></td> </tr><tr> <td>Channel corrosion minor</td> <td></td> </tr><tr> <td>Wall corrosion minor</td> <td></td> </tr></table>

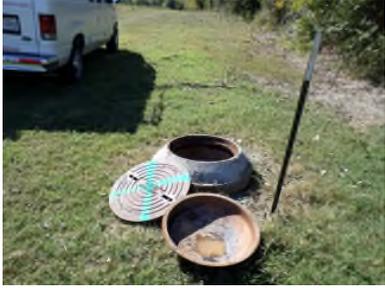
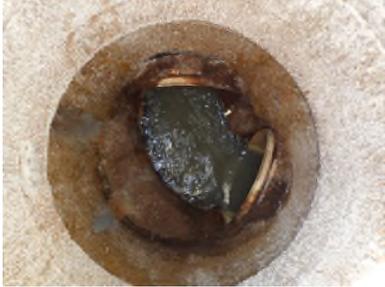
<p>Defects</p> <p>Chimney corrosion minor</p> <p>Frame corrosion minor</p> <p>Cone corrosion minor</p> <p>Bench corrosion moderate</p> <p>Channel corrosion moderate</p> <p>Wall corrosion moderate</p> <div style="text-align: right; margin-top: 20px;"> <p><i>Overall Score</i></p> <p>Total <b>65</b></p> </div>
--	--

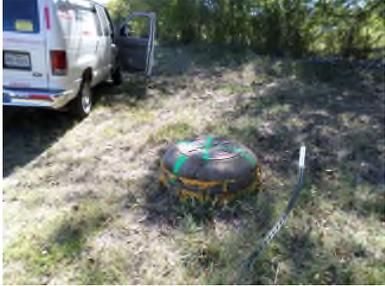
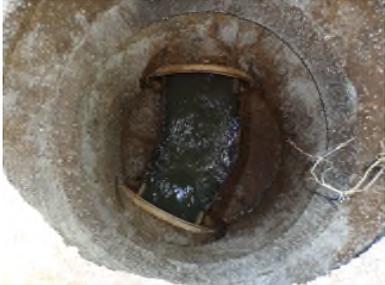
<p>Defects</p> <p>Chimney corrosion moderate</p> <p>Frame base seal crack moderate</p> <p>Cone corrosion moderate</p> <p>Bench corrosion moderate</p> <p>Channel corrosion moderate</p> <p>Wall corrosion moderate</p> <p style="text-align: right;"><i>Overall Score</i></p> <p style="text-align: right;">Total <b>67</b></p>
--	--

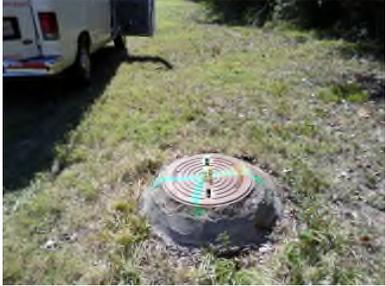
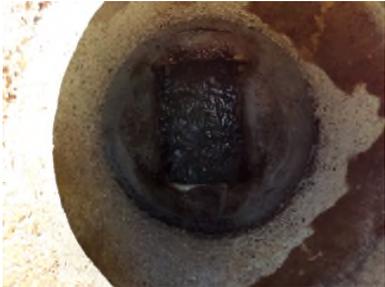
<p>Defects</p> <p>Chimney corrosion moderate</p> <p>Cone corrosion moderate</p> <p>Bench corrosion moderate</p> <p>Channel corrosion moderate</p> <p>Channel Hydraulic major</p> <p>Wall corrosion moderate</p> <p style="text-align: right;"><i>Overall Score</i></p> <p style="text-align: right;">Total <b>75</b></p>
--	---

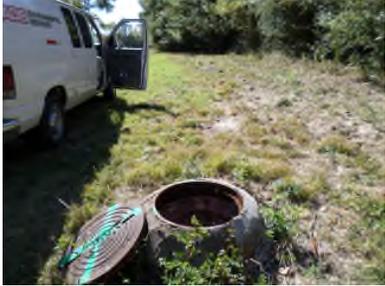
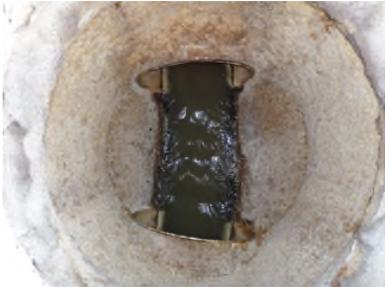
<p>Defects</p> <p>Chimney corrosion moderate</p> <p>Frame base seal corrosion moderate</p> <p>Cone crack moderate</p> <p>Bench corrosion moderate</p> <p>Channel corrosion moderate</p> <p>Wall corrosion moderate</p> <p style="text-align: right;"><i>Overall Score</i></p> <p style="text-align: right;">Total <b>68</b></p>
--	--

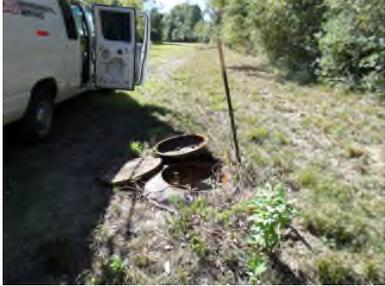
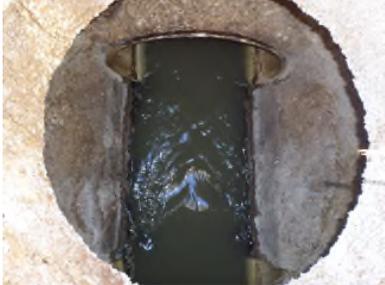
<p>Defects</p> <p>Chimney corrosion moderate</p> <p>Frame base seal corrosion moderate</p> <p>Frame corrosion moderate</p> <p>Cone corrosion moderate</p> <p>Bench corrosion moderate</p> <p>Channel corrosion moderate</p> <p>Wall corrosion moderate</p> <p style="text-align: right;"><i>Overall Score</i></p> <p style="text-align: right;">Total <b>67</b></p>
--	--

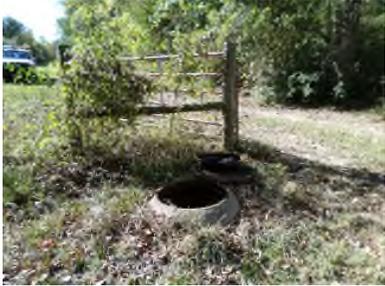
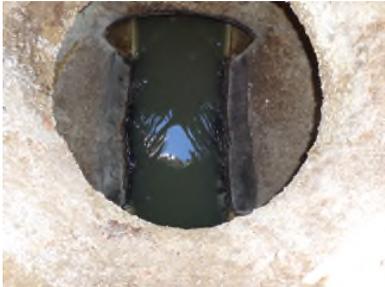
<p>Defects</p> <p>Chimney corrosion moderate</p> <p>Frame base seal corrosion moderate</p> <p>Cone corrosion moderate</p> <p>Bench corrosion moderate</p> <p>Channel corrosion moderate</p> <p>Wall corrosion moderate</p> <p style="text-align: right;"><i>Overall Score</i></p> <p style="text-align: right;">Total <b>77</b></p>
--	--

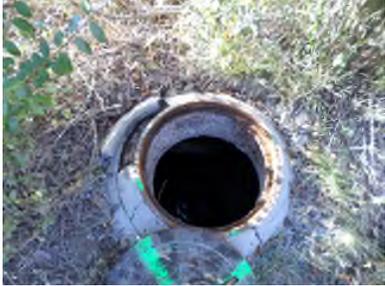
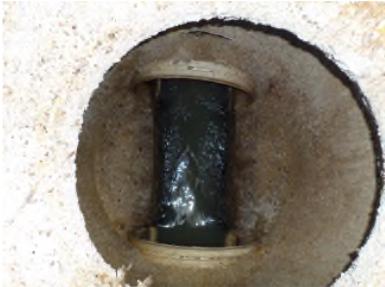
<p>Defects</p> <p>Chimney corrosion moderate</p> <p>Cone corrosion moderate</p> <p>Bench corrosion moderate</p> <p>Channel corrosion moderate</p> <p>Wall corrosion moderate</p> <p style="text-align: right;"><i>Overall Score</i></p> <p style="text-align: right;">Total <b>66</b></p>
--	--

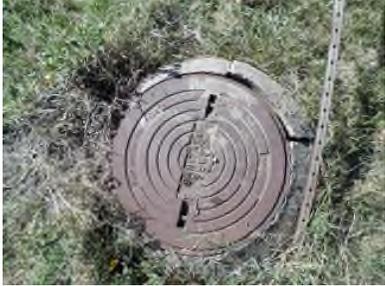
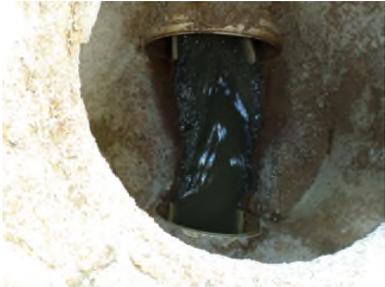
<p>Defects</p> <p>Chimney corrosion moderate</p> <p>Frame base seal corrosion moderate</p> <p>Frame corrosion moderate</p> <p>Cone corrosion moderate</p> <p>Bench corrosion moderate</p> <p>Channel crack moderate</p> <p>Wall corrosion moderate</p> <p style="text-align: right;"><i>Overall Score</i></p> <table style="width: 100%;"> <tr> <td style="text-align: right;">Total</td> <td style="text-align: right;"><b>66</b></td> </tr> </table>	Total	<b>66</b>
Total	<b>66</b>

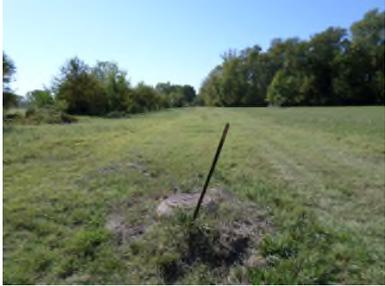
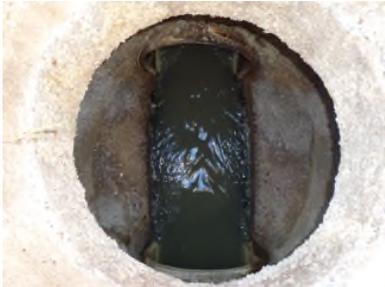
<p>Defects</p>

<table><tr> <td style="width: 70%;">Chimney corrosion moderate</td> <td style="width: 30%; text-align: right;"><i>Overall Score</i></td> </tr><tr> <td>Frame base seal crack moderate</td> <td style="text-align: right;">Total <b>58</b></td> </tr><tr> <td>Cone corrosion minor</td> <td></td> </tr><tr> <td>Bench corrosion moderate</td> <td></td> </tr><tr> <td>Channel corrosion moderate</td> <td></td> </tr><tr> <td>Wall corrosion minor</td> <td></td> </tr></table>

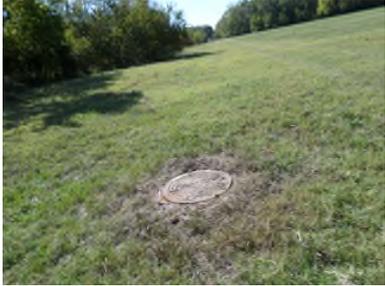
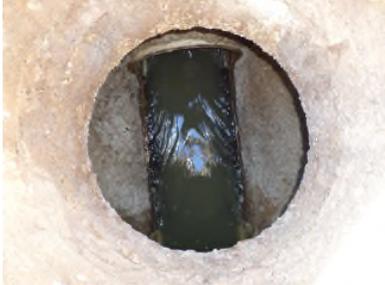
<p>Defects</p> <p>Chimney crack minor</p> <p>Frame base seal corrosion minor</p> <p>Frame corrosion moderate</p> <p>Cone corrosion moderate</p> <p>Bench crack minor</p> <p>Channel corrosion minor</p> <p>Wall corrosion minor</p> <p style="text-align: right;"><i>Overall Score</i></p> <p style="text-align: right;">Total <b>66</b></p>
--	---

The concrete is cracked around the frame. This location contains an inflow dish.

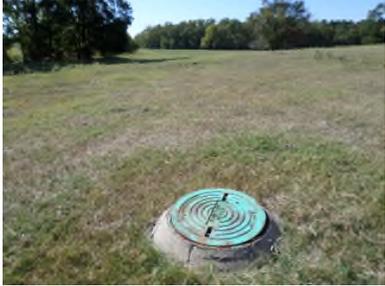
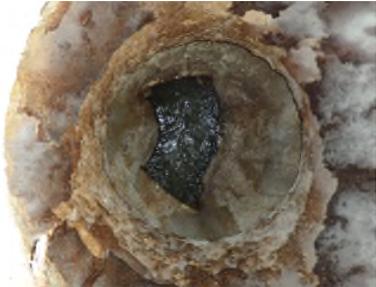
<p>Defects</p> <p>Chimney crack major</p> <p>Chimney roots moderate</p> <p>Cone crack major</p> <p>Bench corrosion major</p> <p>Channel corrosion major</p> <p>Wall corrosion major</p>
--	---

*Overall Score*  
Total **96**

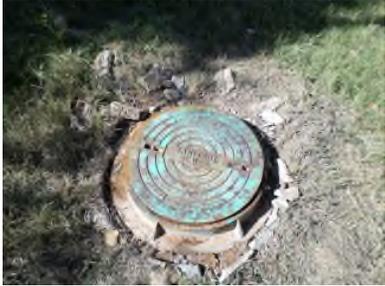
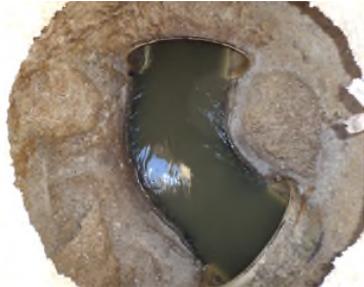
<p>Defects</p> <p>Chimney corrosion moderate</p> <p>Frame offset moderate</p> <p>Cone corrosion moderate</p> <p>Chimney I/I evidence major</p> <p>Bench corrosion moderate</p> <p>Channel corrosion moderate</p> <p>Wall corrosion moderate</p> <p style="text-align: right;"><i>Overall Score</i></p> <p style="text-align: right;">Total <b>66</b></p>
--	---

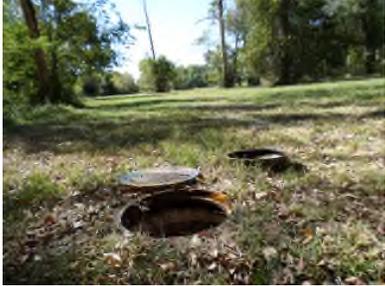
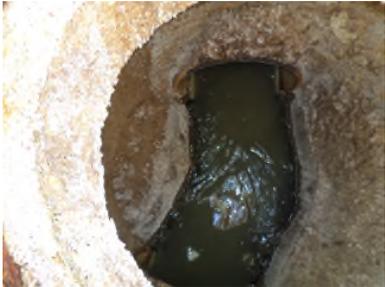
<p>Defects</p> <p>Chimney corrosion minor</p> <p>Frame base seal corrosion moderate</p> <p>Frame corrosion moderate</p> <p>Grade ring crack major</p> <p>Cone corrosion major</p> <p>Bench corrosion moderate</p> <p>Channel corrosion moderate</p> <p>Wall corrosion major</p> <p style="text-align: right;"><i>Overall Score</i></p> <p style="text-align: right;">Total           <b>95</b></p>
--	---

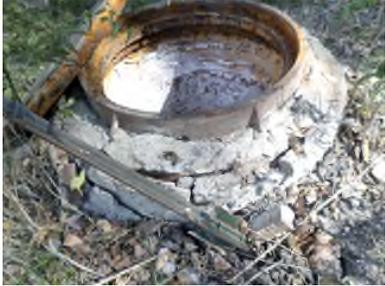
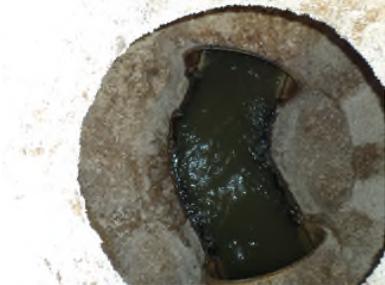
<p>Defects</p> <p>Chimney corrosion minor</p> <p>Frame base seal corrosion moderate</p> <p>Cone corrosion minor</p> <p>Frame corrosion major</p> <p>Bench corrosion moderate</p> <p>Channel corrosion minor</p> <p>Wall corrosion minor</p> <p style="text-align: right;"><i>Overall Score</i></p> <p style="text-align: right;">Total           <b>80</b></p>
--	---

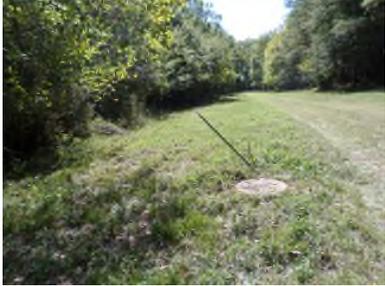
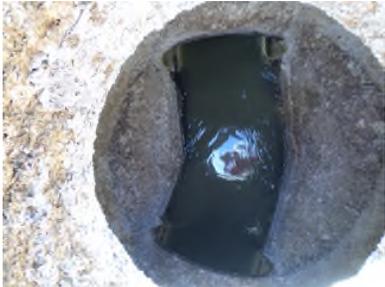
<p>Defects</p>

<table><tr> <td>Frame base seal corrosion moderate</td> <td style="text-align: right;"><i>Overall Score</i></td> </tr><tr> <td>Frame crack moderate</td> <td style="text-align: right;">Total <b>65</b></td> </tr><tr> <td>Cone corrosion moderate</td> <td></td> </tr><tr> <td>Bench corrosion moderate</td> <td></td> </tr><tr> <td>Channel corrosion moderate</td> <td></td> </tr><tr> <td>Wall corrosion moderate</td> <td></td> </tr></table>

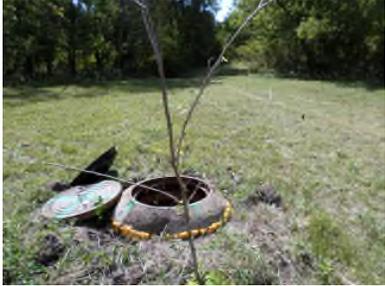
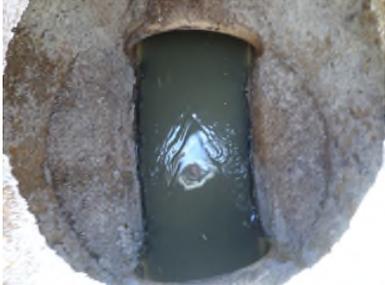
<p>Defects</p> <p>Chimney corrosion moderate</p> <p>Frame base seal corrosion moderate</p> <p>Frame corrosion moderate</p> <p>Cone crack moderate</p> <p>Bench corrosion moderate</p> <p>Channel corrosion moderate</p> <p>Wall corrosion moderate</p> <p style="text-align: right;"><i>Overall Score</i></p> <p style="text-align: right;">Total <b>69</b></p>
--	--

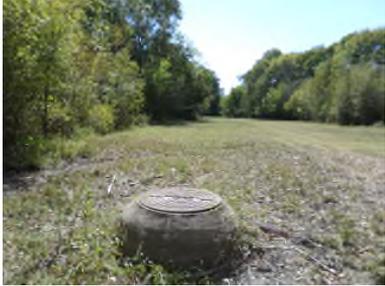
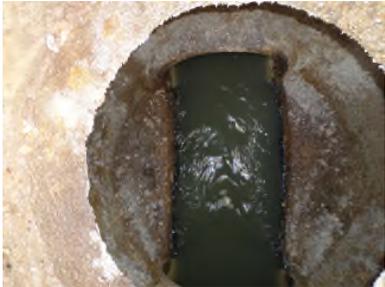
<p>Defects</p> <p>Cone corrosion minor</p> <p>Bench corrosion minor</p> <p>Channel corrosion minor</p> <p>Wall corrosion minor</p> <p style="text-align: right;"><i>Overall Score</i></p> <p style="text-align: right;">Total <b>46</b></p>
--	--

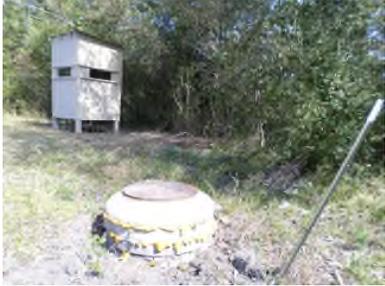
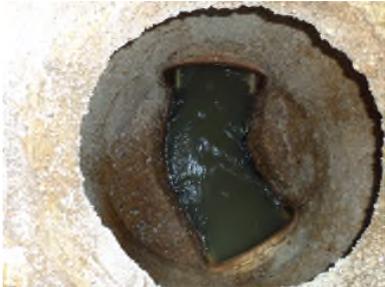
<p>Defects</p> <p>Cone corrosion moderate</p> <p>Bench corrosion moderate</p> <p>Channel corrosion moderate</p> <p>Wall corrosion moderate</p> <p style="text-align: right;"><i>Overall Score</i></p> <p style="text-align: right;">Total <b>61</b></p>
--	--

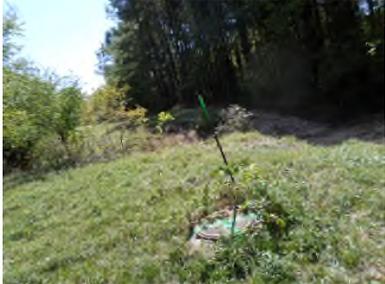
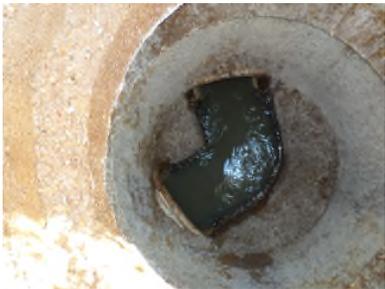
<p>Defects</p> <p>Chimney corrosion moderate</p> <p>Cone corrosion moderate</p> <p>Bench corrosion moderate</p> <p>Channel corrosion moderate</p> <p>Wall corrosion moderate</p> <p style="text-align: right;"><i>Overall Score</i></p> <p style="text-align: right;">Total        <b>66</b></p>
--	---

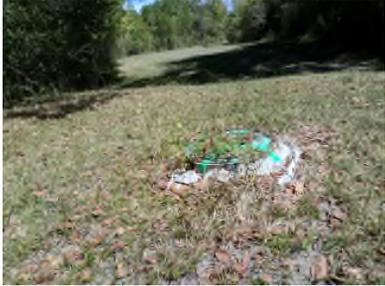
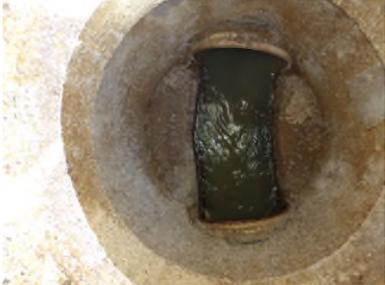
<p>Defects</p> <p>Chimney corrosion minor</p> <p>Cone corrosion minor</p> <p>Bench corrosion minor</p> <p>Channel corrosion minor</p> <p>Wall corrosion minor</p> <p style="text-align: right;"><i>Overall Score</i></p> <p style="text-align: right;">Total <b>46</b></p>
--	---

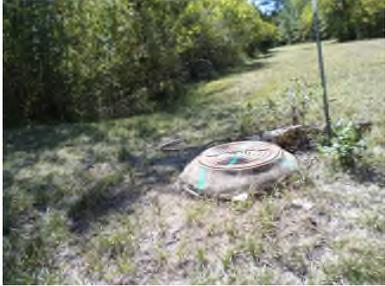
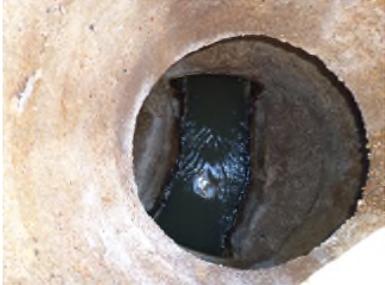
<p>Defects</p> <p>Chimney corrosion moderate</p> <p>Cone corrosion moderate</p> <p>Bench corrosion moderate</p> <p>Wall corrosion moderate</p> <p style="text-align: right;"><i>Overall Score</i></p> <p style="text-align: right;">Total       <b>63</b></p>
--	--

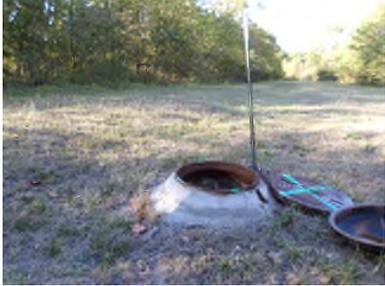
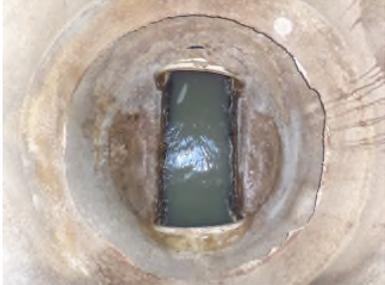
<p>Defects</p> <p style="text-align: right;"><i>Overall Score</i></p> <p style="text-align: right;">Total           <b>10</b></p>
--	---

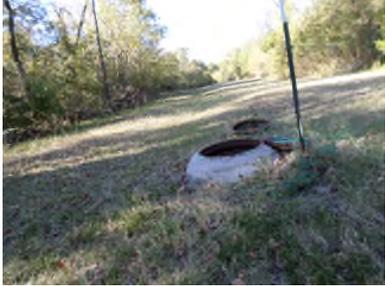
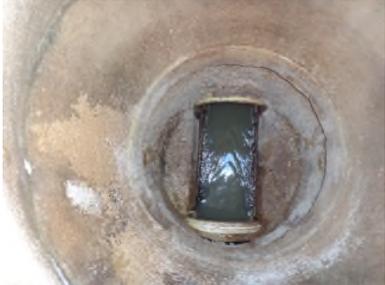
<p>Defects</p> <p style="text-align: right;"><i>Overall Score</i></p> <p style="text-align: right;">Total           <b>39</b></p>
--	---

Comments  
The concrete is cracked around the the frame. This location is an inflow dish.

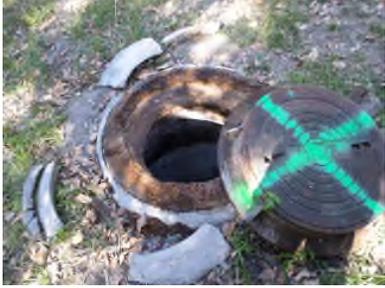
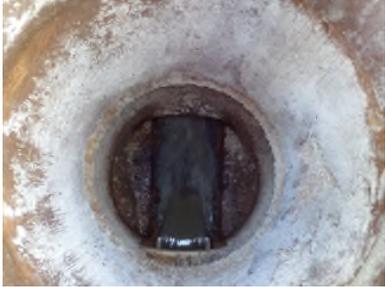
<p>Defects</p> <p>Frame offset moderate</p> <p>Cone corrosion minor</p> <p>Wall corrosion minor</p> <p style="text-align: right;"><i>Overall Score</i></p> <p style="text-align: right;">Total <b>77</b></p>
--	---

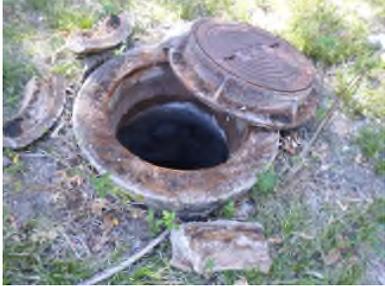
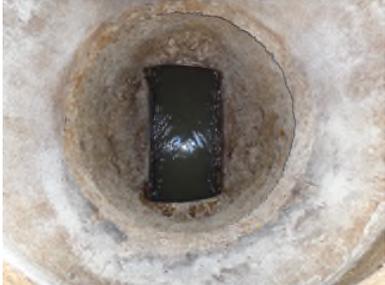
<p>Defects</p> <p>Chimney corrosion moderate</p> <p>Frame offset completely displaced</p> <p>Cone corrosion moderate</p> <p>Bench corrosion moderate</p> <p>Channel corrosion moderate</p> <p>Wall corrosion moderate</p> <p style="text-align: right;"><i>Overall Score</i></p> <p style="text-align: right;">Total <b>82</b></p>
--	---

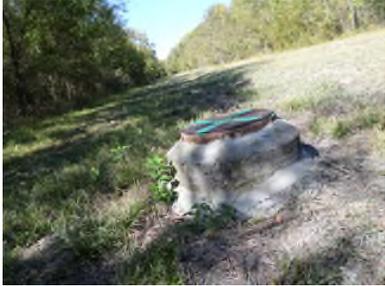
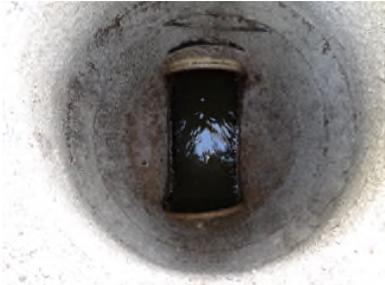
<p>Defects</p> <p>Chimney corrosion moderate</p> <p>Cone corrosion moderate</p> <p>Bench corrosion moderate</p> <p>Channel corrosion moderate</p> <p>Channel hydraulic major</p> <p>Wall corrosion moderate</p> <p>Pipe connection offset moderate</p> <table style="width: 100%; margin-top: 20px;"> <tr> <td style="text-align: right;"><i>Overall Score</i></td> <td></td> </tr> <tr> <td style="text-align: right;">Total</td> <td style="text-align: right;"><b>96</b></td> </tr> </table>	<i>Overall Score</i>		Total	<b>96</b>
<i>Overall Score</i>					
Total	<b>96</b>

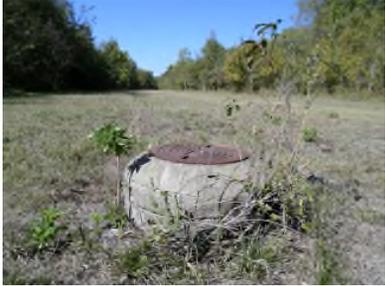
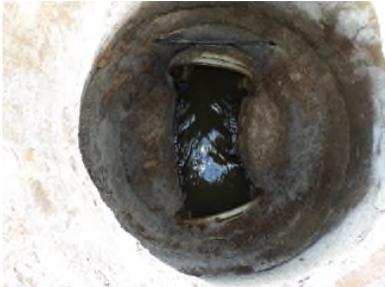
<p>Defects</p> <p>Chimney corrosion moderate</p> <p>Cone corrosion major</p> <p>Bench corrosion major</p> <p>Channel corrosion major</p> <p>Wall corrosion major</p> <p style="text-align: right;"><i>Overall Score</i></p> <p style="text-align: right;">Total <b>96</b></p>
--	--

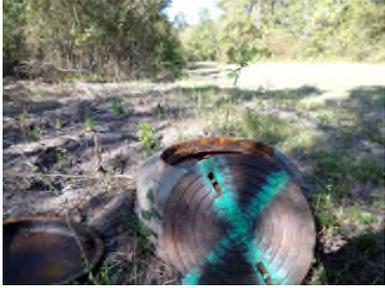
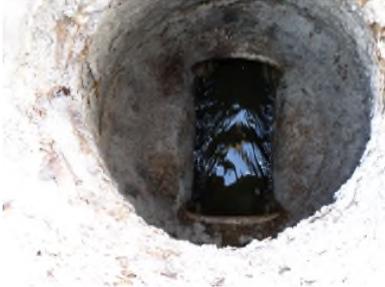
Chimney corrosion major	<i>Overall Score</i>	Frame base seal corrosion minor	Total <b>95</b>	Frame corrosion minor		Cone corrosion major		Bench corrosion major		Channel corrosion major		Wall corrosion major	
Chimney corrosion major	<i>Overall Score</i>														
Frame base seal corrosion minor	Total <b>95</b>														
Frame corrosion minor															
Cone corrosion major															
Bench corrosion major															
Channel corrosion major															
Wall corrosion major

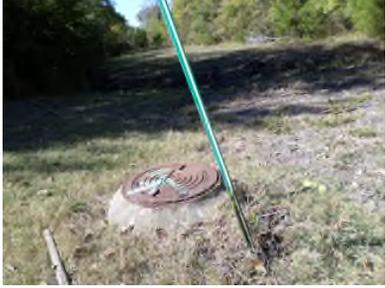
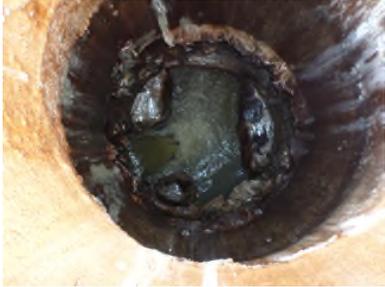
<p>Defects</p> <p>Chimney corrosion moderate</p> <p>Cone corrosion moderate</p> <p>Bench corrosion moderate</p> <p>Channel corrosion moderate</p> <p>Wall corrosion moderate</p> <p style="text-align: right;"><i>Overall Score</i></p> <p style="text-align: right;">Total <b>65</b></p>
--	--

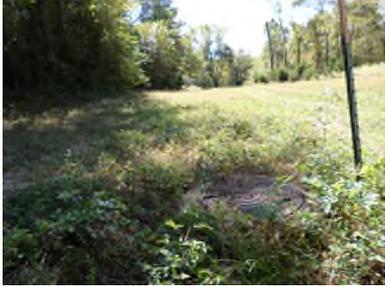
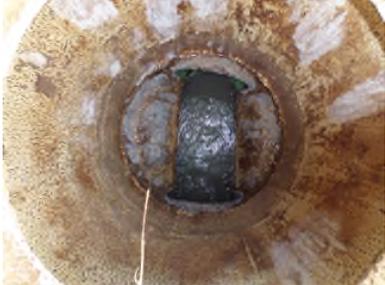
<p>Defects</p> <p style="text-align: right;"><i>Overall Score</i></p> <p style="text-align: right;">Total           <b>0</b></p>
--	--

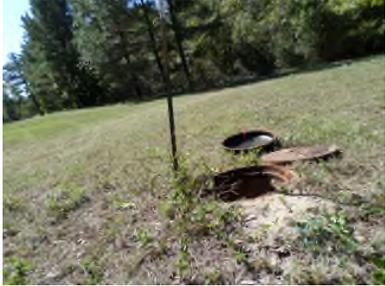
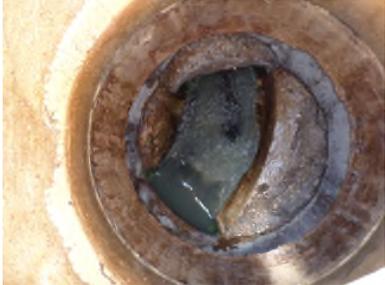
<p>Defects</p> <p>Bench corrosion minor</p> <p>Channel corrosion minor</p> <table style="width: 100%; margin-top: 20px;"> <tr> <td style="text-align: right;"><i>Overall Score</i></td> <td></td> </tr> <tr> <td style="text-align: right;">Total</td> <td style="text-align: right;"><b>32</b></td> </tr> </table>	<i>Overall Score</i>		Total	<b>32</b>
<i>Overall Score</i>					
Total	<b>32</b>

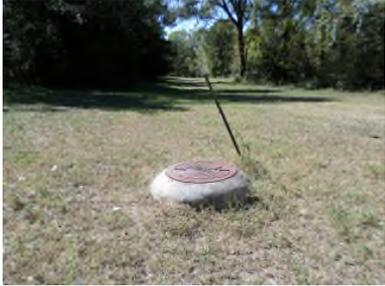
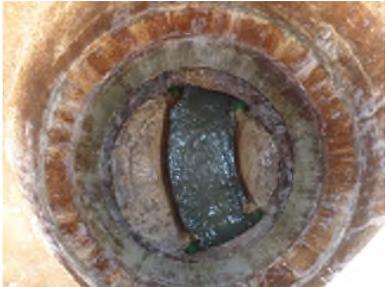
<p>Defects</p> <p>Channel corrosion minor</p> <p style="text-align: right;"><i>Overall Score</i></p> <p style="text-align: right;">Total           <b>22</b></p>
--	--

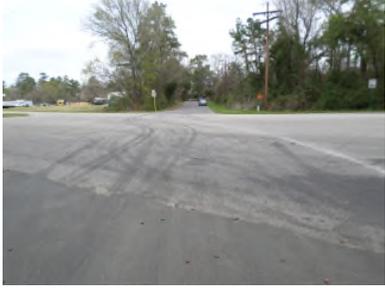
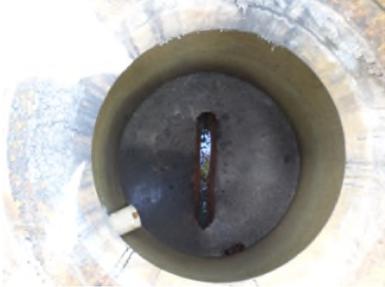
Cover Fit Tight	<i>Overall Score</i>	Chimney I/I minor	Total <b>19</b>	Cover seal missing		Grade ring corrosion minor	
Cover Fit Tight	<i>Overall Score</i>								
Chimney I/I minor	Total <b>19</b>								
Cover seal missing									
Grade ring corrosion minor

Comments  
Frame seal has deteriorated. Evidence of infiltration present.

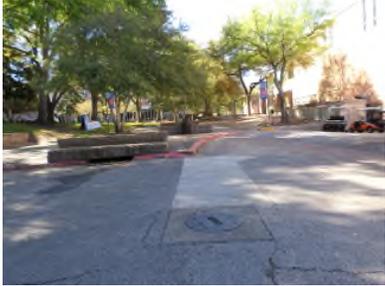
<p>Defects</p> <table style="width: 100%;"> <tr> <td>Cover Fit Tight</td> <td style="text-align: right;"><i>Overall Score</i></td> </tr> <tr> <td>Cover seal missing</td> <td style="text-align: right;">Total <b>8</b></td> </tr> </table>	Cover Fit Tight	<i>Overall Score</i>	Cover seal missing	Total <b>8</b>
Cover Fit Tight	<i>Overall Score</i>				
Cover seal missing	Total <b>8</b>

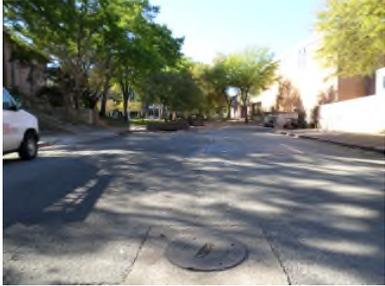
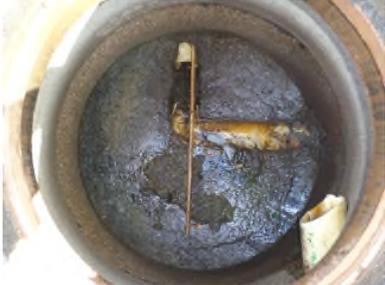
<p>Defects</p> <table style="width: 100%;"> <tr> <td>Cover fit loose</td> <td style="text-align: right;"><i>Overall Score</i></td> </tr> <tr> <td>Cover seal missing</td> <td style="text-align: right;">Total <b>15</b></td> </tr> </table>	Cover fit loose	<i>Overall Score</i>	Cover seal missing	Total <b>15</b>
Cover fit loose	<i>Overall Score</i>				
Cover seal missing	Total <b>15</b>

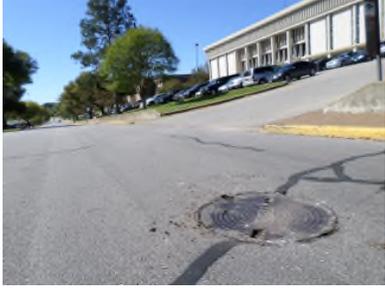
Cover Fit Tight	<i>Overall Score</i>	Cover seal missing	Total <b>23</b>	Channel debris moderate	
Cover Fit Tight	<i>Overall Score</i>						
Cover seal missing	Total <b>23</b>						
Channel debris moderate

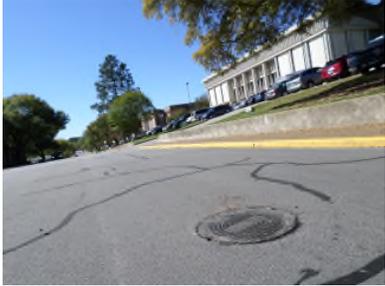
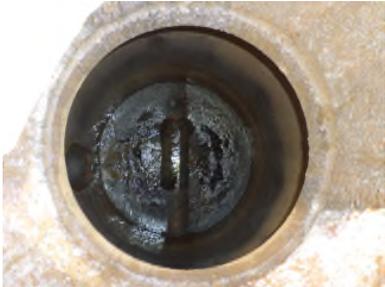
Cover Fit Tight	<i>Overall Score</i>	Cover seal missing	Total <b>13</b>	Frame base seal corrosion minor	
Cover Fit Tight	<i>Overall Score</i>						
Cover seal missing	Total <b>13</b>						
Frame base seal corrosion minor

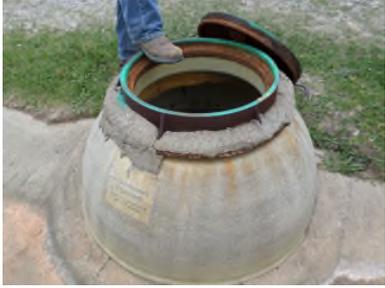
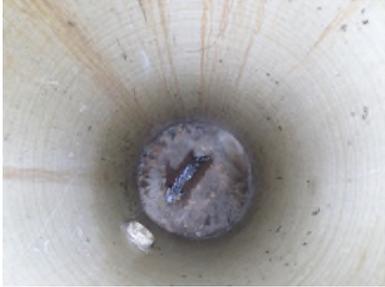
<p>Defects</p> <p>Bench crack minor</p> <p>Sewer connection crack moderate</p> <table style="width: 100%; border: none;"> <tr> <td style="text-align: right;"><i>Overall Score</i></td> <td></td> </tr> <tr> <td style="text-align: right;">Total</td> <td style="text-align: right;"><b>13</b></td> </tr> </table>	<i>Overall Score</i>		Total	<b>13</b>
<i>Overall Score</i>					
Total	<b>13</b>

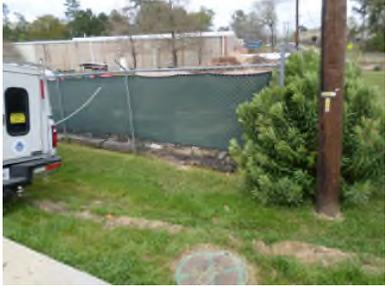
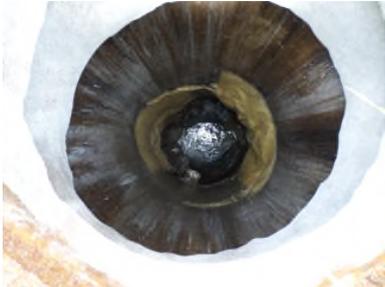
<p>Defects</p> <table style="width: 100%;"> <tr> <td>Cover Fit Tight</td> <td style="text-align: right;"><i>Overall Score</i></td> </tr> <tr> <td>Cover seal missing</td> <td style="text-align: right;">Total <b>8</b></td> </tr> </table>	Cover Fit Tight	<i>Overall Score</i>	Cover seal missing	Total <b>8</b>
Cover Fit Tight	<i>Overall Score</i>				
Cover seal missing	Total <b>8</b>

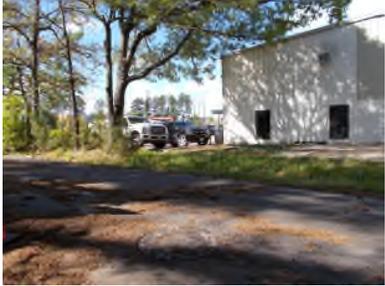
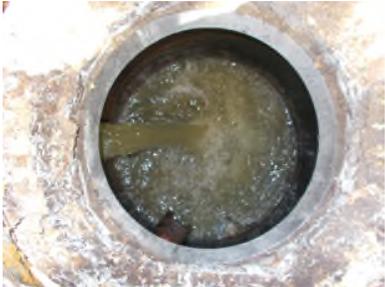
Cover Fit Tight	<i>Overall Score</i>	Chimney corrosion minor	Total <b>13</b>	Cover seal missing	
Cover Fit Tight	<i>Overall Score</i>						
Chimney corrosion minor	Total <b>13</b>						
Cover seal missing

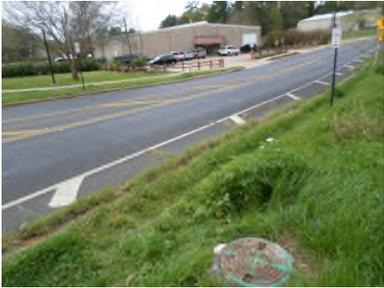
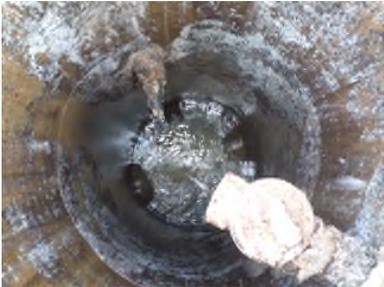
Cover Fit Tight	<i>Overall Score</i>	Chimney mortar missing moderate	Total <b>77</b>	Cover seal missing		Frame base seal I/I minor		Frame base seal roots minor		Channel hydraulic restriction moderate		Chamber corrosion minor		Chamber joint offset moderate	
Cover Fit Tight	<i>Overall Score</i>																
Chimney mortar missing moderate	Total <b>77</b>																
Cover seal missing																	
Frame base seal I/I minor																	
Frame base seal roots minor																	
Channel hydraulic restriction moderate																	
Chamber corrosion minor																	
Chamber joint offset moderate

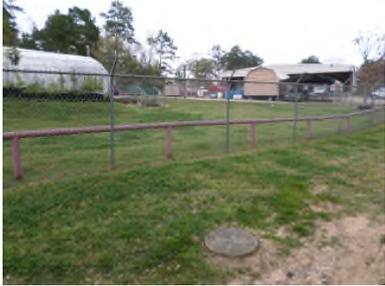
<p>Defects</p> <p>Cover seal missing</p> <p style="text-align: right;"><i>Overall Score</i></p> <p style="text-align: right;">Total <b>5</b></p>
--	--

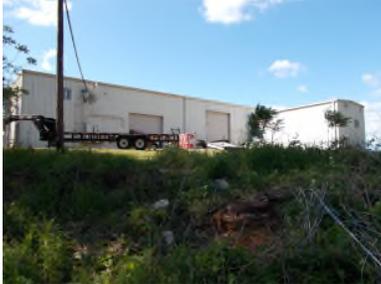
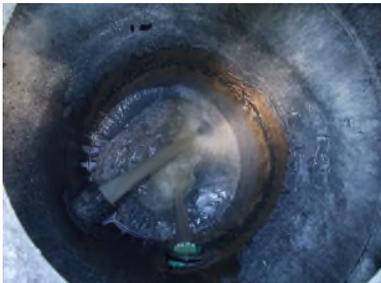
Cover Fit Tight	<i>Overall Score</i>	Chimney corrosion moderate	Total <b>33</b>	Frame base seal corrosion moderate		Frame corrosion moderate	
Cover Fit Tight	<i>Overall Score</i>								
Chimney corrosion moderate	Total <b>33</b>								
Frame base seal corrosion moderate									
Frame corrosion moderate
