## **APPENDIX C**

### **Water System Field Testing Results**

**PROJECT:** Water and Wastewater Condition and Capacity Assessment Studies  
Spring Lake Water Plant Pump Testing

### Water and Wastewater System Condition and Capacity Studies

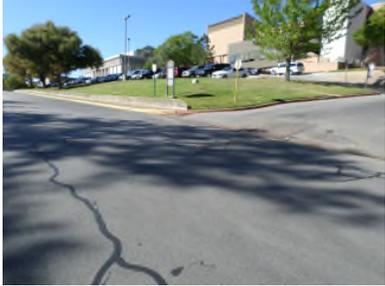
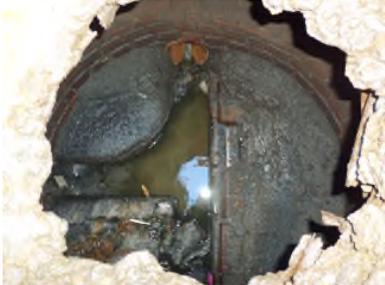
Cover Fit Tight	<i>Overall Score</i>	Cover seal missing	Total <b>23</b>	Channel debris moderate	
Cover Fit Tight	<i>Overall Score</i>						
Cover seal missing	Total <b>23</b>						
Channel debris moderate

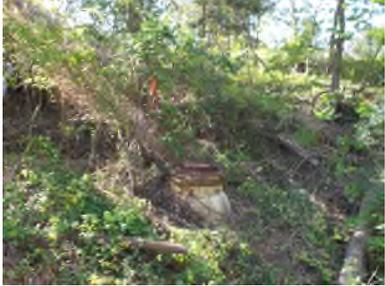
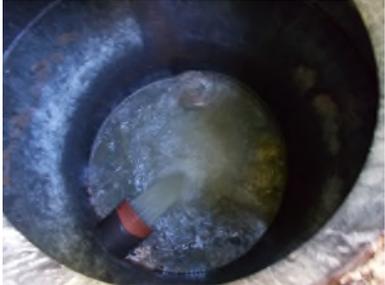
Cover Fit Tight	<i>Overall Score</i>	Cover seal missing	Total <b>50</b>	Frame base seal corrosion moderate		Frame corrosion moderate	
Cover Fit Tight	<i>Overall Score</i>								
Cover seal missing	Total <b>50</b>								
Frame base seal corrosion moderate									
Frame corrosion moderate

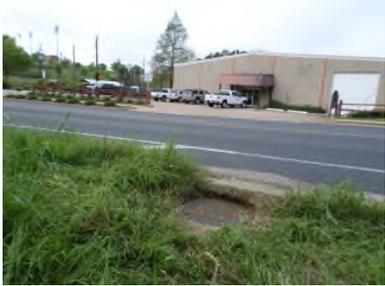
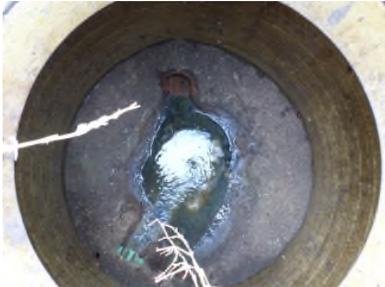
<p>Defects</p> <ul style="list-style-type: none"> <li>Cover corrosion minor</li> <li>Cover Fit Tight</li> <li>Chimney crack minor</li> <li>Chimney corrosion minor</li> <li>Chimney mortar missing moderate</li> <li>Cover I/I moderate</li> <li>Cover seal missing</li> <li>Cover surface wear minor</li> <li>Sewer connection crack minor</li> </ul> <div style="text-align: right; margin-top: 20px;"> <p><i>Overall Score</i></p> <p>Total <b>54</b></p> </div>
--	---

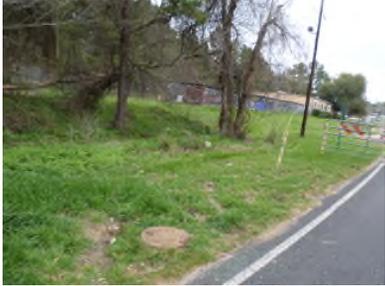
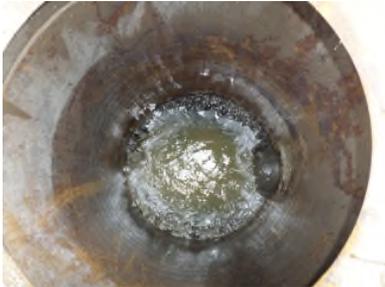
Cover Fit Tight	<i>Overall Score</i>	Bench corrosion minor	Total <b>36</b>	Channel corrosion minor		Channel hydraulic restriction moderate		Sewer connection crack minor	
Cover Fit Tight	<i>Overall Score</i>										
Bench corrosion minor	Total <b>36</b>										
Channel corrosion minor											
Channel hydraulic restriction moderate											
Sewer connection crack minor

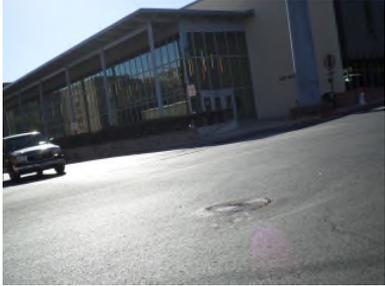
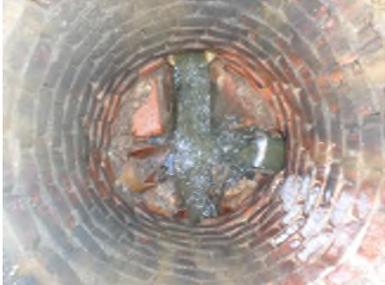
<p>Defects</p> <p>Sewer connection crack moderate</p> <p style="text-align: right;"><i>Overall Score</i></p> <p style="text-align: right;">Total            <b>6</b></p>
--	--

Comments  
3' O' Clock and 9 O' Clock pipes are cracked.

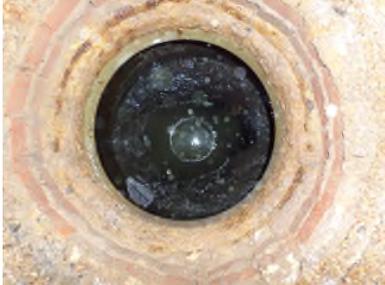
Defects		
Comments This location was surcharged during inspection, therefore certain data was unable to be collected.

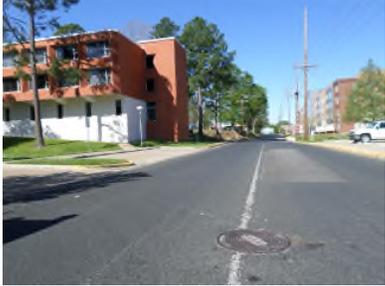
Defects		<i>Overall Score</i>
Cover Fit Tight		Total
Cover seal missing		<b>8</b>

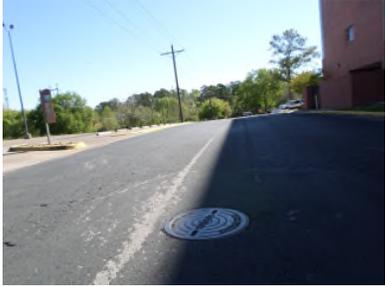
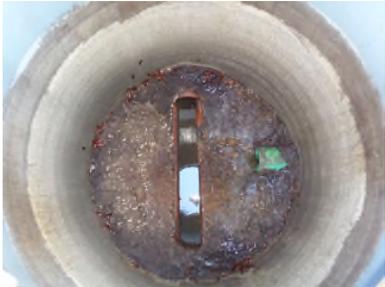
<p>Defects</p> <p>Cover Fit Tight</p> <table style="width: 100%;"> <tr> <td colspan="2" style="text-align: right;"><i>Overall Score</i></td> </tr> <tr> <td style="text-align: right;">Total</td> <td style="text-align: right;"><b>3</b></td> </tr> </table>	<i>Overall Score</i>		Total	<b>3</b>
<i>Overall Score</i>					
Total	<b>3</b>

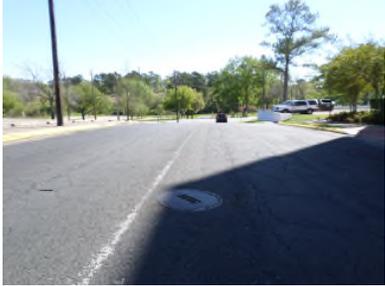
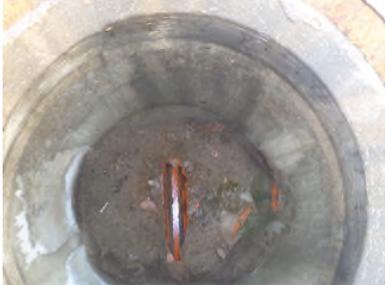
<p>Defects</p> <p>Cover Fit Tight</p> <table style="width: 100%;"> <tr> <td colspan="2" style="text-align: right;"><i>Overall Score</i></td> </tr> <tr> <td style="text-align: right;">Total</td> <td style="text-align: right;"><b>3</b></td> </tr> </table>	<i>Overall Score</i>		Total	<b>3</b>
<i>Overall Score</i>					
Total	<b>3</b>

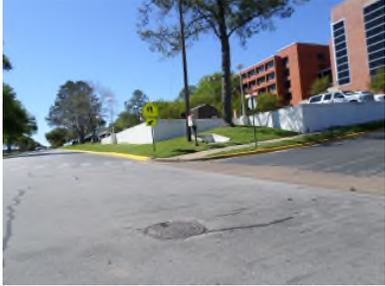
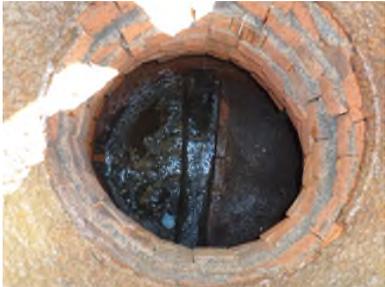
<p>Defects</p> <p>Cover Fit Tight</p> <table style="width: 100%;"> <tr> <td colspan="2" style="text-align: right;"><i>Overall Score</i></td> </tr> <tr> <td style="text-align: right;">Total</td> <td style="text-align: right;"><b>3</b></td> </tr> </table>	<i>Overall Score</i>		Total	<b>3</b>
<i>Overall Score</i>					
Total	<b>3</b>

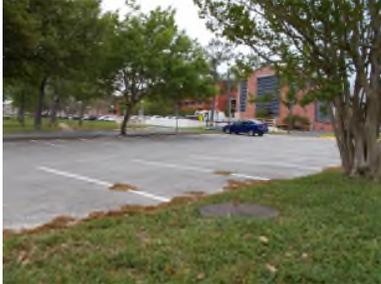
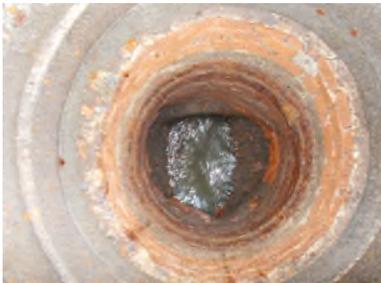
<p>Defects</p> <table style="width: 100%;"> <tr> <td>Cover Fit Tight</td> <td style="text-align: right;"><i>Overall Score</i></td> </tr> <tr> <td>Cover seal missing</td> <td style="text-align: right;">Total <b>3</b></td> </tr> </table>	Cover Fit Tight	<i>Overall Score</i>	Cover seal missing	Total <b>3</b>
Cover Fit Tight	<i>Overall Score</i>				
Cover seal missing	Total <b>3</b>

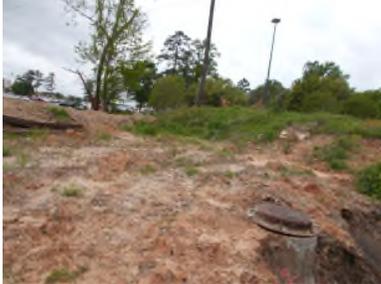
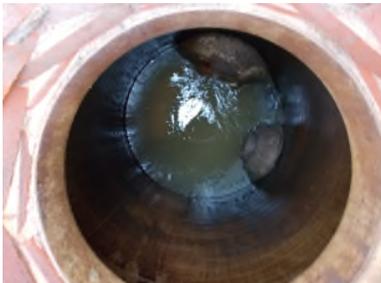
<p>Defects</p> <table style="width: 100%;"> <tr> <td>Cover Fit Tight</td> <td style="text-align: right;"><i>Overall Score</i></td> </tr> <tr> <td>Frame corrosion major</td> <td style="text-align: right;">Total <b>18</b></td> </tr> </table>	Cover Fit Tight	<i>Overall Score</i>	Frame corrosion major	Total <b>18</b>
Cover Fit Tight	<i>Overall Score</i>				
Frame corrosion major	Total <b>18</b>

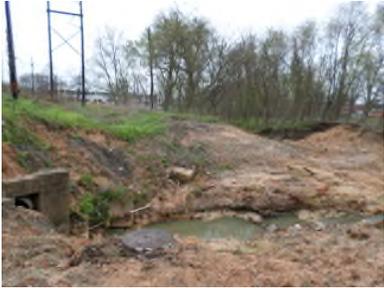
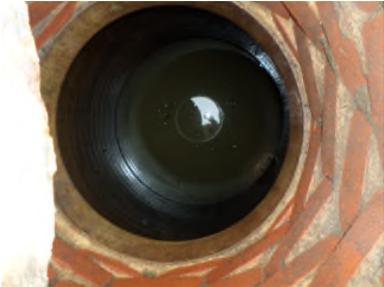
Cover Fit Tight	<i>Overall Score</i>	
		Frame offset completely displaced	Total	<b>23</b>
Pipe Configuration				Construction Materials
				<i>Grade Ring</i> None
				<i>Flat Slab</i> None
				<i>Chimney</i> Brick
				<i>Cone</i> None
				<i>Wall</i> Brick
				<i>Bench</i> N/A
				<i>Channel</i> N/A
				<i>Steps</i> None
Comments Frame detaches from the manhole. This location was surcharged during inspection. Incoming lines, outgoing lines, the bench and channel could not be inspected.

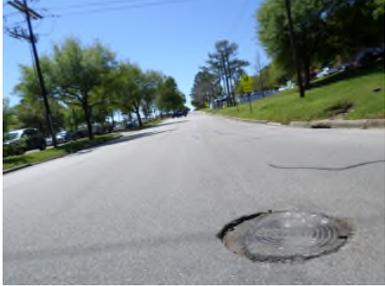
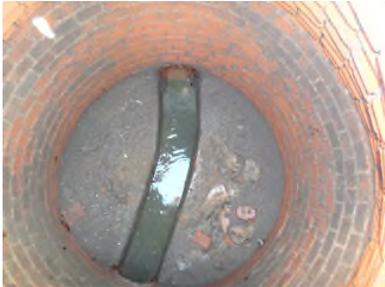
<p>Defects</p> <table style="width: 100%;"> <tr> <td>Cover Fit Tight</td> <td style="text-align: right;"><i>Overall Score</i></td> </tr> <tr> <td>Cover seal missing</td> <td style="text-align: right;">Total <b>8</b></td> </tr> </table>	Cover Fit Tight	<i>Overall Score</i>	Cover seal missing	Total <b>8</b>
Cover Fit Tight	<i>Overall Score</i>				
Cover seal missing	Total <b>8</b>

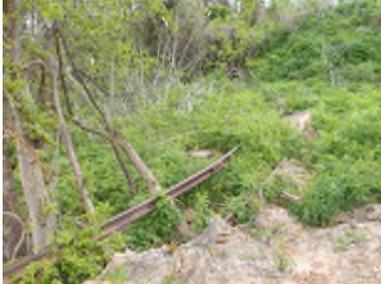
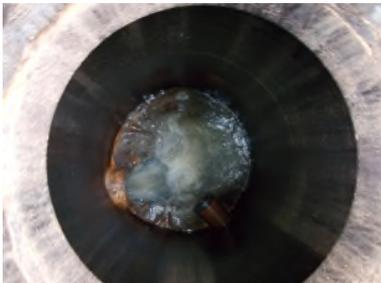
Cover Fit Tight	<i>Overall Score</i>	Cover seal missing	Total <b>18</b>	Frame corrosion moderate	
Cover Fit Tight	<i>Overall Score</i>						
Cover seal missing	Total <b>18</b>						
Frame corrosion moderate

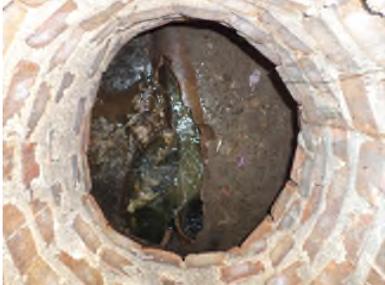
Cover Fit Tight	<i>Overall Score</i>	Cover seal missing	Total <b>14</b>	Connection crack moderate	
Cover Fit Tight	<i>Overall Score</i>						
Cover seal missing	Total <b>14</b>						
Connection crack moderate

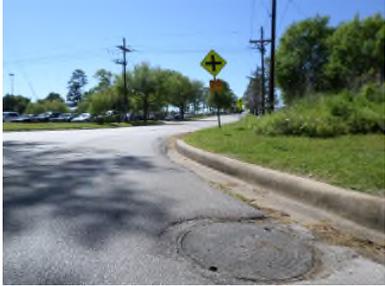
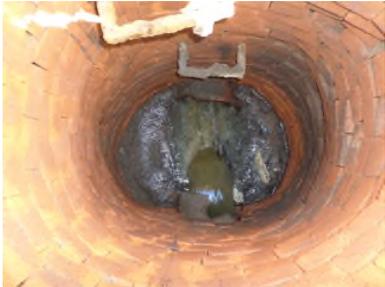
<p>Defects</p> <p>Cover corrosion minor</p> <p>Cover Fit Tight</p> <p>Cover seal missing</p> <p>Lateral corrosion moderate</p> <p style="text-align: right;"><i>Overall Score</i></p> <p style="text-align: right;">Total        <b>23</b></p>
--	---

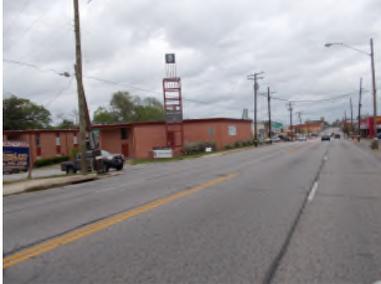
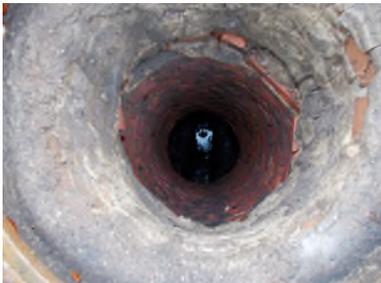
<p>Defects</p> <table style="width: 100%;"> <tr> <td>Cover Fit Tight</td> <td style="text-align: right;"><i>Overall Score</i></td> </tr> <tr> <td>Lateral corrosion moderate</td> <td style="text-align: right;">Total <b>13</b></td> </tr> </table>	Cover Fit Tight	<i>Overall Score</i>	Lateral corrosion moderate	Total <b>13</b>
Cover Fit Tight	<i>Overall Score</i>				
Lateral corrosion moderate	Total <b>13</b>

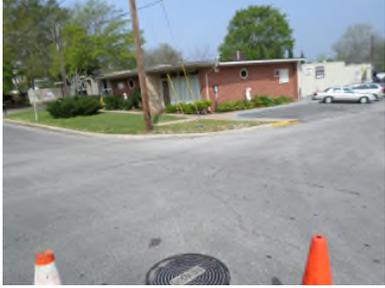
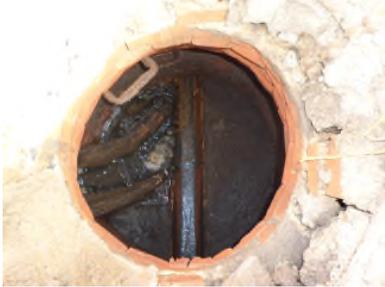
Cover Fit Tight	<i>Overall Score</i>	Cover seal missing	Total <b>23</b>	Lateral corrosion major	
Cover Fit Tight	<i>Overall Score</i>						
Cover seal missing	Total <b>23</b>						
Lateral corrosion major

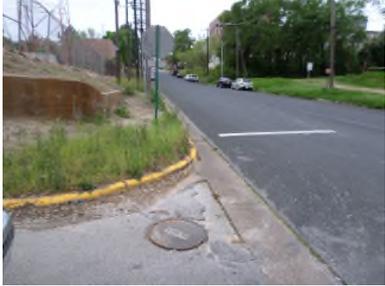
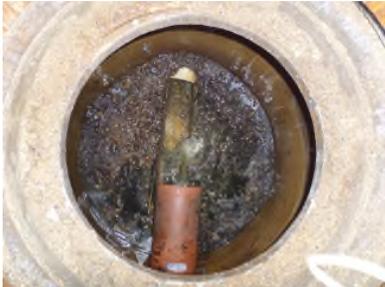
<p>Defects</p> <table style="width: 100%;"> <tr> <td>Cover Fit Tight</td> <td style="text-align: right;"><i>Overall Score</i></td> </tr> <tr> <td>Cover seal missing</td> <td style="text-align: right;">Total <b>8</b></td> </tr> </table>	Cover Fit Tight	<i>Overall Score</i>	Cover seal missing	Total <b>8</b>
Cover Fit Tight	<i>Overall Score</i>				
Cover seal missing	Total <b>8</b>

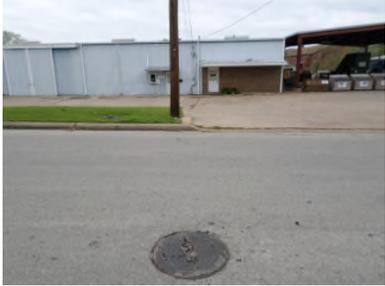
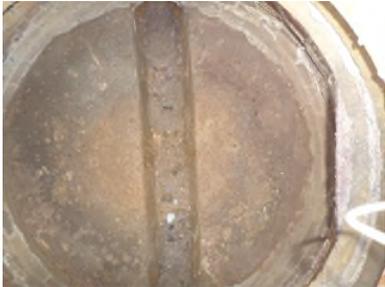
<p>Defects</p> <p>Cover seal missing</p> <table style="width: 100%; margin-top: 20px;"> <tr> <td colspan="2" style="text-align: right;"><i>Overall Score</i></td> </tr> <tr> <td style="text-align: right;">Total</td> <td style="text-align: right; font-weight: bold;">5</td> </tr> </table>	<i>Overall Score</i>		Total	5
<i>Overall Score</i>					
Total	5

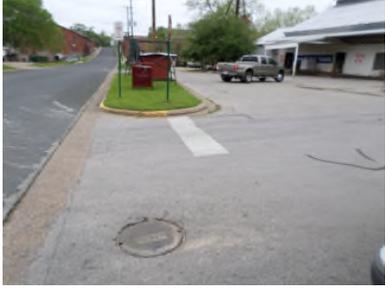
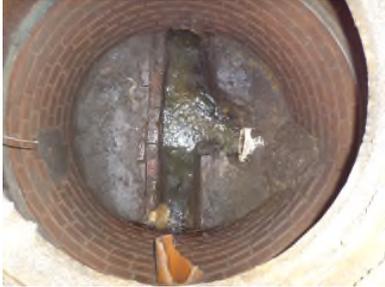
Cover Fit Tight	<i>Overall Score</i>	Cover seal missing	Total <b>11</b>	Sewer connection crack minor	
Cover Fit Tight	<i>Overall Score</i>						
Cover seal missing	Total <b>11</b>						
Sewer connection crack minor

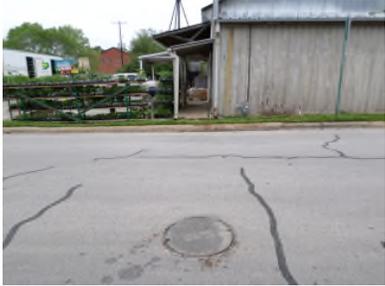
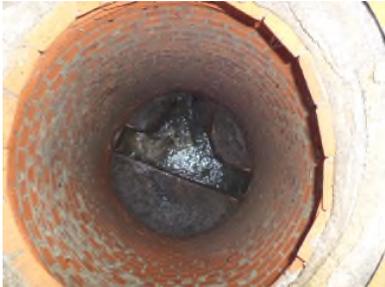
Cover Fit Tight	<i>Overall Score</i>	Cover seal missing	Total <b>23</b>	Channel debris moderate	
Cover Fit Tight	<i>Overall Score</i>						
Cover seal missing	Total <b>23</b>						
Channel debris moderate

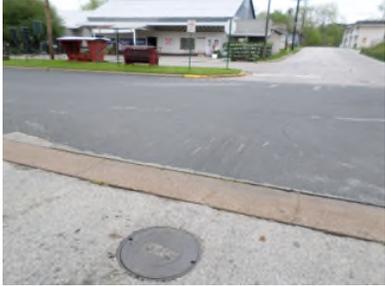
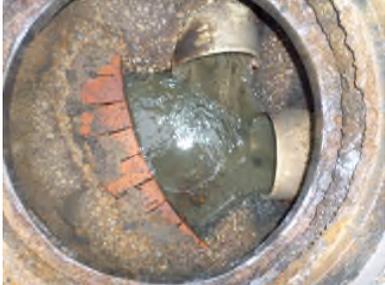
Cover Fit Tight	<i>Overall Score</i>	Cover seal missing	Total <b>26</b>	Cover surface wear minor		Frame corrosion minor		Bench corrosion moderate	
Cover Fit Tight	<i>Overall Score</i>										
Cover seal missing	Total <b>26</b>										
Cover surface wear minor											
Frame corrosion minor											
Bench corrosion moderate

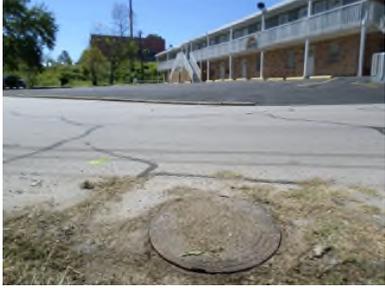
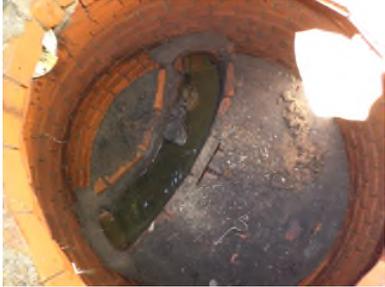
<p>Defects</p> <table style="width: 100%;"> <tr> <td>Cover Fit Tight</td> <td style="text-align: right;"><i>Overall Score</i></td> </tr> <tr> <td>Cover seal missing</td> <td style="text-align: right;">Total <b>8</b></td> </tr> </table>	Cover Fit Tight	<i>Overall Score</i>	Cover seal missing	Total <b>8</b>
Cover Fit Tight	<i>Overall Score</i>				
Cover seal missing	Total <b>8</b>

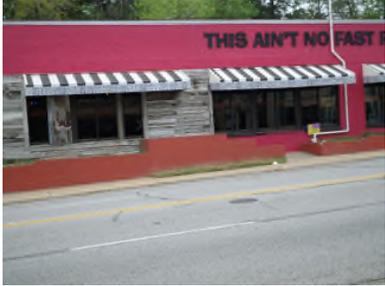
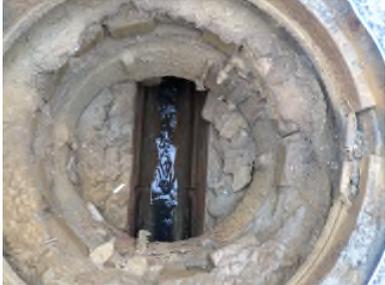
<table><tr> <td>Cover Fit Tight</td> <td style="text-align: right;"><i>Overall Score</i></td> </tr><tr> <td>Chimney bricks missing minor</td> <td style="text-align: right;">Total <b>78</b></td> </tr><tr> <td>Chimney corrosion moderate</td> <td></td> </tr><tr> <td>Chimney mortar missing moderate</td> <td></td> </tr><tr> <td>Chamber corrosion moderate</td> <td></td> </tr><tr> <td>Chimney bricks missing moderate</td> <td></td> </tr></table>

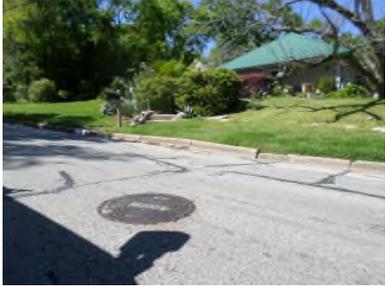
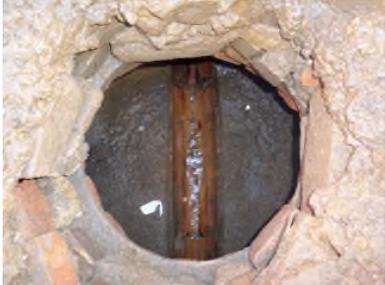
Defects	
Cover Fit Tight	<i>Overall Score</i>
Lateral connection crack moderate	Total <b>24</b>
Sewer connection crack moderate

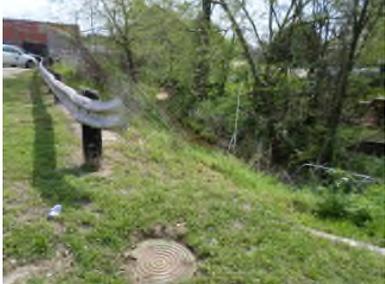
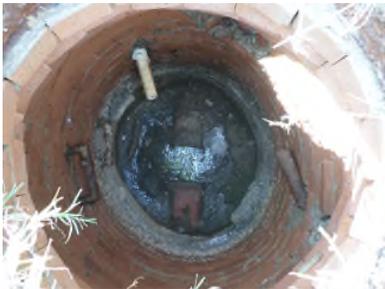
<p>Defects</p> <p>Cover Fit Tight</p> <p>Cover seal missing</p> <p>Lateral corrosion minor</p> <p style="text-align: right;"><i>Overall Score</i></p> <p style="text-align: right;">Total        <b>13</b></p>
--	---

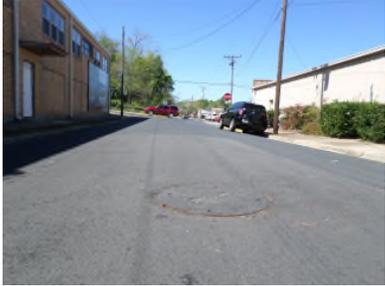
<table><tr> <td>Cover Fit Tight</td> <td style="text-align: right;"><i>Overall Score</i></td> </tr><tr> <td>Cover seal missing</td> <td></td> </tr><tr> <td>Cover surface wear moderate</td> <td></td> </tr><tr> <td>Frame base seal corrosion major</td> <td></td> </tr></table>

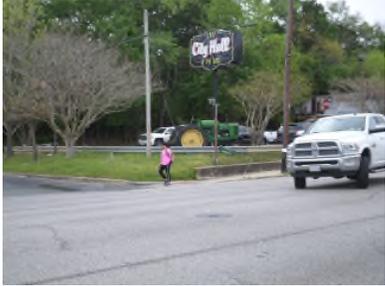
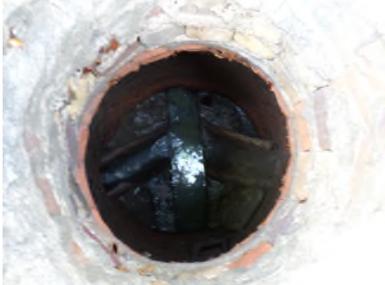
<table><tr> <td>Cover Fit Tight</td> <td style="text-align: right;"><i>Overall Score</i></td> </tr><tr> <td>Frame corrosion moderate</td> <td style="text-align: right;">Total <b>30</b></td> </tr><tr> <td>Steps broken major</td> <td></td> </tr><tr> <td>Lateral corrosion minor</td> <td></td> </tr></table>

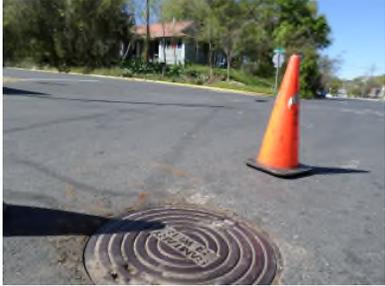
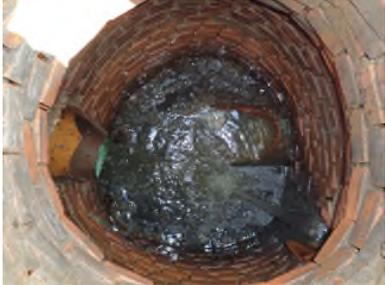
<table><tr> <td>Cover Fit Tight</td> <td style="text-align: right;"><i>Overall Score</i></td> </tr><tr> <td>Chimney corrosion moderate</td> <td style="text-align: right;">Total <b>54</b></td> </tr><tr> <td>Cover seal missing</td> <td></td> </tr><tr> <td>Cone corroded minor</td> <td></td> </tr><tr> <td>Bench corrosion moderate</td> <td></td> </tr><tr> <td>Channel corrosion moderate</td> <td></td> </tr><tr> <td>Chamber corrosion minor</td> <td></td> </tr><tr> <td>Sewer connection crack moderate</td> <td></td> </tr></table>

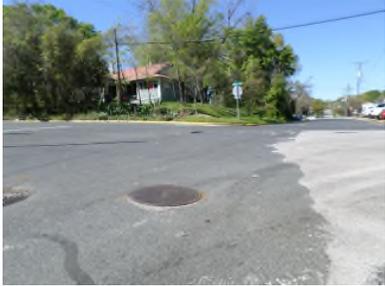
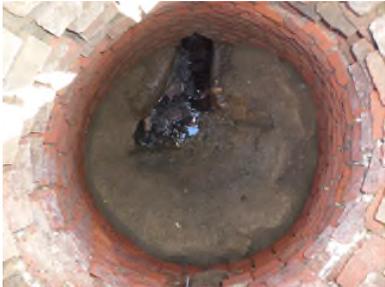
<p>Defects</p> <p>Cover crack minor</p> <p>Cover Fit Tight</p> <p>Cover seal missing</p> <p>Frame base seal corrosion moderate</p> <p>Channel hydraulic restriction moderate</p> <p>Sewer connection crack moderate</p> <p style="text-align: right;"><i>Overall Score</i></p> <p style="text-align: right;">Total        <b>44</b></p>
--	--

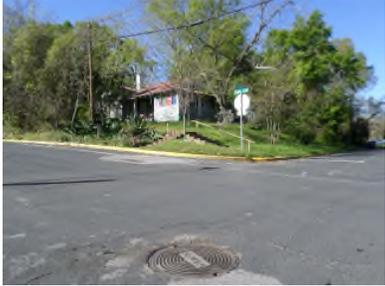
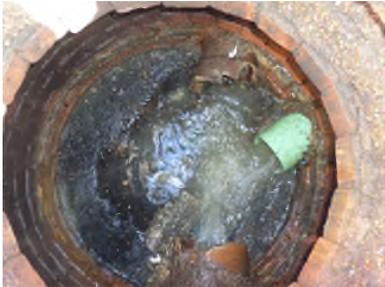
<p>Defects</p> <ul style="list-style-type: none"> <li>Cover Fit Tight</li> <li>Cover seal missing</li> <li>Cover surface wear minor</li> <li>Bench corrosion moderate</li> <li>Channel corrosion moderate</li> <li>Chamber corrosion moderate</li> <li>Sewer connection crack moderate</li> <li>Steps broken major</li> <li>Lateral corrosion major</li> </ul> <p style="text-align: right;"><i>Overall Score</i></p> <p style="text-align: right;">Total <b>74</b></p>
--	---

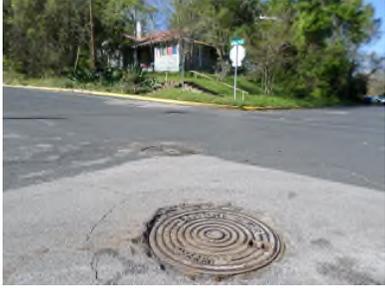
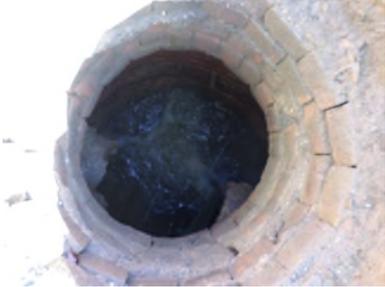
<table><tr> <td>Cover Fit Tight</td> <td style="text-align: right;"><i>Overall Score</i></td> </tr><tr> <td>Cover seal missing</td> <td style="text-align: right;">Total <b>71</b></td> </tr><tr> <td>Bench corrosion moderate</td> <td></td> </tr><tr> <td>Channel corrosion moderate</td> <td></td> </tr><tr> <td>Chamber corrosion moderate</td> <td></td> </tr><tr> <td>Sewer connection crack moderate</td> <td></td> </tr><tr> <td>Steps broken major</td> <td></td> </tr><tr> <td>Lateral corrosion major</td> <td></td> </tr></table>

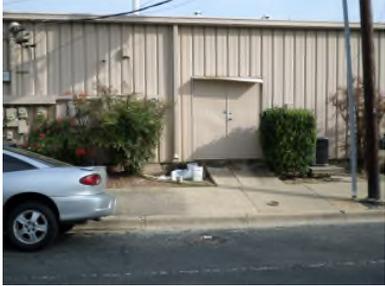
<p>Defects</p> <table style="width: 100%;"> <tr> <td>Cover Fit Tight</td> <td style="text-align: right;"><i>Overall Score</i></td> </tr> <tr> <td>Cover seal missing</td> <td style="text-align: right;">Total <b>8</b></td> </tr> </table>	Cover Fit Tight	<i>Overall Score</i>	Cover seal missing	Total <b>8</b>
Cover Fit Tight	<i>Overall Score</i>				
Cover seal missing	Total <b>8</b>

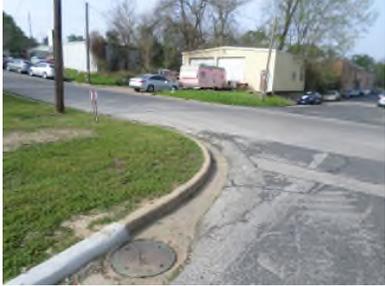
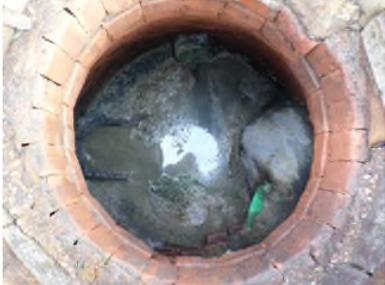
<p>Defects</p> <table style="width: 100%;"> <tr> <td>Cover Fit Tight</td> <td style="text-align: right;"><i>Overall Score</i></td> </tr> <tr> <td>Cover seal missing</td> <td style="text-align: right;">Total <b>8</b></td> </tr> </table>	Cover Fit Tight	<i>Overall Score</i>	Cover seal missing	Total <b>8</b>
Cover Fit Tight	<i>Overall Score</i>				
Cover seal missing	Total <b>8</b>

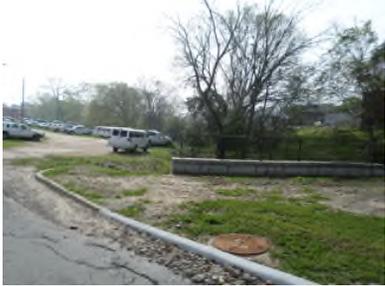
<p>Defects</p> <table style="width: 100%;"> <tr> <td>Cover Fit Tight</td> <td style="text-align: right;"><i>Overall Score</i></td> </tr> <tr> <td>Chimney seal defect major</td> <td style="text-align: right;">Total <b>33</b></td> </tr> </table>	Cover Fit Tight	<i>Overall Score</i>	Chimney seal defect major	Total <b>33</b>
Cover Fit Tight	<i>Overall Score</i>				
Chimney seal defect major	Total <b>33</b>

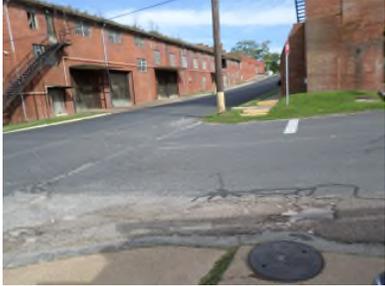
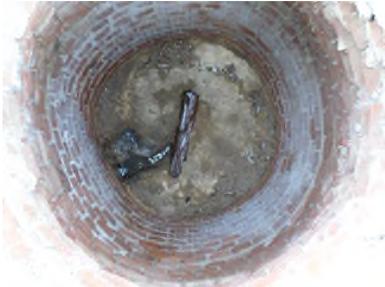
<p>Defects</p> <table style="width: 100%;"> <tr> <td>Cover Fit Tight</td> <td style="text-align: right;"><i>Overall Score</i></td> </tr> <tr> <td>Cover seal missing</td> <td style="text-align: right;">Total <b>8</b></td> </tr> </table>	Cover Fit Tight	<i>Overall Score</i>	Cover seal missing	Total <b>8</b>
Cover Fit Tight	<i>Overall Score</i>				
Cover seal missing	Total <b>8</b>

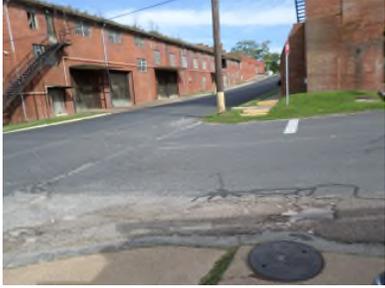
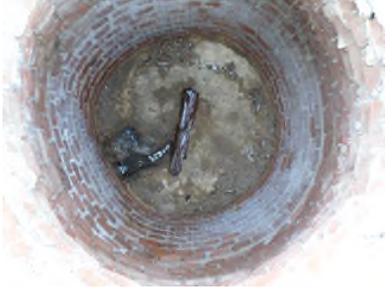
<p>Defects</p> <table style="width: 100%;"> <tr> <td>Cover Fit Tight</td> <td style="text-align: right;"><i>Overall Score</i></td> </tr> <tr> <td>Cover seal missing</td> <td style="text-align: right;">Total <b>8</b></td> </tr> </table>	Cover Fit Tight	<i>Overall Score</i>	Cover seal missing	Total <b>8</b>
Cover Fit Tight	<i>Overall Score</i>				
Cover seal missing	Total <b>8</b>

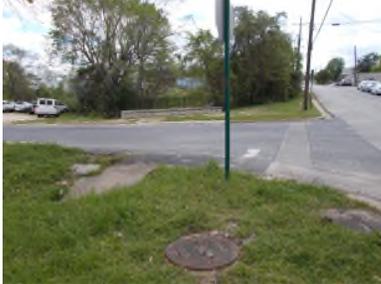
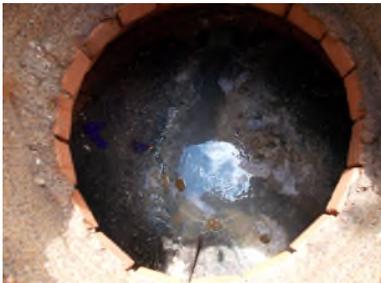
<p>Defects</p> <p>Cover crack minor</p> <p>Cover Fit Tight</p> <p>Cover seal missing</p> <p style="text-align: right;"><i>Overall Score</i></p> <p style="text-align: right;">Total        <b>13</b></p>
--	---

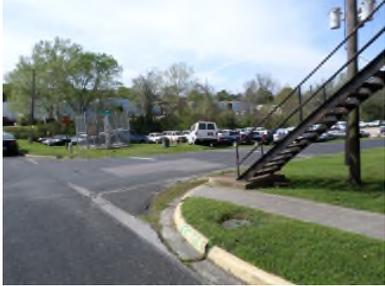
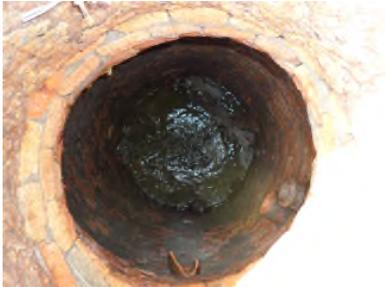
<p>Defects</p> <ul style="list-style-type: none"> <li>Cover crack minor</li> <li>Cover corrosion moderate</li> <li>Cover fit loose</li> <li>Cover I/I moderate</li> <li>Cover surface wear major</li> </ul> <table style="width: 100%; margin-top: 20px;"> <tr> <td style="text-align: right;"><i>Overall Score</i></td> <td></td> </tr> <tr> <td style="text-align: right;">Total</td> <td style="text-align: right;"><b>52</b></td> </tr> </table>	<i>Overall Score</i>		Total	<b>52</b>
<i>Overall Score</i>					
Total	<b>52</b>

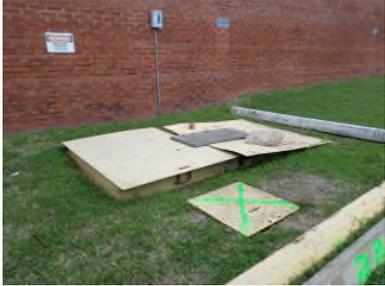
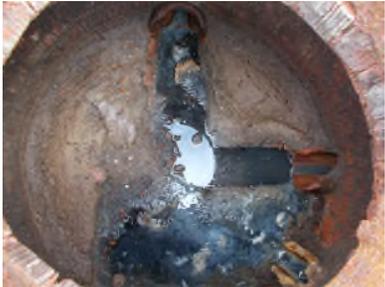
Cover Fit Tight	<i>Overall Score</i>
Cover seal missing	Total <b>23</b>
Channel debris moderate

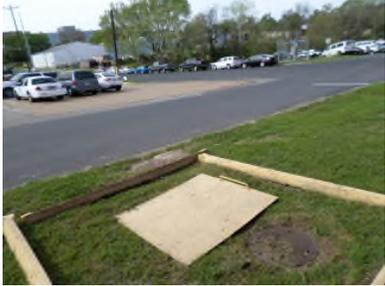
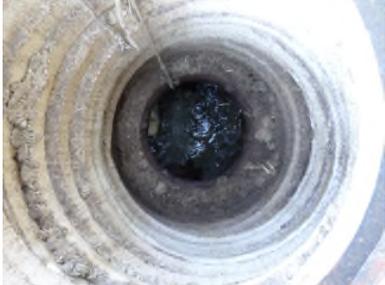
<p>Defects</p> <table style="width: 100%;"> <tr> <td>Cover Fit Tight</td> <td style="text-align: right;"><i>Overall Score</i></td> </tr> <tr> <td>Cover seal missing</td> <td style="text-align: right;">Total <b>8</b></td> </tr> </table>	Cover Fit Tight	<i>Overall Score</i>	Cover seal missing	Total <b>8</b>
Cover Fit Tight	<i>Overall Score</i>				
Cover seal missing	Total <b>8</b>

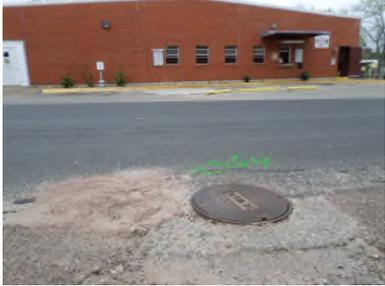
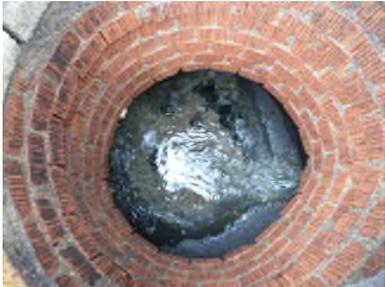
Cover Fit Tight	<i>Overall Score</i>	Cover seal missing	Total <b>13</b>	Bench debris moderate	
Cover Fit Tight	<i>Overall Score</i>						
Cover seal missing	Total <b>13</b>						
Bench debris moderate

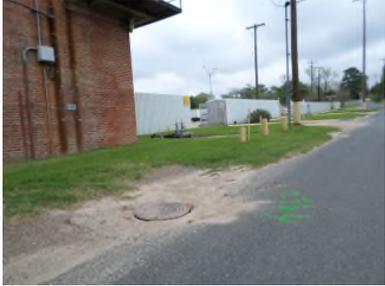
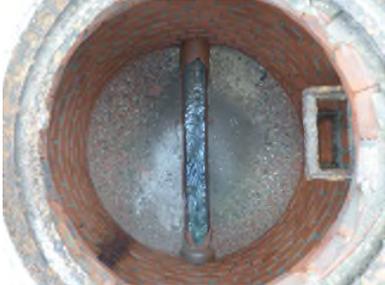
Cover Fit Tight	<i>Overall Score</i>	Sewer connection crack moderate	Total <b>19</b>	Lateral corrosion moderate	
Cover Fit Tight	<i>Overall Score</i>						
Sewer connection crack moderate	Total <b>19</b>						
Lateral corrosion moderate

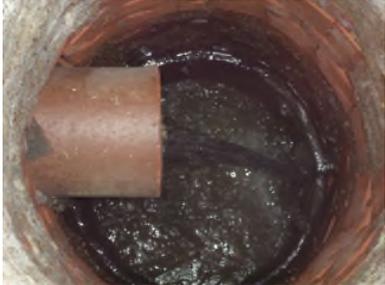
<p>Defects</p> <p>Cover seal missing</p> <p style="text-align: right;"><i>Overall Score</i></p> <p style="text-align: right;">Total <b>5</b></p>
--	--

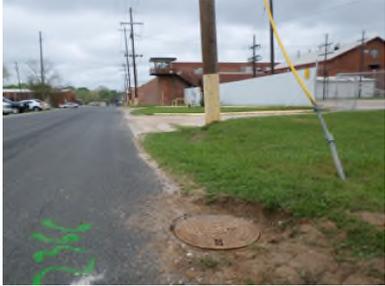
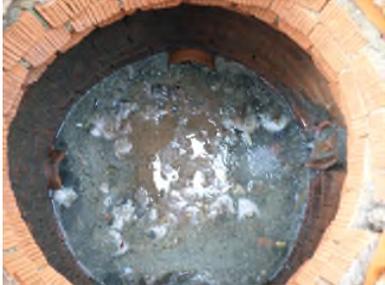
<p>Defects</p> <table style="width: 100%;"> <tr> <td>Cover Fit Tight</td> <td style="text-align: right;"><i>Overall Score</i></td> </tr> <tr> <td>Cover seal missing</td> <td style="text-align: right;">Total <b>8</b></td> </tr> </table>	Cover Fit Tight	<i>Overall Score</i>	Cover seal missing	Total <b>8</b>
Cover Fit Tight	<i>Overall Score</i>				
Cover seal missing	Total <b>8</b>

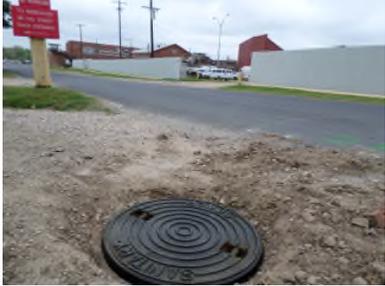
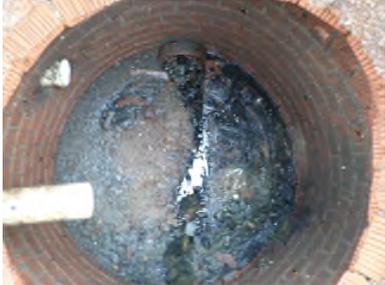
<p>Defects</p> <p>Cover fit rocking</p> <p>Cover I/I major</p> <p>Channel debris moderate</p> <p>Channel hydraulic restriction moderate</p> <p>Sewer connection crack moderate</p> <p style="text-align: right;"><i>Overall Score</i></p> <p style="text-align: right;">Total <b>74</b></p>
--	--

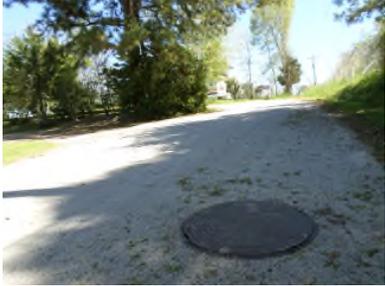
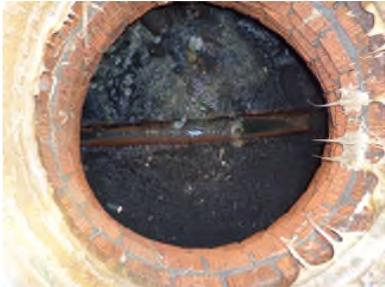
Cover Fit Tight	<i>Overall Score</i>	Cover seal missing	Total <b>21</b>	Cover surface wear minor		Frame base seal corrosion moderate	
Cover Fit Tight	<i>Overall Score</i>								
Cover seal missing	Total <b>21</b>								
Cover surface wear minor									
Frame base seal corrosion moderate

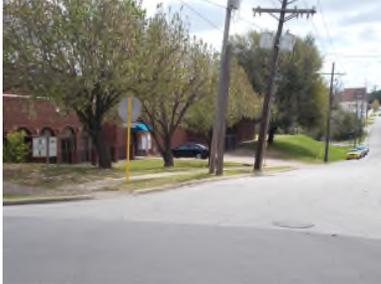
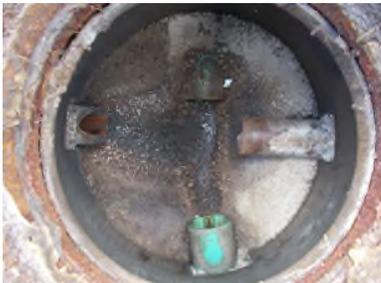
<p>Defects</p> <table style="width: 100%;"> <tr> <td>Cover Fit Tight</td> <td style="text-align: right;"><i>Overall Score</i></td> </tr> <tr> <td>Cover seal missing</td> <td style="text-align: right;">Total <b>8</b></td> </tr> </table>	Cover Fit Tight	<i>Overall Score</i>	Cover seal missing	Total <b>8</b>
Cover Fit Tight	<i>Overall Score</i>				
Cover seal missing	Total <b>8</b>

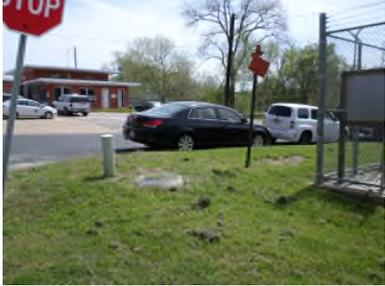
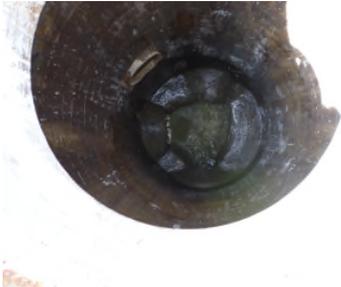
<p>Defects</p> <p>Cover seal missing</p> <p style="text-align: right;"><i>Overall Score</i></p> <p style="text-align: right;">Total <b>5</b></p>
--	--

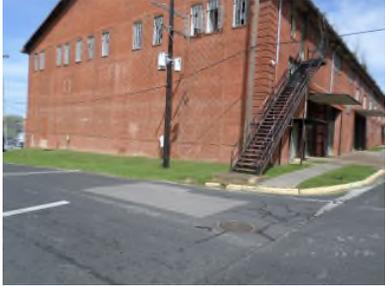
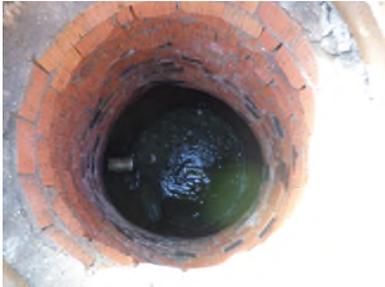
<p>Defects</p> <table style="width: 100%;"> <tr> <td>Cover Fit Tight</td> <td style="text-align: right;"><i>Overall Score</i></td> </tr> <tr> <td>Cover seal missing</td> <td style="text-align: right;">Total <b>8</b></td> </tr> </table>	Cover Fit Tight	<i>Overall Score</i>	Cover seal missing	Total <b>8</b>
Cover Fit Tight	<i>Overall Score</i>				
Cover seal missing	Total <b>8</b>

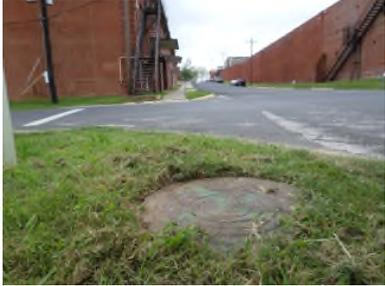
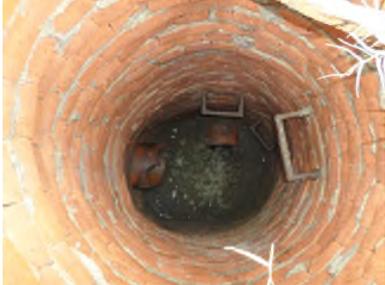
<p>Defects</p> <p>Cover corrosion moderate</p> <p>Cover I/I minor</p> <p>Cover seal missing</p> <p>Cover surface wear major</p> <p>Channel hydraulic restriction moderate</p> <p>Lateral corrosion moderate</p> <div style="text-align: right; margin-top: 20px;"> <p><i>Overall Score</i></p> <p>Total <b>66</b></p> </div>
--	--

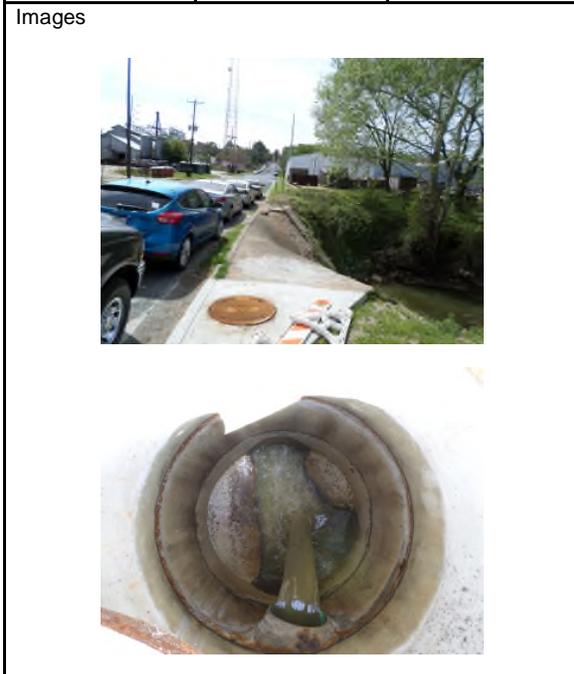
Location Description  1471 Avenue I	Manhole Grade At Grade
	Grade Difference (ft) 0.00
	Cover to Invert Depth (ft) 7.58

Cover Fit Tight	<i>Overall Score</i>
Cover seal missing	Total <b>8</b>

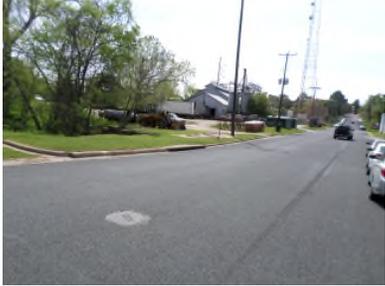
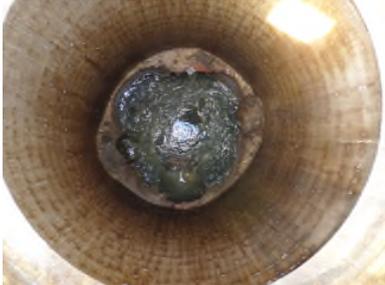
<p>Defects</p> <table style="width: 100%;"> <tr> <td>Cover Fit Tight</td> <td style="text-align: right;"><i>Overall Score</i></td> </tr> <tr> <td>Sewer connection crack moderate</td> <td style="text-align: right;">Total <b>15</b></td> </tr> </table>	Cover Fit Tight	<i>Overall Score</i>	Sewer connection crack moderate	Total <b>15</b>
Cover Fit Tight	<i>Overall Score</i>				
Sewer connection crack moderate	Total <b>15</b>

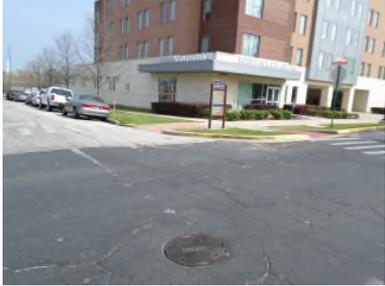
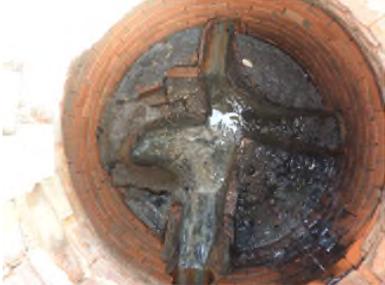
<p>Defects</p>

<table><tr> <td>Cover Fit Tight</td> <td style="text-align: right;"><i>Overall Score</i></td> </tr><tr> <td>Cover seal missing</td> <td style="text-align: right;">Total <b>87</b></td> </tr><tr> <td>Bench broken moderate</td> <td></td> </tr><tr> <td>Bench corrosion major</td> <td></td> </tr><tr> <td>Bench mortar missing major</td> <td></td> </tr><tr> <td>Sewer connection crack moderate</td> <td></td> </tr><tr> <td>Steps broken major</td> <td></td> </tr></table>

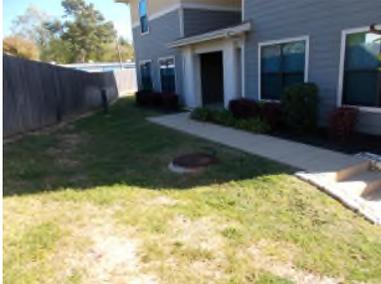
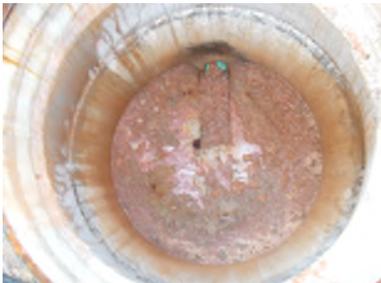
<p>Defects</p> <p>Channel debris moderate</p> <p style="text-align: right;"><i>Overall Score</i></p> <p style="text-align: right;">Total           <b>15</b></p>
--	--

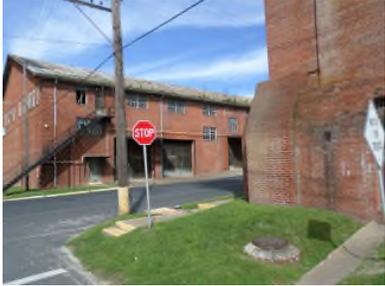
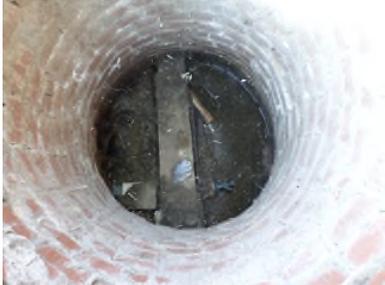
Cover Fit Tight	<i>Overall Score</i>	Cover seal missing	Total <b>28</b>	Channel hydraulic restriction moderate	
Cover Fit Tight	<i>Overall Score</i>						
Cover seal missing	Total <b>28</b>						
Channel hydraulic restriction moderate

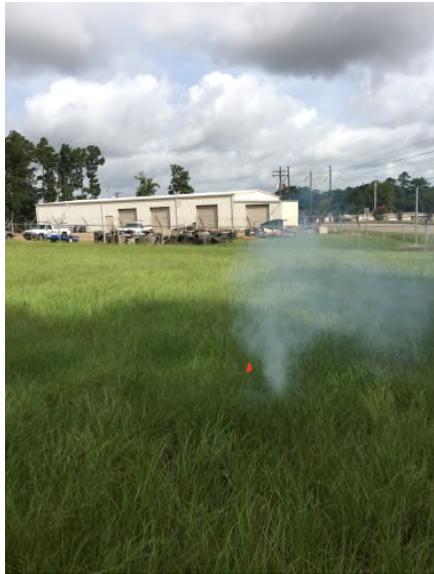
Basin / Sub-Basin AJ-12	Set-Up DM001	Defect No 1	Date 7/16/2016	Time 10:00:00 AM	Crew Leader DM
----------------------------	-----------------	----------------	-------------------	---------------------	-------------------

Defect Type Private	Surface Cover Side Yard	Surface Cover Material Grass	Smoke From Lateral	Intensity Medium
------------------------	----------------------------	---------------------------------	-----------------------	---------------------

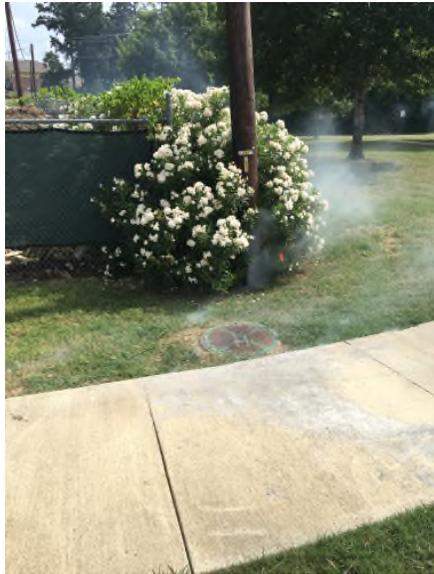
Basin / Sub-Basin AJ-12	Set-Up DM002	Defect No 1	Date 7/16/2016	Time 11:05:00 AM	Crew Leader DM
----------------------------	-----------------	----------------	-------------------	---------------------	-------------------

Defect Type Private	Surface Cover Front Yard	Surface Cover Material Grass	Smoke From Manhole	Intensity Medium
------------------------	-----------------------------	---------------------------------	-----------------------	---------------------

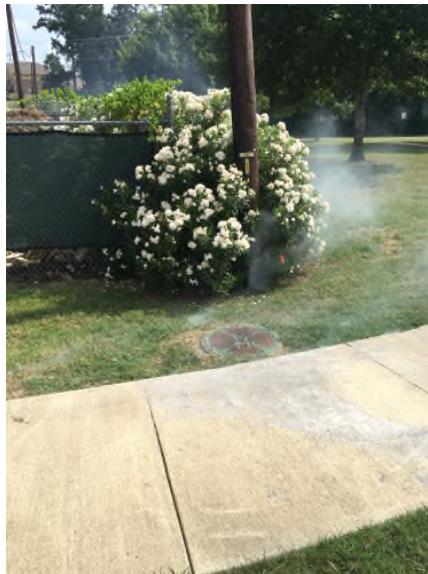
Basin / Sub-Basin AJ-12	Set-Up DM002	Defect No 2	Date 7/16/2016	Time 11:05:00 AM	Crew Leader DM
----------------------------	-----------------	----------------	-------------------	---------------------	-------------------

Defect Type Public	Surface Cover Side Yard	Surface Cover Material Grass	Smoke From Lateral	Intensity Medium
-----------------------	----------------------------	---------------------------------	-----------------------	---------------------

Comments  
N: 30.7157; W: -95.5404 Utility pole intrusion

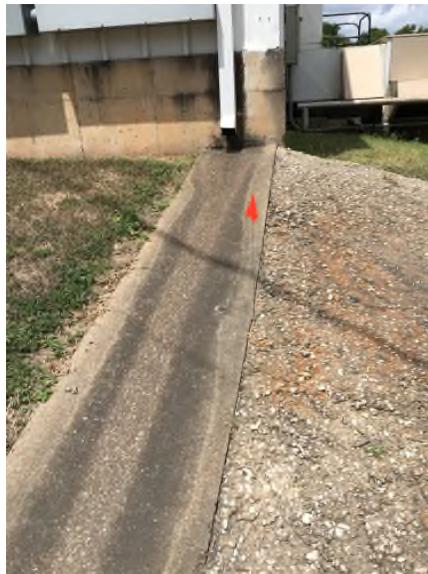
Basin / Sub-Basin AJ-12	Set-Up DM005	Defect No 1	Date 7/16/2016	Time 12:20:00 PM	Crew Leader DM
----------------------------	-----------------	----------------	-------------------	---------------------	-------------------

Defect Type Public	Surface Cover Driveway	Surface Cover Material Concrete	Smoke From Sewer Line	Intensity Medium
-----------------------	---------------------------	------------------------------------	--------------------------	---------------------

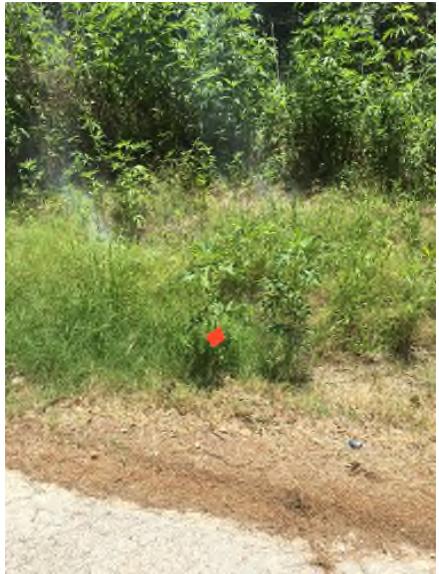
Basin / Sub-Basin AJ-12	Set-Up DM008	Defect No 1	Date 7/16/2016	Time 1:48:00 PM	Crew Leader DM
----------------------------	-----------------	----------------	-------------------	--------------------	-------------------

Defect Type Public	Surface Cover Driveway	Surface Cover Material Gravel	Smoke From Sewer Line	Intensity Heavy
-----------------------	---------------------------	----------------------------------	--------------------------	--------------------

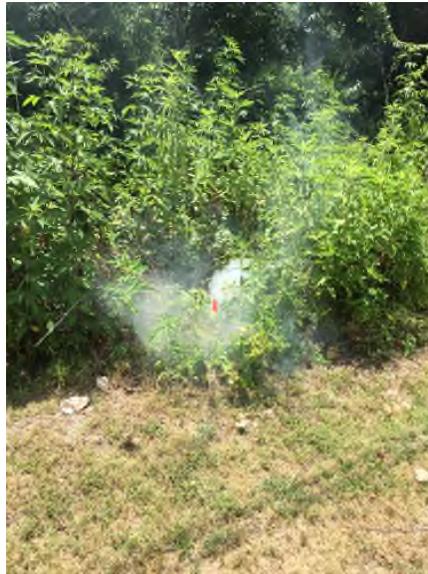
Basin / Sub-Basin AJ-12	Set-Up DM008	Defect No 2	Date 7/16/2016	Time 1:48:00 PM	Crew Leader DM
----------------------------	-----------------	----------------	-------------------	--------------------	-------------------

Defect Type Public	Surface Cover Other	Surface Cover Material Grass	Smoke From Sewer Line	Intensity Medium
-----------------------	------------------------	---------------------------------	--------------------------	---------------------

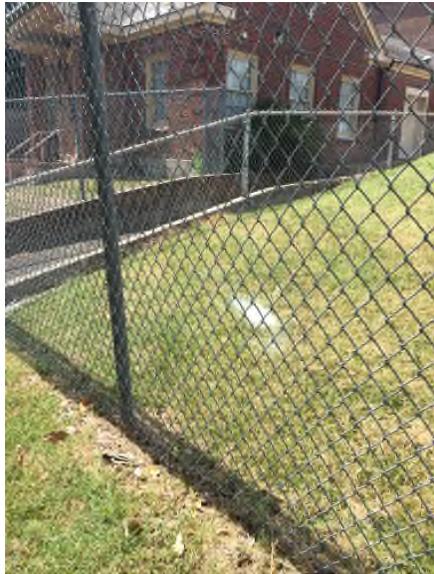
Basin / Sub-Basin AJ-12	Set-Up DM010	Defect No 1	Date 7/16/2016	Time 3:30:00 PM	Crew Leader DM
----------------------------	-----------------	----------------	-------------------	--------------------	-------------------

Defect Type Private	Surface Cover Front Yard	Surface Cover Material Grass	Smoke From Lateral	Intensity Medium
------------------------	-----------------------------	---------------------------------	-----------------------	---------------------

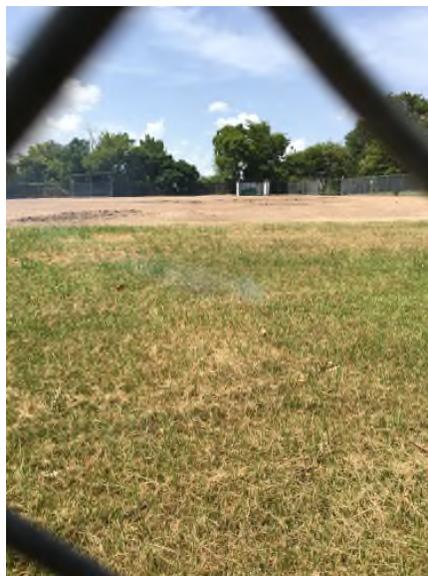
Basin / Sub-Basin AJ-12	Set-Up DM010	Defect No 2	Date 7/16/2016	Time 3:30:00 PM	Crew Leader DM
----------------------------	-----------------	----------------	-------------------	--------------------	-------------------

Defect Type Private	Surface Cover Front Yard	Surface Cover Material Grass	Smoke From Lateral	Intensity Medium
------------------------	-----------------------------	---------------------------------	-----------------------	---------------------

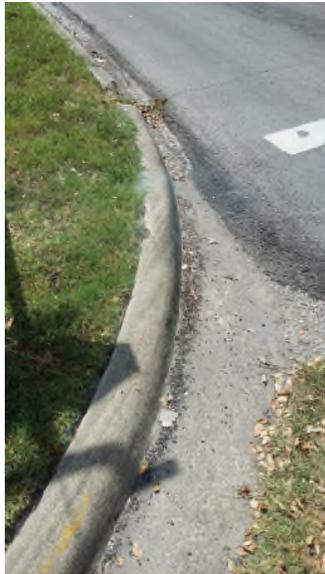
Basin / Sub-Basin AJ-12	Set-Up DM010	Defect No 3	Date 7/16/2016	Time 3:30:00 PM	Crew Leader DM
----------------------------	-----------------	----------------	-------------------	--------------------	-------------------

Defect Type Private	Surface Cover Street	Surface Cover Material Concrete	Smoke From Manhole	Intensity Medium
------------------------	-------------------------	------------------------------------	-----------------------	---------------------

Comments  
Smoke seeping out from pavement

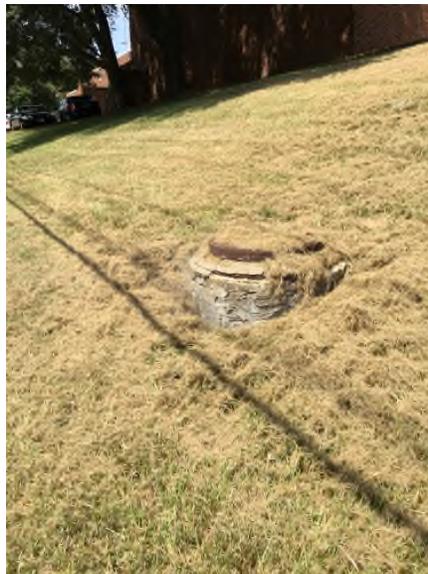
Basin / Sub-Basin AJ-12	Set-Up DM010	Defect No 4	Date 7/16/2016	Time 3:30:00 PM	Crew Leader DM
----------------------------	-----------------	----------------	-------------------	--------------------	-------------------

Defect Type Private	Surface Cover Side Yard	Surface Cover Material Grass	Smoke From Manhole	Intensity Light
------------------------	----------------------------	---------------------------------	-----------------------	--------------------

Comments  
Leak at wall-smoke blowing out of manhole cone seal at grade

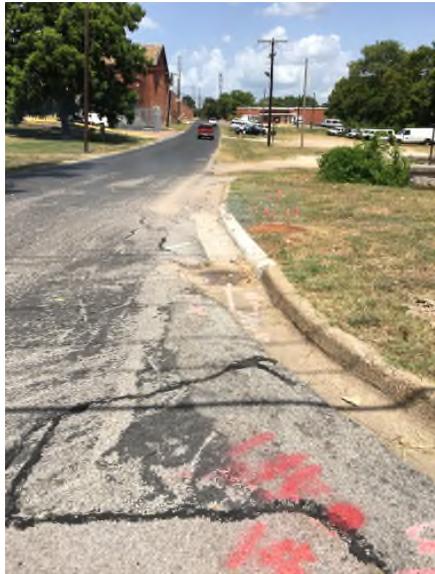
Basin / Sub-Basin AJ-12	Set-Up DM010	Defect No 5	Date 7/16/2016	Time 3:00:00 PM	Crew Leader DM
----------------------------	-----------------	----------------	-------------------	--------------------	-------------------

Defect Type Private	Surface Cover Street	Surface Cover Material Concrete	Smoke From Manhole	Intensity Heavy
------------------------	-------------------------	------------------------------------	-----------------------	--------------------

Comments  
Subject to inflow and location does not have an inflow dish.

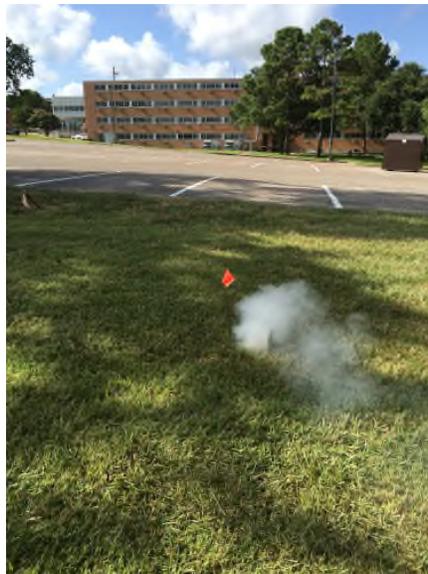
Basin / Sub-Basin AJ-12	Set-Up DM011	Defect No 1	Date 7/17/2016	Time 8:45:00 AM	Crew Leader DM
----------------------------	-----------------	----------------	-------------------	--------------------	-------------------

Defect Type Private	Surface Cover Side Yard	Surface Cover Material Grass	Smoke From Lateral	Intensity Medium
------------------------	----------------------------	---------------------------------	-----------------------	---------------------

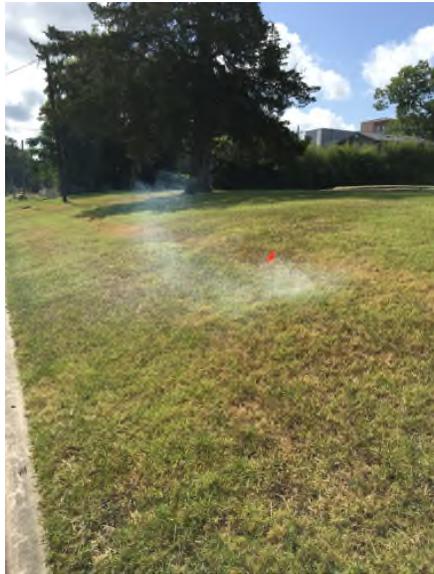
Basin / Sub-Basin AJ-12	Set-Up DM011	Defect No 2	Date 7/17/2016	Time 8:45:00 AM	Crew Leader DM
----------------------------	-----------------	----------------	-------------------	--------------------	-------------------

Defect Type Private	Surface Cover Side Yard	Surface Cover Material Grass	Smoke From Lateral	Intensity Medium
------------------------	----------------------------	---------------------------------	-----------------------	---------------------

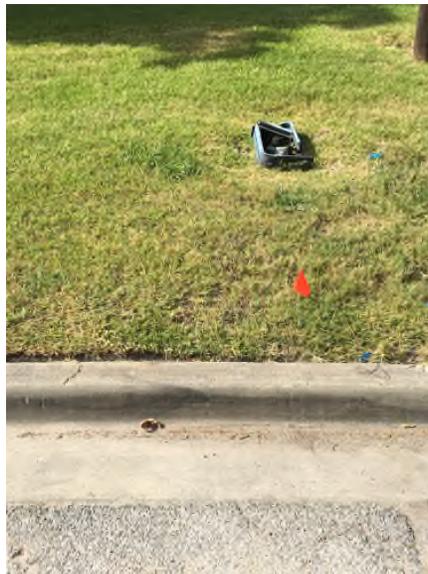
Basin / Sub-Basin AJ-12	Set-Up DM011	Defect No 3	Date 7/17/2016	Time 8:45:00 AM	Crew Leader DM
----------------------------	-----------------	----------------	-------------------	--------------------	-------------------

Defect Type Public	Surface Cover Side Yard	Surface Cover Material Grass	Smoke From Lateral	Intensity Medium
-----------------------	----------------------------	---------------------------------	-----------------------	---------------------

Comments  
Service lateral collapsed at edge of road. Potential inflow.
