## **APPENDIX C**

### **Water System Field Testing Results**

**PROJECT:** Water and Wastewater Condition and Capacity Assessment Studies  
Spring Lake Water Plant Pump Testing

### Water and Wastewater System Condition and Capacity Studies

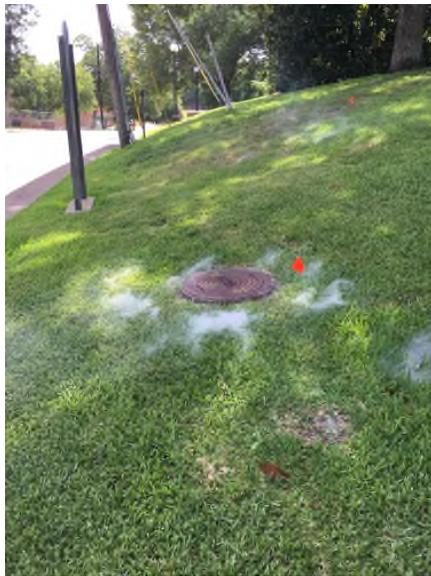
Basin / Sub-Basin AJ-12	Set-Up DM012	Defect No 1	Date 7/17/2016	Time 11:00:00 AM	Crew Leader DM
----------------------------	-----------------	----------------	-------------------	---------------------	-------------------

Defect Type Private	Surface Cover Side Yard	Surface Cover Material Grass	Smoke From Manhole	Intensity Medium
------------------------	----------------------------	---------------------------------	-----------------------	---------------------

Comments  
Manhole wall leak

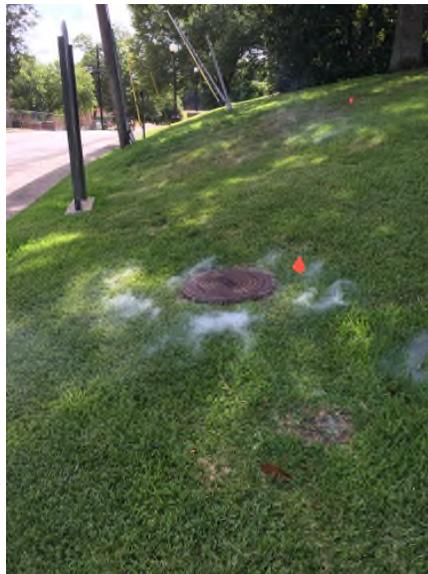
Basin / Sub-Basin AJ-12	Set-Up DM012	Defect No 2	Date 7/17/2016	Time 11:00:00 AM	Crew Leader DM
----------------------------	-----------------	----------------	-------------------	---------------------	-------------------

Defect Type Private	Surface Cover Side Yard	Surface Cover Material Grass	Smoke From Sewer Line	Intensity Medium
------------------------	----------------------------	---------------------------------	--------------------------	---------------------

Comments  
Mainline leak between manholes. N: 30.7164; W: -95.5505

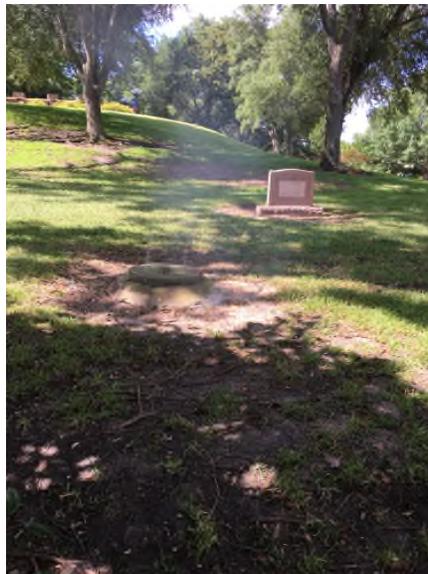
Defect Type Private	Surface Cover Side Yard	Surface Cover Material Grass	Smoke From Manhole	Intensity Medium
------------------------	----------------------------	---------------------------------	-----------------------	---------------------

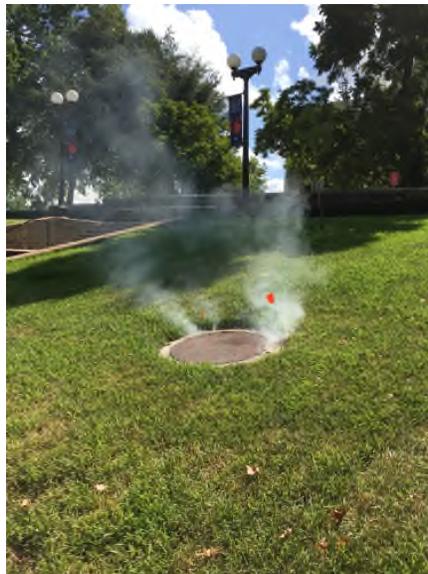
Defect Type Private	Surface Cover Field	Surface Cover Material Grass	Smoke From Manhole	Intensity Medium
------------------------	------------------------	---------------------------------	-----------------------	---------------------

Comments  
Subject to inflow with no inflow dish

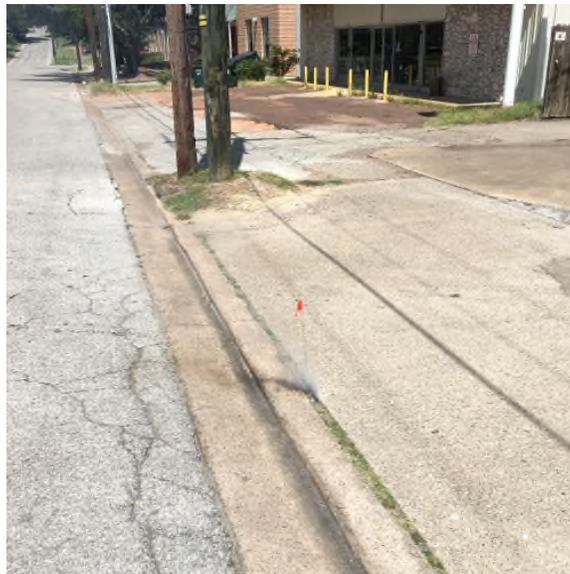
Defect Type Private	Surface Cover Driveway	Surface Cover Material Concrete	Smoke From Lateral	Intensity Heavy
------------------------	---------------------------	------------------------------------	-----------------------	--------------------

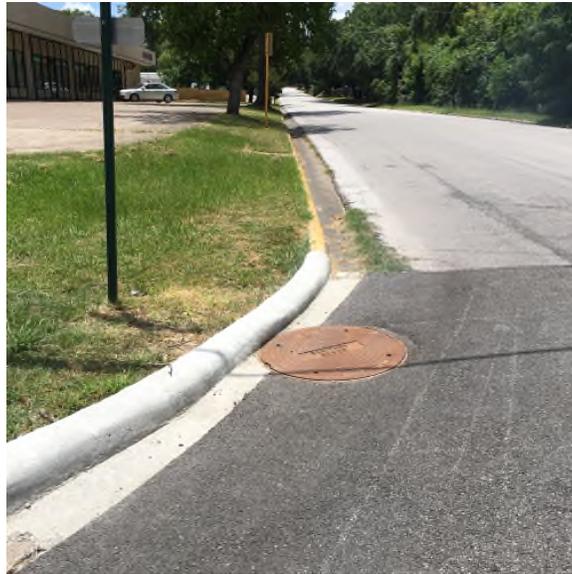
Defect Type Private	Surface Cover Street	Surface Cover Material Asphalt	Smoke From Manhole	Intensity Heavy
------------------------	-------------------------	-----------------------------------	-----------------------	--------------------

Comments  
Subject to inflow

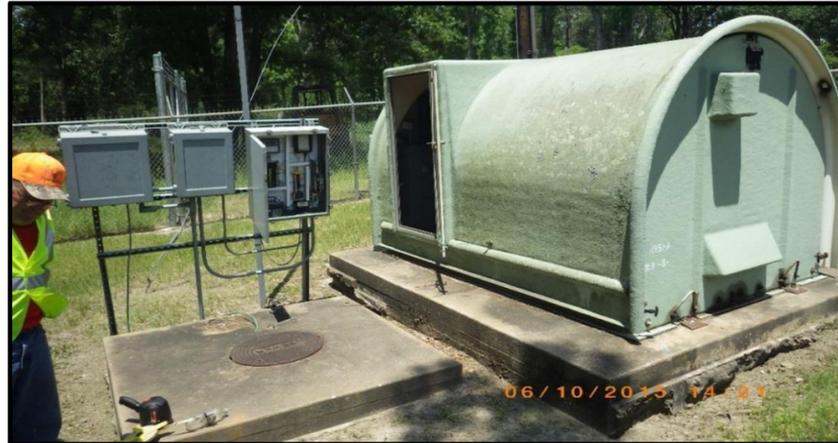
Component Group	Component Condition Rating	Weight Factor	Weighted Component Rating	Comments
Electrical – MCC, Back-up Power, Cables	3	20%	0.60	Age
Pumps and Motors	3	20%	0.60	Age
Instrumentation - SCADA, alarms	2	15%	0.30	Rack needs rehab.
Structure - Hatches, Corrosion, Cracks, Leaking, Ventilation, Odor Control	3	20%	0.60	Heavy root intrusion. 24" manhole access. No wet well coating.
Piping and Valves	3	15%	0.45	Check valve 2 not closing. Heavy corrosion in wet well.
Site - Drainage, Access Drive, Security, Fencing	2	10%	0.20	Driveway needs gravel touch up. No site lighting.
Total Inspection Score	-	100%	2.75	
Impact of Work Order Data	-	-	0.00	Below average number of work orders
<b>Condition Rating</b>	-	-	<b>2.75</b>

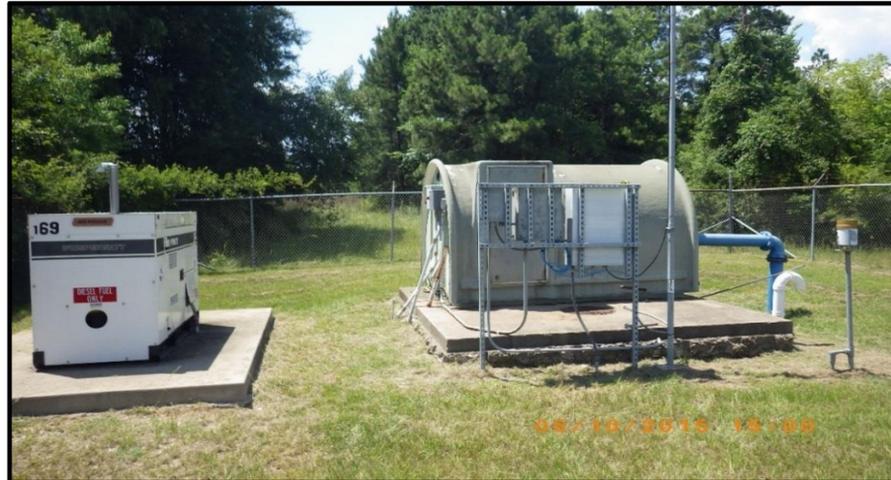
Component Group	Component Condition Rating	Weight Factor	Weighted Component Rating	Comments
Electrical – MCC, Back-up Power, Cables	3	20%	0.60	Broken conduits.
Pumps and Motors	3	20%	0.60	Pump 1 not priming. Age.
Instrumentation - SCADA, alarms	2	15%	0.30	
Structure - Hatches, Corrosion, Cracks, Leaking, Ventilation, Odor Control	5	20%	1.00	Complete wall deterioration with rebar showing. Heavy root intrusion. 24" manhole access. Undermining of structural slab.
Piping and Valves	3	15%	0.45	Heavy Corrosion in wet well.
Site - Drainage, Access Drive, Security, Fencing	3	10%	0.30	Needs grading. Fence needs repair.
Total Inspection Score	-	100%	3.25	
Impact of Work Order Data	-	-	0.25	Above average number of work orders
<b>Condition Rating</b>	-	-	<b>3.50</b>

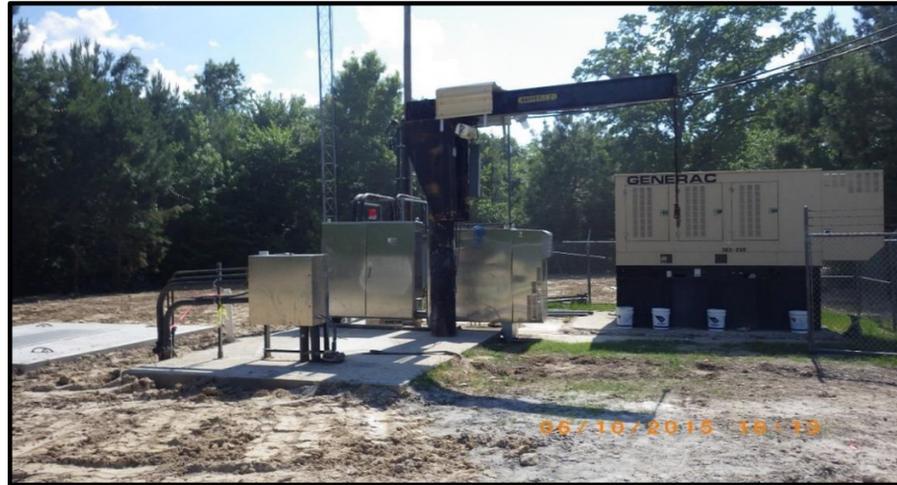
Component Group	Component Condition Rating	Weight Factor	Weighted Component Rating	Comments
Electrical – MCC, Back-up Power, Cables	3	20%	0.60	Bad condition overall.
Pumps and Motors	3	20%	0.60	Only 1 pump in operation currently. VFD # 2 is being repaired.
Instrumentation - SCADA, alarms	2	15%	0.30	
Structure - Hatches, Corrosion, Cracks, Leaking, Ventilation, Odor Control	3	20%	0.60	Wet well liner needs repair. Valve Vault holding water. Crane needs repair.
Piping and Valves	3	15%	0.45	Moderate corrosion in wet well Check valve No. 1 leaking in valve vault.
Site - Drainage, Access Drive, Security, Fencing	2	10%	0.20	Access drive touchups needed. Needs some grading.
Total Inspection Score	-	100%	2.75	
Impact of Work Order Data	-	-	0.25	Above average number of work orders
<b>Condition Rating</b>	-	-	<b>3.00</b>

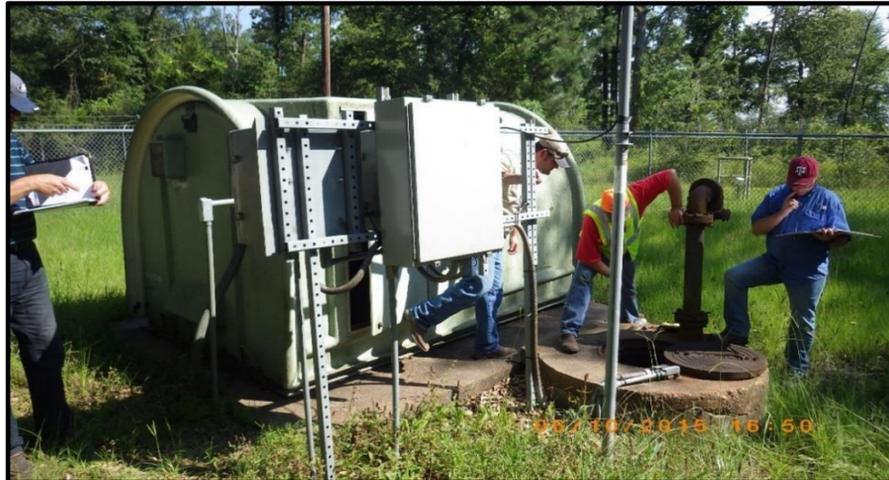
Component Group	Component Condition Rating	Weight Factor	Weighted Component Rating	Comments
Electrical – MCC, Back-up Power, Cables	4	20%	0.80	Age
Pumps and Motors	4	20%	0.80	No drawdown observed on either pump.
Instrumentation - SCADA, alarms	3	15%	0.45	
Structure - Hatches, Corrosion, Cracks, Leaking, Ventilation, Odor Control	5	20%	1.00	Complete deterioration of wet well. 24" manhole access.
Piping and Valves	3	15%	0.45	Piping submerged in wet well.
Site - Drainage, Access Drive, Security, Fencing	2	10%	0.20	Some low areas. (Poor drainage)
Total Inspection Score	-	100%	3.70	
Impact of Work Order Data	-	-	0.00	Below average number of work orders
<b>Condition Rating</b>	-	-	<b>3.70</b>

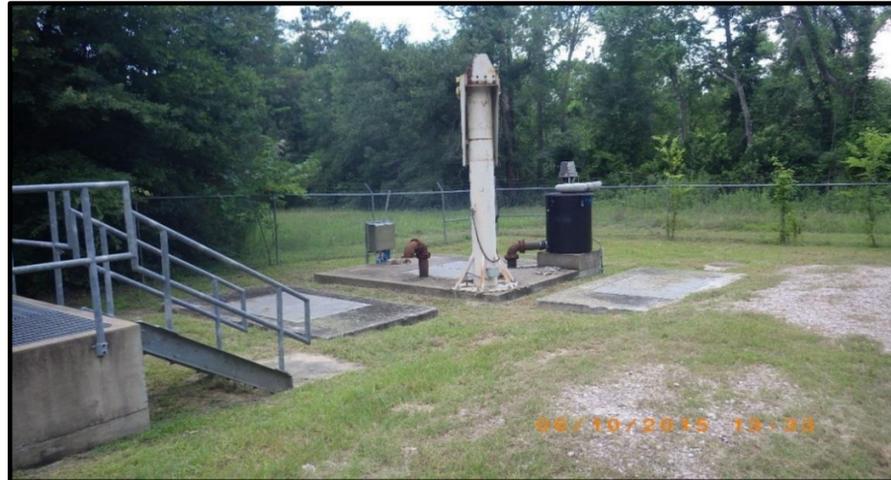
Facility Information	
Address:	259 Sunset Lake Dr
Year in Service:	
Type of Facility:	Submersible
Number of Pumps:	2
Firm Capacity:	1.44 MGD @ 65' TDH
Horsepower:	40 hp
Monitoring:	SCADA
Generator:	135 kW

Component Group	Component Condition Rating	Weight Factor	Weighted Component Rating	Comments
Electrical – MCC, Back-up Power, Cables	2	20%	0.40	
Pumps and Motors	2	20%	0.40	Age
Instrumentation - SCADA, alarms	2	15%	0.30	
Structure - Hatches, Corrosion, Cracks, Leaking, Ventilation, Odor Control	3	20%	0.60	Odor control system not working. Hoist chain problematic. No safety grate. Broken pump rail.
Piping and Valves	2	15%	0.30	Light corrosion in wet well.
Site - Drainage, Access Drive, Security, Fencing	2	10%	0.20	Touch up gravel drive.
Total Inspection Score	-	100%	2.20	
Impact of Work Order Data	-	-	0.00	Below average number of work orders
<b>Condition Rating</b>	-	-	<b>2.20</b>

Condition Rating	Criticality Rating	Overall Risk Rating	Risk Category
<b>Lift Station Risk Rating</b>	<b>2.20</b>	<b>3.25</b>	<b>5.45</b>	<b>Moderate Risk</b>

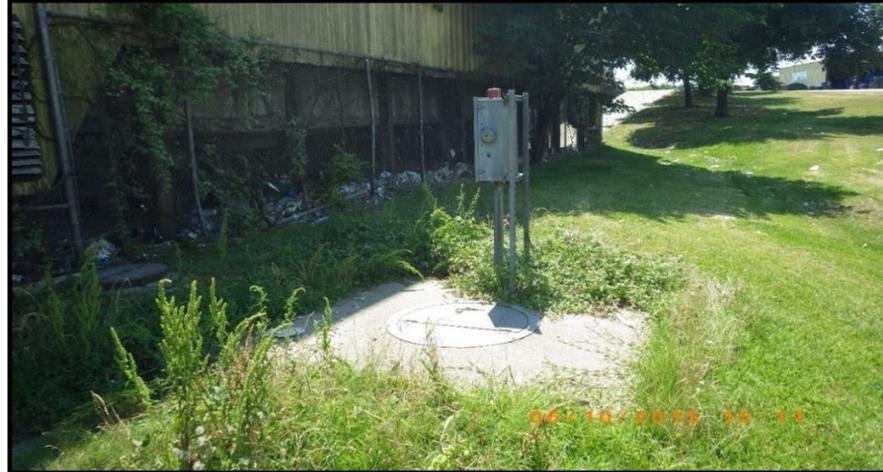
Facility Information	
Address:	590B IH 45 N
Year in Service:	
Type of Facility:	Submersible
Number of Pumps:	2
Firm Capacity:	
Horsepower:	
Monitoring:	No SCADA
Generator:	175 kW

Component Group	Component Condition Rating	Weight Factor	Weighted Component Rating	Comments
Electrical – MCC, Back-up Power, Cables	3	20%	0.60	
Pumps and Motors	3	20%	0.60	Age
Instrumentation - SCADA, alarms	2	15%	0.30	No SCADA. Floats.
Structure - Hatches, Corrosion, Cracks, Leaking, Ventilation, Odor Control	3	20%	0.60	I/I at upstream manhole. Wet well hatch needs lock. Pump rail supports heavily corroded.
Piping and Valves	2	15%	0.30	PVC pipe in wet well.
Site - Drainage, Access Drive, Security, Fencing	2	10%	0.20	
Total Inspection Score	-	100%	2.60	
Impact of Work Order Data	-	-	0.00	Below average number of work orders
<b>Condition Rating</b>	-	-	<b>2.60</b>

Condition Rating	Criticality Rating	Overall Risk Rating	Risk Category
<b>Lift Station Risk Rating</b>	<b>2.60</b>	<b>0.25</b>	<b>2.85</b>	<b>Low Risk</b>

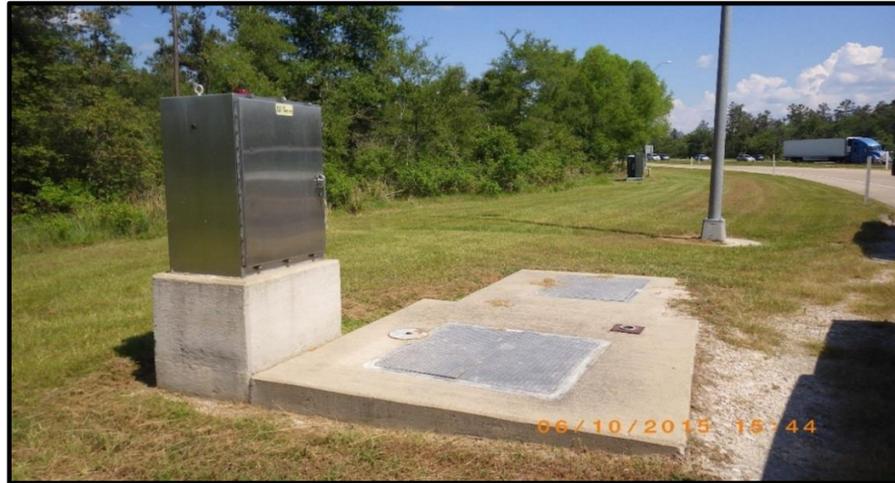
Facility Information	
Address:	1576 IH 45 N
Year in Service:	
Type of Facility:	Submersible
Number of Pumps:	2
Firm Capacity:	
Horsepower:	9.4 hp
Monitoring:	No SCADA
Generator:	No Generator

Component Group	Component Condition Rating	Weight Factor	Weighted Component Rating	Comments
Electrical – MCC, Back-up Power, Cables	2	20%	0.40	
Pumps and Motors	2	20%	0.40	Age
Instrumentation - SCADA, alarms	2	15%	0.30	
Structure - Hatches, Corrosion, Cracks, Leaking, Ventilation, Odor Control	2	20%	0.40	Valve vault holding water.
Piping and Valves	2	15%	0.30	Light corrosion in wet well. Could use a coating.
Site - Drainage, Access Drive, Security, Fencing	1	10%	0.10	
Total Inspection Score	-	100%	1.90	
Impact of Work Order Data	-	-	0.00	Below average number of work orders
<b>Condition Rating</b>	-	-	<b>1.90</b>

Condition Rating	Criticality Rating	Overall Risk Rating	Risk Category
<b>Lift Station Risk Rating</b>	<b>1.90</b>	<b>0.25</b>	<b>2.15</b>	<b>Low Risk</b>

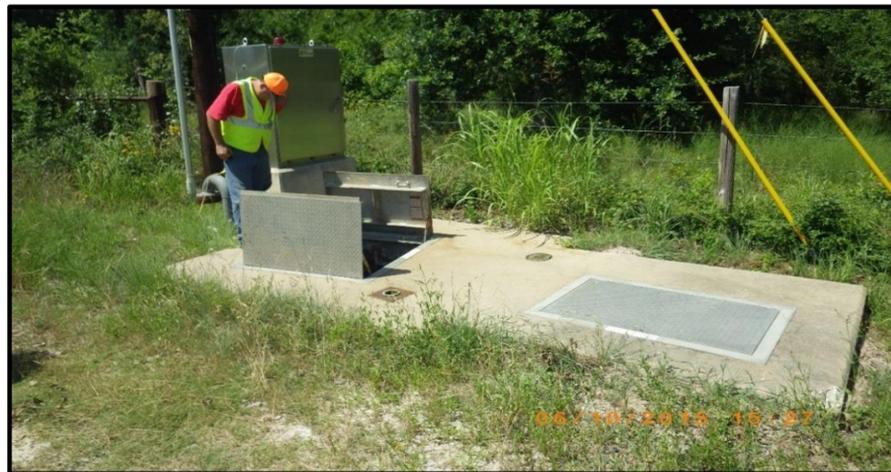
<u>Facility Information</u>	
Address:	1270 IH 45 N
Year in Service:	
Type of Facility:	Submersible
Number of Pumps:	2
Firm Capacity:	
Horsepower:	16.7 hp
Monitoring:	No SCADA
Generator:	No Generator

Component Group	Component Condition Rating	Weight Factor	Weighted Component Rating	Comments
Electrical – MCC, Back-up Power, Cables	4	20%	0.80	Water infiltration of panel
Pumps and Motors	3	20%	0.60	Pump 1 replaced approximately 5 months ago and about 30% more efficient than pump 2
Instrumentation - SCADA, alarms	2	15%	0.30	No SCADA. Floats.
Structure - Hatches, Corrosion, Cracks, Leaking, Ventilation, Odor Control	5	20%	1.00	Complete deterioration of wet well. No safety grate. No lock on hatch.
Piping and Valves	4	15%	0.60	Severe corrosion in well and vault.
Site - Drainage, Access Drive, Security, Fencing	3	10%	0.30	Erosion of gravel drive
Total Inspection Score	-	100%	3.60	
Impact of Work Order Data	-	-	0.00	Below average number of work orders
<b>Condition Rating</b>	-	-	<b>3.60</b>

Condition Rating	Criticality Rating	Overall Risk Rating	Risk Category
<b>Lift Station Risk Rating</b>	<b>3.60</b>	<b>2.75</b>	<b>6.35</b>	<b>High Risk</b>

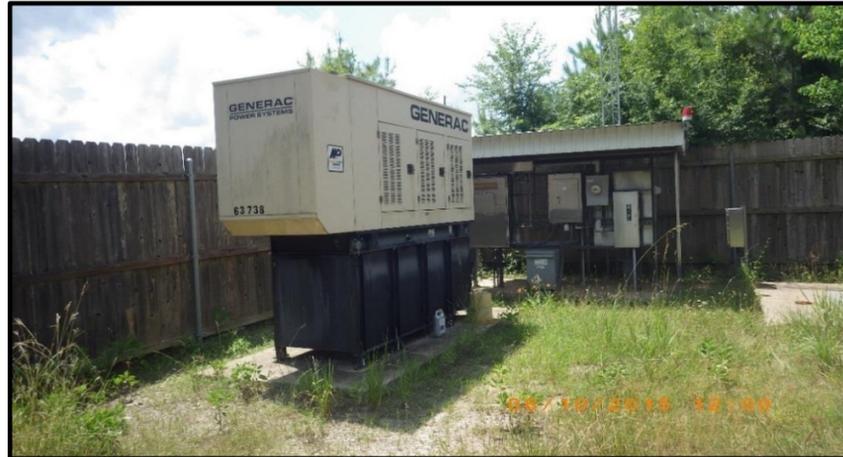
Facility Information	
Address:	260 Rush Rd
Year in Service:	
Type of Facility:	Submersible
Number of Pumps:	2
Firm Capacity:	0.89 MGD @ 103' TDH
Horsepower:	
Monitoring:	SCADA
Generator:	130 kW

Component Group	Component Condition Rating	Weight Factor	Weighted Component Rating	Comments
Electrical – MCC, Back-up Power, Cables	4	20%	0.80	Severe corrosion.
Pumps and Motors	2	20%	0.40	Age
Instrumentation - SCADA, alarms	2	15%	0.30	
Structure - Hatches, Corrosion, Cracks, Leaking, Ventilation, Odor Control	2	20%	0.40	Crane very difficult to operate. No safety grate.
Piping and Valves	2	15%	0.30	Moderate corrosion in wet well.
Site - Drainage, Access Drive, Security, Fencing	2	10%	0.20	Fence needs repair. Needs all weather drive.
Total Inspection Score	-	100%	2.40	
Impact of Work Order Data	-	-	0.00	Below average number of work orders
<b>Condition Rating</b>	-	-	<b>2.40</b>

Condition Rating	Criticality Rating	Overall Risk Rating	Risk Category
<b>Lift Station Risk Rating</b>	<b>2.40</b>	<b>4.00</b>	<b>6.40</b>	<b>High Risk</b>

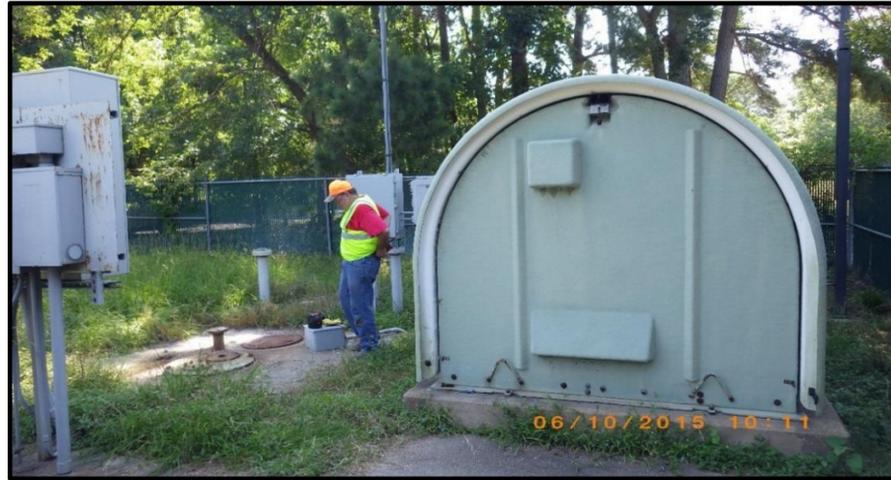
Facility Information	
Address:	214 Brook Hollow Dr
Year in Service:	
Type of Facility:	End Suction (Self Priming)
Number of Pumps:	2
Firm Capacity:	1.08 MGD @ 48' TDH
Horsepower:	50 hp
Monitoring:	SCADA
Generator:	275 kW (Portable)

Component Group	Component Condition Rating	Weight Factor	Weighted Component Rating	Comments
Electrical – MCC, Back-up Power, Cables	3	20%	0.60	Rusting enclosures.
Pumps and Motors	3	20%	0.60	No drawdown observed on pump 1.
Instrumentation - SCADA, alarms	2	15%	0.30	
Structure - Hatches, Corrosion, Cracks, Leaking, Ventilation, Odor Control	3	20%	0.60	24" manhole access. Non-sealing wet well. Visible aggregate.
Piping and Valves	3	15%	0.45	Moderate corrosion in wet well.
Site - Drainage, Access Drive, Security, Fencing	3	10%	0.30	Submerged in wet water. Fencing needs repair.
Total Inspection Score	-	100%	2.85	
Impact of Work Order Data	-	-	0.25	Above average number of work orders
<b>Condition Rating</b>	-	-	<b>3.10</b>

Condition Rating	Criticality Rating	Overall Risk Rating	Risk Category
<b>Lift Station Risk Rating</b>	<b>3.10</b>	<b>3.75</b>	<b>6.85</b>	<b>High Risk</b>

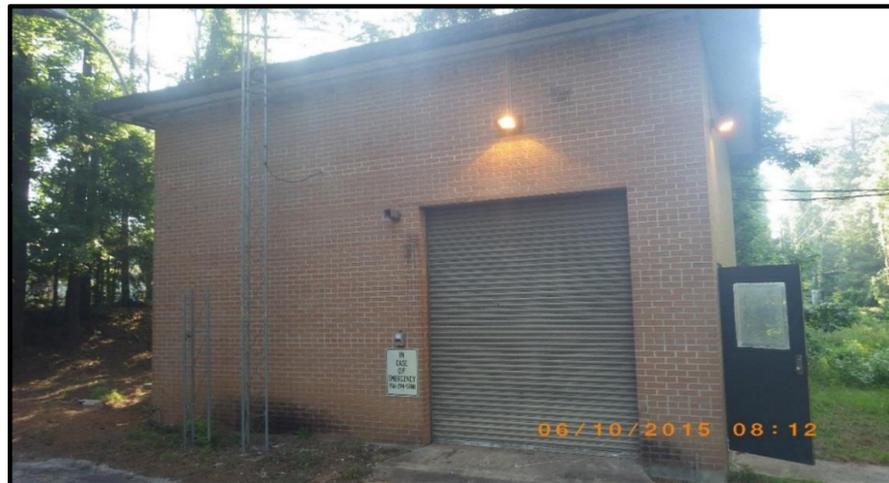
Facility Information	
Address:	1861 Camelia Dr
Year in Service:	1970's
Type of Facility:	End Suction (Self Priming)
Number of Pumps:	2
Firm Capacity:	1.43 MGD
Below average number of work	Above average number of work
Monitoring:	75 hp
Generator:	SCADA
	205 kW

Component Group	Component Condition Rating	Weight Factor	Weighted Component Rating	Comments
Electrical – MCC, Back-up Power, Cables	4	20%	0.80	Motor starters and NTC need to be replaced.
Pumps and Motors	4	20%	0.80	One motor just re-worked. Single pump in operation.
Instrumentation - SCADA, alarms	2	15%	0.30	Concern over classification of inside building.
Structure - Hatches, Corrosion, Cracks, Leaking, Ventilation, Odor Control	3	20%	0.60	Needs ventilation. Some brick deterioration. Rusted hoist support beam. Wet well 24" manhole access with no functioning ladder. No coating on wet well.
Piping and Valves	4	15%	0.60	Age. Check valve 1 not working. Isolation valves not working. Moderate corrosion of piping in wet well.
Site - Drainage, Access Drive, Security, Fencing	2	10%	0.20	
Total Inspection Score	-	100%	3.30	
Impact of Work Order Data	-	-	0.25	Above average number of work orders
<b>Condition Rating</b>	-	-	<b>3.55</b>

Condition Rating	Criticality Rating	Overall Risk Rating	Risk Category
<b>Lift Station Risk Rating</b>	<b>3.55</b>	<b>4.00</b>	<b>7.55</b>	<b>Extreme Risk</b>

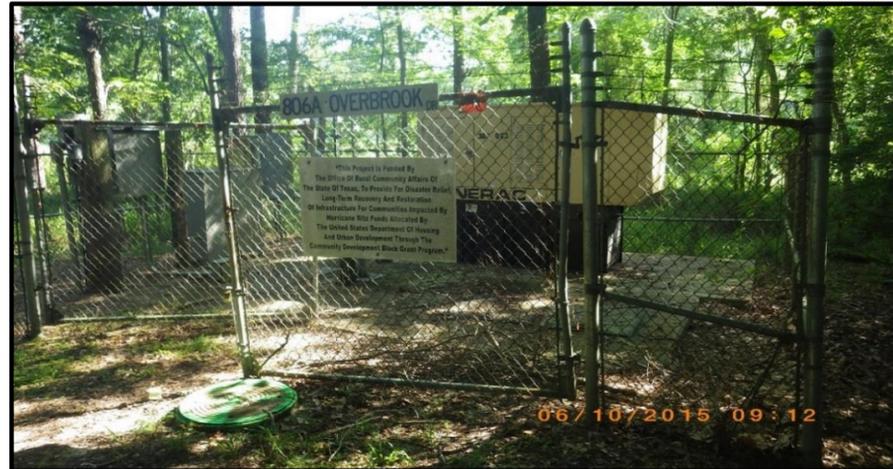
Facility Information	
Address:	806A Overbrook Dr
Year in Service:	
Type of Facility:	Submersible
Number of Pumps:	2
Firm Capacity:	
Horsepower:	
Monitoring:	SCADA
Generator:	40 kW

Component Group	Component Condition Rating	Weight Factor	Weighted Component Rating	Comments
Electrical – MCC, Back-up Power, Cables	4	20%	0.80	Control panel and phase shift needs to be replaced.
Pumps and Motors	3	20%	0.60	Age. Pump rail deterioration. No pump chains.
Instrumentation - SCADA, alarms	2	15%	0.30	No SCADA. Floats.
Structure - Hatches, Corrosion, Cracks, Leaking, Ventilation, Odor Control	4	20%	0.80	Severe rusting and corrosion of hatches; needs replacement. Valve vault holding water. Wet well needs rehab.
Piping and Valves	4	15%	0.60	Heavy corrosion in wet well. Isolation valves not working.
Site - Drainage, Access Drive, Security, Fencing	4	10%	0.40	Site submerged in large May rain event. Needs driveway improvements and lighting. May need wood fence due to future homes expected on nearby lots.
Total Inspection Score	-	100%	3.50	
Impact of Work Order Data	-	-	0.00	Below average number of work orders

Condition Rating	Criticality Rating	Overall Risk Rating	Risk Category
<b>Lift Station Risk Rating</b>	<b>3.50</b>	<b>3.25</b>	<b>6.75</b>	<b>High Risk</b>

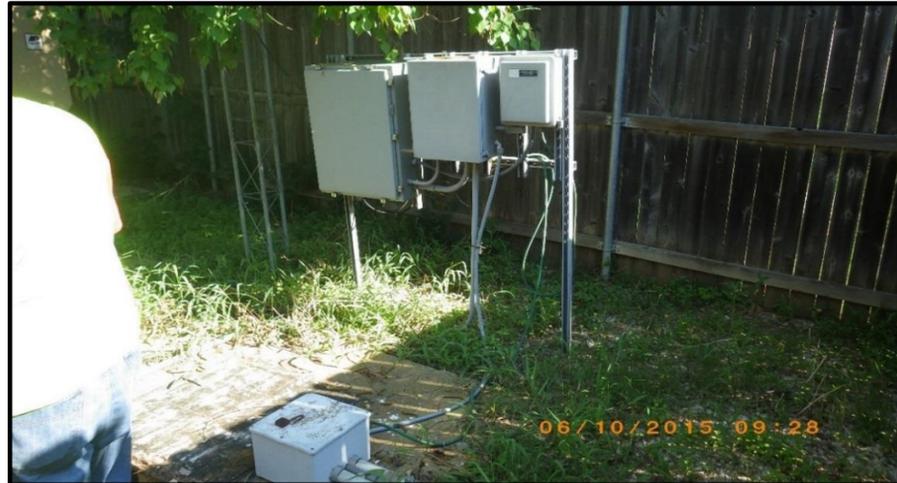
Facility Information	
Address:	833A Overbrook Dr
Year in Service:	
Type of Facility:	Submersible
Number of Pumps:	2
Firm Capacity:	
Horsepower:	15 hp
Monitoring:	SCADA
Generator:	100 kW

Component Group	Component Condition Rating	Weight Factor	Weighted Component Rating	Comments
Electrical – MCC, Back-up Power, Cables	3	20%	0.60	
Pumps and Motors	3	20%	0.60	Age
Instrumentation - SCADA, alarms	2	15%	0.30	
Structure - Hatches, Corrosion, Cracks, Leaking, Ventilation, Odor Control	4	20%	0.80	Circumferential crack in wet well; evidence of I/I. Heavy corrosion of wet well cover.
Piping and Valves	4	15%	0.60	Moderate corrosion in wet well. Age. Check valves and plug valves need to be replaced.
Site - Drainage, Access Drive, Security, Fencing	2	10%	0.20	Needs gravel drive. No lighting.
Total Inspection Score	-	100%	3.10	
Impact of Work Order Data	-	-	0.25	Above average number of work orders
<b>Condition Rating</b>	-	-	<b>3.35</b>

Condition Rating	Criticality Rating	Overall Risk Rating	Risk Category
<b>Lift Station Risk Rating</b>	<b>3.35</b>	<b>2.75</b>	<b>6.10</b>	<b>High Risk</b>

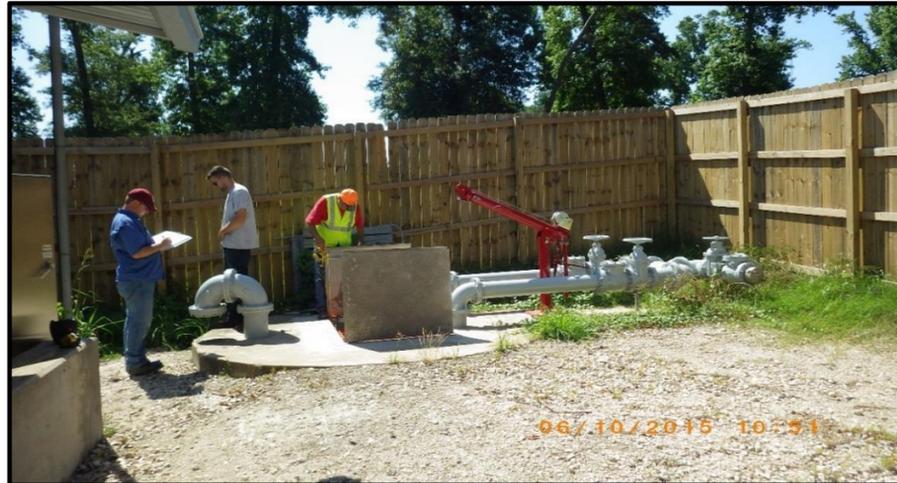
Facility Information	
Address:	638 Cherry Hills Dr
Year in Service:	
Type of Facility:	Submersible
Number of Pumps:	2
Firm Capacity:	1.22 MGD
Horsepower:	
Monitoring:	SCADA
Generator:	100 kW

Component Group	Component Condition Rating	Weight Factor	Weighted Component Rating	Comments
Electrical – MCC, Back-up Power, Cables	3	20%	0.60	40 Volt panel is old.
Pumps and Motors	1	20%	0.20	New.
Instrumentation - SCADA, alarms	2	15%	0.30	
Structure - Hatches, Corrosion, Cracks, Leaking, Ventilation, Odor Control	1	20%	0.20	
Piping and Valves	1	15%	0.15	
Site - Drainage, Access Drive, Security, Fencing	1	10%	0.10	Site needs lighting.
Total Inspection Score	-	100%	1.55	
Impact of Work Order Data	-	-	0.00	Below average number of work orders
<b>Condition Rating</b>	-	-	<b>1.55</b>

Condition Rating	Criticality Rating	Overall Risk Rating	Risk Category
<b>Lift Station Risk Rating</b>	1.55	3.75	5.30	Moderate Risk

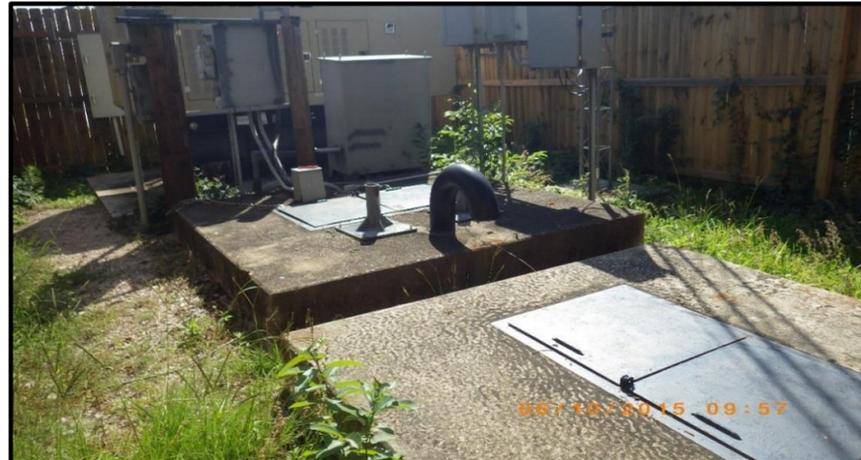
Facility Information	
Address:	1440 River Oaks Dr
Year in Service:	
Type of Facility:	Submersible
Number of Pumps:	2
Firm Capacity:	0.86 MGD @ 60' TDH
Horsepower:	
Monitoring:	SCADA
Generator:	135 kW

Component Group	Component Condition Rating	Weight Factor	Weighted Component Rating	Comments
Electrical – MCC, Back-up Power, Cables	4	20%	0.80	Control panel needs to be replaced.
Pumps and Motors	2	20%	0.40	Age
Instrumentation - SCADA, alarms	2	15%	0.30	
Structure - Hatches, Corrosion, Cracks, Leaking, Ventilation, Odor Control	3	20%	0.60	Hatches need to be replaced. Needs new liner in wet well.
Piping and Valves	3	15%	0.45	Heavy corrosion in wet well. Age.
Site - Drainage, Access Drive, Security, Fencing	1	10%	0.10	Needs security lighting.
Total Inspection Score	-	100%	2.65	
Impact of Work Order Data	-	-	0.00	Below average number of work orders
<b>Condition Rating</b>	-	-	<b>2.65</b>

Condition Rating	Criticality Rating	Overall Risk Rating	Risk Category
<b>Lift Station Risk Rating</b>	<b>2.65</b>	<b>3.75</b>	<b>6.40</b>	<b>High Risk</b>

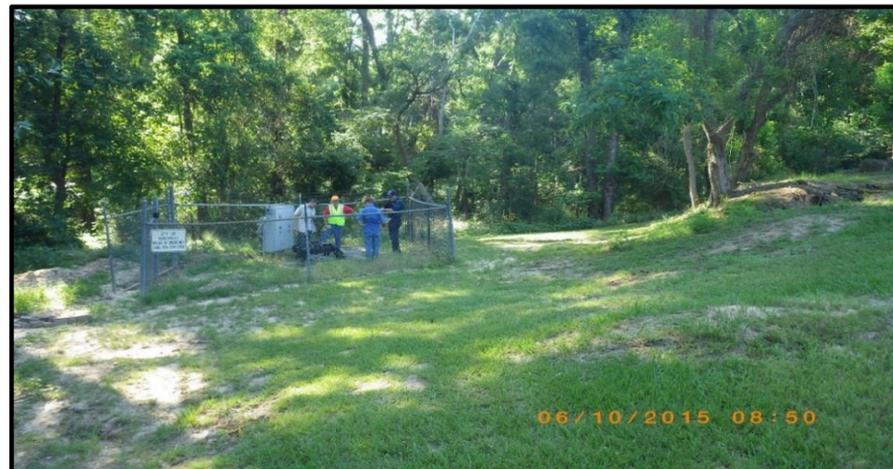
<u>Facility Information</u>	
Address:	1933 Greentree Dr
Year in Service:	
Type of Facility:	Submersible
Number of Pumps:	2
Firm Capacity:	0.22 MGD @ 40' TDH
Horsepower:	5 hp?
Monitoring:	No SCADA
Generator:	Installation Pending

Component Group	Component Condition Rating	Weight Factor	Weighted Component Rating	Comments
Electrical – MCC, Back-up Power, Cables	4	20%	0.80	Water has infiltrated holes in cabinet; rusting.
Pumps and Motors	4	20%	0.80	No rails. Must pull pumps with discharge pipe. One pump not working well.
Instrumentation - SCADA, alarms	3	15%	0.45	Floats. No SCADA.
Structure - Hatches, Corrosion, Cracks, Leaking, Ventilation, Odor Control	3	20%	0.60	No coating on wet well. Unsafe access hatch.
Piping and Valves	2	15%	0.30	Age.
Site - Drainage, Access Drive, Security, Fencing	4	10%	0.40	Site submerged in large May 2015 rain event. Driveway in poor condition. Fence violates TCEQ requirements. Needs lighting.
Total Inspection Score	-	100%	3.35	
Impact of Work Order Data	-	-	0.00	Below average number of work orders
<b>Condition Rating</b>	-	-	<b>3.35</b>

Condition Rating	Criticality Rating	Overall Risk Rating	Risk Category
<b>Lift Station Risk Rating</b>	<b>3.35</b>	<b>3.50</b>	<b>6.85</b>	<b>High Risk</b>

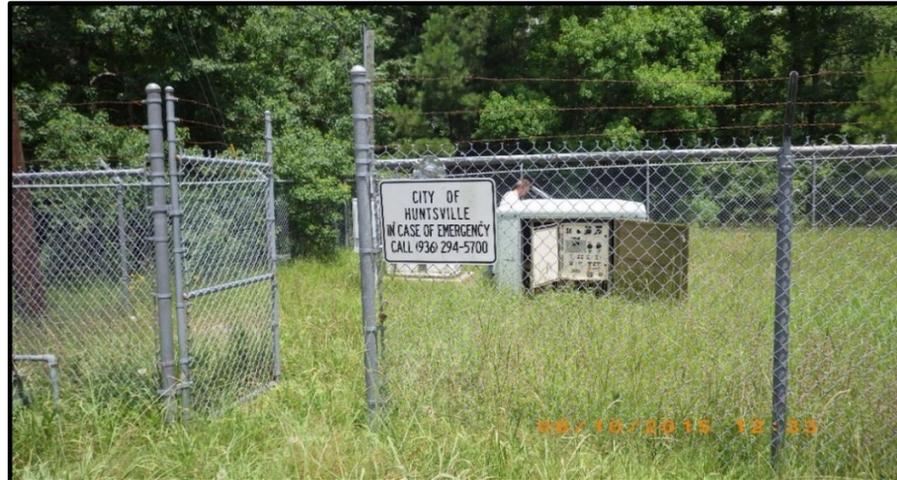
Facility Information	
Address:	202A Graham Rd
Year in Service:	
Type of Facility:	Submersible
Number of Pumps:	2
Firm Capacity:	
Horsepower:	
Monitoring:	No SCADA
Generator:	10 kW

Component Group	Component Condition Rating	Weight Factor	Weighted Component Rating	Comments
Electrical – MCC, Back-up Power, Cables	3	20%	0.60	Age
Pumps and Motors	2	20%	0.40	Age
Instrumentation - SCADA, alarms	3	15%	0.45	Age. Bubbler.
Structure - Hatches, Corrosion, Cracks, Leaking, Ventilation, Odor Control	3	20%	0.60	Wet well wall needs coating. Pump rails deteriorating.
Piping and Valves	3	15%	0.45	Heavy corrosion in wet well.
Site - Drainage, Access Drive, Security, Fencing	2	10%	0.20	Drive needs gravel touch up.
Total Inspection Score	-	100%	2.70	
Impact of Work Order Data	-	-	0.00	Below average number of work orders
<b>Condition Rating</b>	-	-	<b>2.70</b>

Condition Rating	Criticality Rating	Overall Risk Rating	Risk Category
<b>Lift Station Risk Rating</b>	<b>2.70</b>	<b>2.50</b>	<b>5.20</b>	<b>Moderate Risk</b>

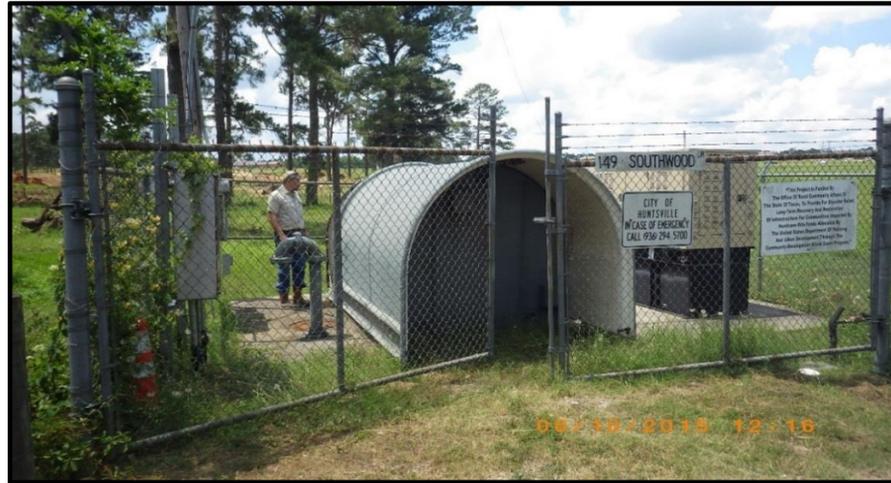
Facility Information	
Address:	1149 Southwood Dr
Year in Service:	
Type of Facility:	End Suction (Self Priming)
Number of Pumps:	2
Firm Capacity:	0.36 MGD @ 60' TDH
Horsepower:	10 hp
Monitoring:	SCADA
Generator:	40 kW

Component Group	Component Condition Rating	Weight Factor	Weighted Component Rating	Comments
Electrical – MCC, Back-up Power, Cables	2	20%	0.40	
Pumps and Motors	2	20%	0.40	*Were not able to run pumps due to downstream construction.
Instrumentation - SCADA, alarms	2	15%	0.30	
Structure - Hatches, Corrosion, Cracks, Leaking, Ventilation, Odor Control	3	20%	0.60	24" manhole access. Tree root intrusion near invert due to poor seal. Wet well has fiberglass liner.
Piping and Valves	2	15%	0.30	Moderate corrosion on force main in wet well.
Site - Drainage, Access Drive, Security, Fencing	1	10%	0.10	
Total Inspection Score	-	100%	2.10	
Impact of Work Order Data	-	-	0.00	Below average number of work orders
<b>Condition Rating</b>	-	-	<b>2.10</b>

Condition Rating	Criticality Rating	Overall Risk Rating	Risk Category
<b>Lift Station Risk Rating</b>	<b>2.10</b>	<b>0.75</b>	<b>2.85</b>	<b>Low Risk</b>

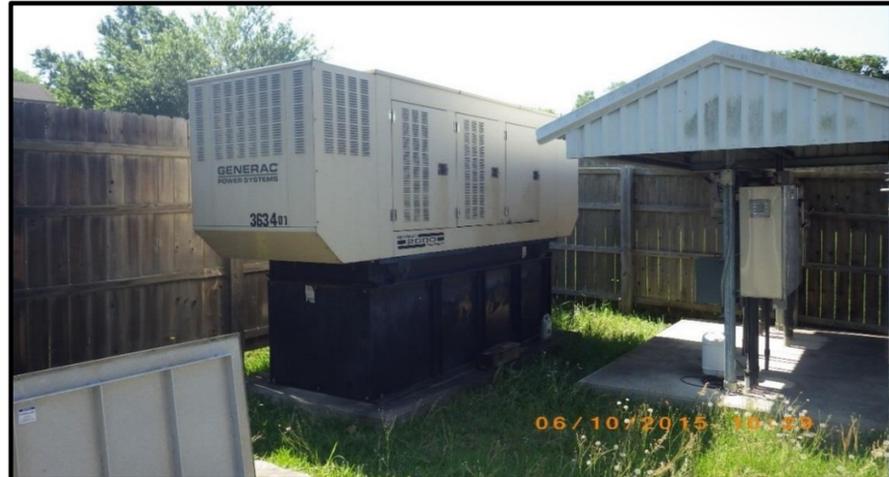
Facility Information	
Address:	294 Brook Hollow Dr
Year in Service:	
Type of Facility:	Submersible
Number of Pumps:	2
Firm Capacity:	1.21 MGD @ 85' TDH
Horsepower:	36 hp
Monitoring:	SCADA
Generator:	130 kW

Component Group	Component Condition Rating	Weight Factor	Weighted Component Rating	Comments
Electrical – MCC, Back-up Power, Cables	1	20%	0.20	
Pumps and Motors	2	20%	0.40	No issues. Age.
Instrumentation - SCADA, alarms	1	15%	0.15	
Structure - Hatches, Corrosion, Cracks, Leaking, Ventilation, Odor Control	3	20%	0.60	Hoist needs improvements. Wet well needs coating. Ladder safety issues (needs hand rail).
Piping and Valves	3	15%	0.45	Moderate corrosion in wet well.
Site - Drainage, Access Drive, Security, Fencing	1	10%	0.10	Site needs lighting.
Total Inspection Score	-	100%	1.90	
Impact of Work Order Data	-	-	0.00	Below average number of work orders
<b>Condition Rating</b>	-	-	<b>1.90</b>

Condition Rating	Criticality Rating	Overall Risk Rating	Risk Category
<b>Lift Station Risk Rating</b>	<b>1.90</b>	<b>4.00</b>	<b>5.90</b>	<b>High Risk</b>

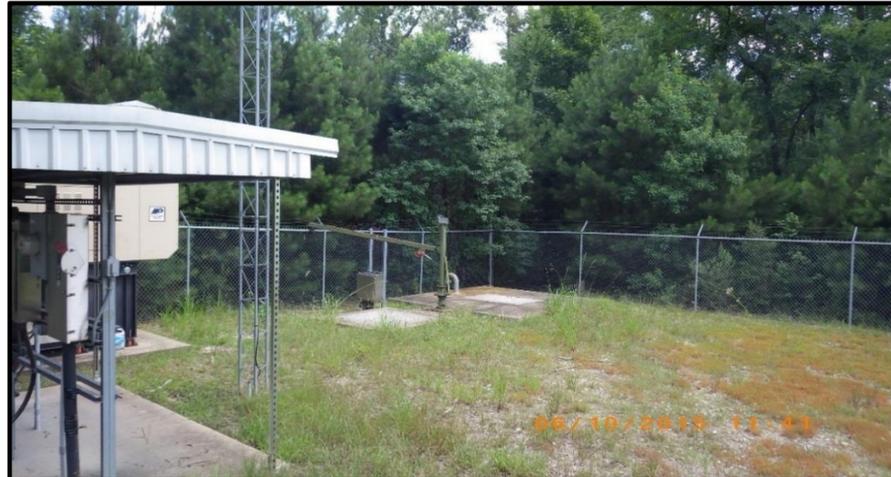
Facility Information	
Address:	7757 SH 75 S
Year in Service:	
Type of Facility:	Submersible
Number of Pumps:	2
Firm Capacity:	
Horsepower:	36 hp
Monitoring:	SCADA
Generator:	130 kW

Component Group	Component Condition Rating	Weight Factor	Weighted Component Rating	Comments
Electrical – MCC, Back-up Power, Cables	2	20%	0.40	
Pumps and Motors	2	20%	0.40	Age
Instrumentation - SCADA, alarms	2	15%	0.30	
Structure - Hatches, Corrosion, Cracks, Leaking, Ventilation, Odor Control	2	20%	0.40	No safety grate.
Piping and Valves	3	15%	0.45	Moderate corrosion in wet well.
Site - Drainage, Access Drive, Security, Fencing	3	10%	0.30	Grate proximity to road.
Total Inspection Score	-	100%	2.25	
Impact of Work Order Data	-	-	0.00	Below average number of work orders
<b>Condition Rating</b>	-	-	<b>2.25</b>

Condition Rating	Criticality Rating	Overall Risk Rating	Risk Category
<b>Lift Station Risk Rating</b>	<b>2.25</b>	<b>3.25</b>	<b>5.50</b>	<b>Moderate Risk</b>

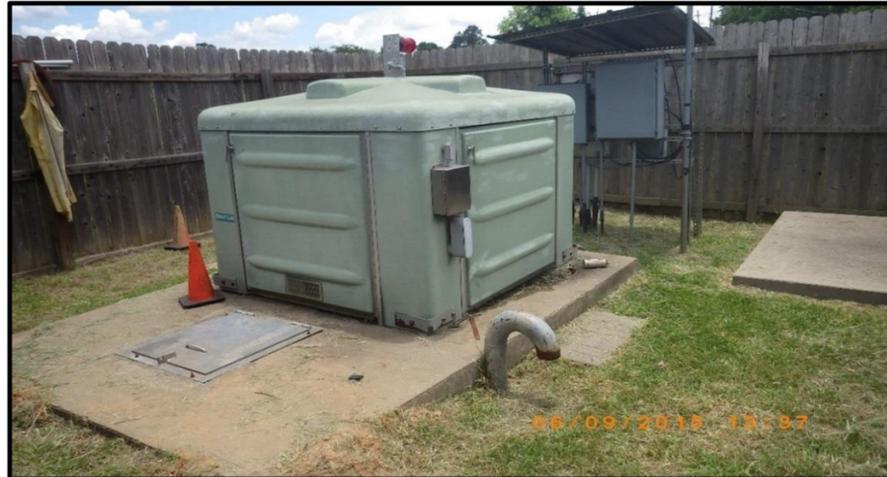
Facility Information	
Address:	5060 Sam Houston Ave
Year in Service:	
Type of Facility:	End Suction (Self Priming)
Number of Pumps:	2
Firm Capacity:	0.34 MGD @ 55' TDH
Horsepower:	3 hp
Monitoring:	SCADA
Generator:	40 kW

Component Group	Component Condition Rating	Weight Factor	Weighted Component Rating	Comments
Electrical – MCC, Back-up Power, Cables	1	20%	0.20	
Pumps and Motors	2	20%	0.40	High return volume into wet well.
Instrumentation - SCADA, alarms	1	15%	0.15	
Structure - Hatches, Corrosion, Cracks, Leaking, Ventilation, Odor Control	2	20%	0.40	Some possible slab undermining.
Piping and Valves	2	15%	0.30	Age. Light corrosion.
Site - Drainage, Access Drive, Security, Fencing	3	10%	0.30	Fence does not meet current TCEQ standards. Enclosure locks do not work.
Total Inspection Score	-	100%	1.75	
Impact of Work Order Data	-	-	0.00	Below average number of work orders
<b>Condition Rating</b>	-	-	<b>1.75</b>

Condition Rating	Criticality Rating	Overall Risk Rating	Risk Category
<b>Lift Station Risk Rating</b>	1.75	3.50	5.25	<b>Moderate Risk</b>

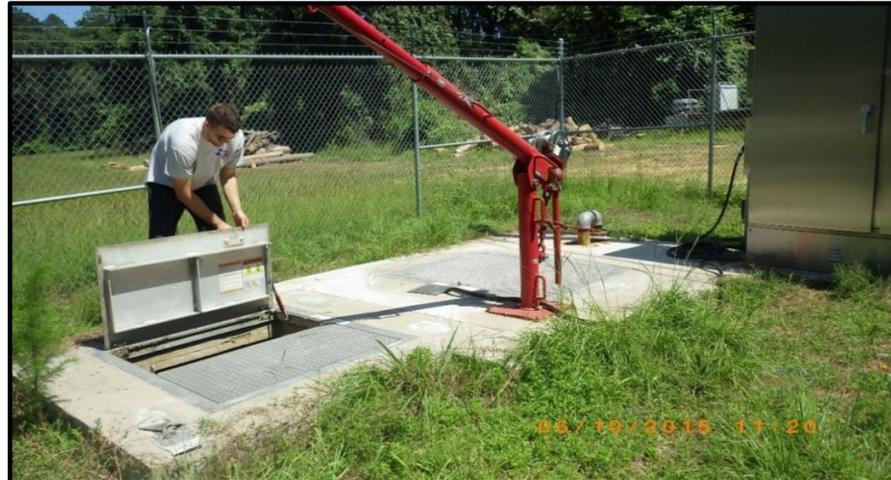
Facility Information	
Address:	142 State Park Maint. Rd
Year in Service:	
Type of Facility:	Submersible
Number of Pumps:	2
Firm Capacity:	
Horsepower:	
Monitoring:	No SCADA
Generator:	150 kW

Component Group	Component Condition Rating	Weight Factor	Weighted Component Rating	Comments
Electrical – MCC, Back-up Power, Cables	2	20%	0.40	
Pumps and Motors	2	20%	0.40	Age
Instrumentation - SCADA, alarms	2	15%	0.30	
Structure - Hatches, Corrosion, Cracks, Leaking, Ventilation, Odor Control	3	20%	0.60	Wet well coating needs repair.
Piping and Valves	3	15%	0.45	Wet well piping has heavy corrosion.
Site - Drainage, Access Drive, Security, Fencing	1	10%	0.10	Site needs lighting.
Total Inspection Score	-	100%	2.25	
Impact of Work Order Data	-	-	0.00	Below average number of work orders
<b>Condition Rating</b>	-	-	<b>2.25</b>

Condition Rating	Criticality Rating	Overall Risk Rating	Risk Category
<b>Lift Station Risk Rating</b>	<b>2.25</b>	<b>3.25</b>	<b>5.50</b>	<b>Moderate Risk</b>

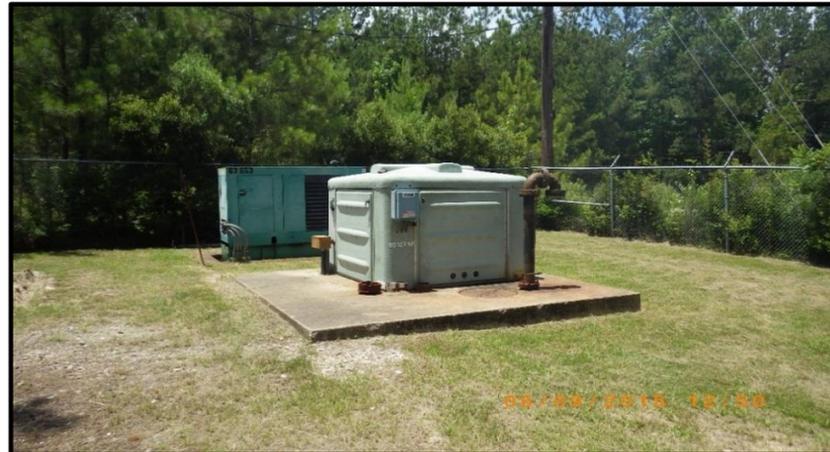
Facility Information	
Address:	219 Bearkat Blvd
Year in Service:	
Type of Facility:	End Suction (Self Priming)
Number of Pumps:	2
Firm Capacity:	0.63 MGD @ 85' TDH
Horsepower:	25 hp
Monitoring:	SCADA
Generator:	100 kW

Component Group	Component Condition Rating	Weight Factor	Weight Factor	Comments
Electrical – MCC, Back-up Power, Cables	3	20%	0.60	Corrosion (transfer switches)
Pumps and Motors	2	20%	0.40	Rags. Pump 1 serviced one year ago. Pump 2 not meeting current demands.
Instrumentation - SCADA, alarms	2	15%	0.30	
Structure - Hatches, Corrosion, Cracks, Leaking, Ventilation, Odor Control	2	20%	0.40	24" manhole access
Piping and Valves	4	15%	0.60	Check valve on Pump 1 leaking. Heavy corrosion on wet well piping. Cross brace holding up force main in wet well, collecting rags and debris.
Site - Drainage, Access Drive, Security, Fencing	2	10%	0.20	Gravel drive.
Total Inspection Score	-	100%	2.50	
Impact of Work Order Data	-	-	0.25	Above average number of work orders
<b>Condition Rating</b>	-	-	<b>2.75</b>

Condition Rating	Criticality Rating	Overall Risk Rating	Risk Category
<b>Lift Station Risk Rating</b>	<b>2.75</b>	<b>4.25</b>	<b>7.00</b>	<b>High Risk</b>

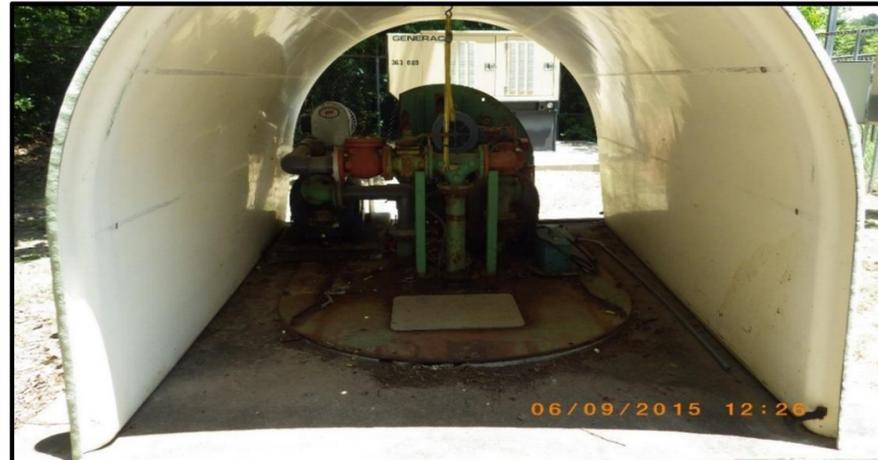
<u>Facility Information</u>	
Address:	631 SH 190
Year in Service:	
Type of Facility:	End Suction (Self Priming)
Number of Pumps:	2
Firm Capacity:	0.29 MGD @ 32' TDH
Horsepower:	7.5 hp
Monitoring:	No SCADA
Generator:	30 kW

Component Group	Component Condition Rating	Weight Factor	Weighted Component Rating	Comments
Electrical – MCC, Back-up Power, Cables	3	20%	0.60	Panel aging.
Pumps and Motors	3	20%	0.60	Some rags. Motors less than two years old. Age. Pump No. 2 not priming (waiting on a part).
Instrumentation - SCADA, alarms	1	15%	0.15	Floats. No SCADA.
Structure - Hatches, Corrosion, Cracks, Leaking, Ventilation, Odor Control	2	20%	0.40	Non-locking steel cover.
Piping and Valves	3	15%	0.45	Some leaking of pipe. Moderate corrosion in wet well.
Site - Drainage, Access Drive, Security, Fencing	2	10%	0.20	Fence damage. Slight grade to wet well.
Total Inspection Score	-	100%	2.40	
Impact of Work Order Data	-	-	0.25	Above average number of work orders
<b>Condition Rating</b>	-	-	<b>2.65</b>

Condition Rating	Criticality Rating	Overall Risk Rating	Risk Category
<b>Lift Station Risk Rating</b>	<b>2.65</b>	<b>4.00</b>	<b>6.65</b>	<b>High Risk</b>

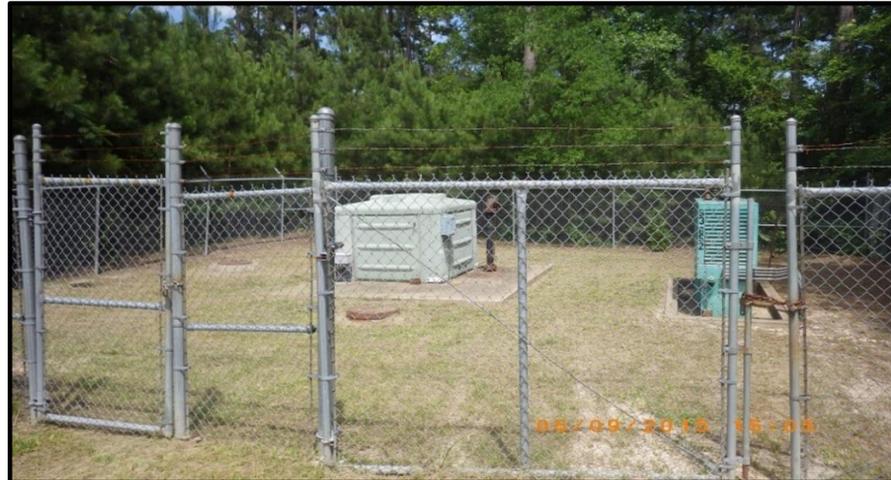
Facility Information	
Address:	414 SH 19
Year in Service:	
Type of Facility:	End Suction (Self Priming)
Number of Pumps:	2
Firm Capacity:	0.35 MGD @ 50' TDH
Horsepower:	5 hp
Monitoring:	SCADA
Generator:	40 kW

Component Group	Component Condition Rating	Weight Factor	Weighted Component Rating	Comments
Electrical – MCC, Back-up Power, Cables	3	20%	0.60	Enclosure rack leaning. Rust on ATS door.
Pumps and Motors	2	20%	0.40	Pump 1 not draining wet well at all. Flapper on order.
Instrumentation - SCADA, alarms	1	15%	0.15	
Structure - Hatches, Corrosion, Cracks, Leaking, Ventilation, Odor Control	2	20%	0.40	24" access manhole. No coating on wet well.
Piping and Valves	3	15%	0.45	Moderate Corrosion in wet well. Piping delaminating in wet well.
Site - Drainage, Access Drive, Security, Fencing	1	10%	0.10	
Total Inspection Score	-	100%	2.10	
Impact of Work Order Data	-	-	0.25	Above average number of work orders
<b>Condition Rating</b>	-	-	<b>2.35</b>

Condition Rating	Criticality Rating	Overall Risk Rating	Risk Category
<b>Lift Station Risk Rating</b>	<b>2.35</b>	<b>4.00</b>	<b>6.35</b>	<b>High Risk</b>

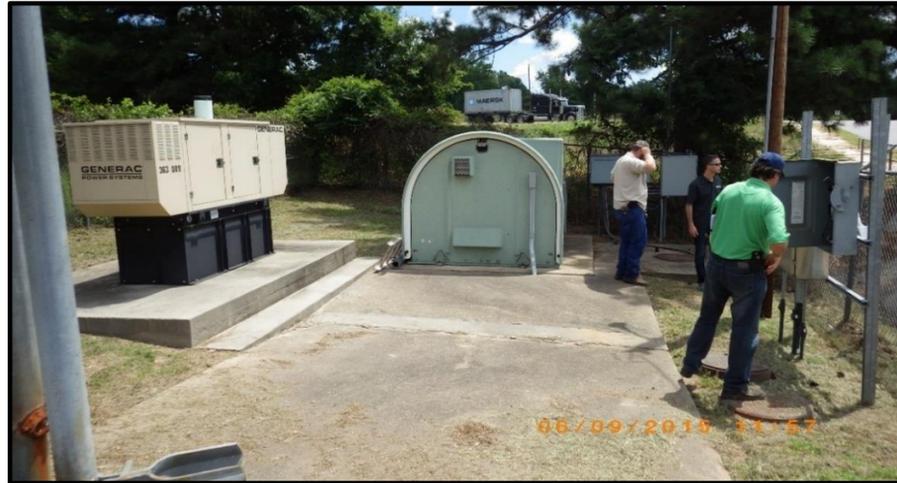
Facility Information	
Address:	919 Old Colony Rd
Year in Service:	25+
Type of Facility:	End Suction (Self Priming)
Number of Pumps:	2
Firm Capacity:	0.22 MGD @ 28.4' TDH
Horsepower:	5 hp
Monitoring:	SCADA
Generator:	30 kW

Component Group	Component Condition Rating	Weight Factor	Weighted Component Rating	Comments
Electrical – MCC, Back-up Power, Cables	4	20%	0.80	Pump control panel in poor condition due to age.
Pumps and Motors	3	20%	0.60	Two and three year old motors. Age/wear on pumps.
Instrumentation - SCADA, alarms	2	15%	0.30	
Structure - Hatches, Corrosion, Cracks, Leaking, Ventilation, Odor Control	4	20%	0.80	24" manhole access. Heavy corrosion on wet well. Wall deterioration. Fiberglass enclosure does not fully open.
Piping and Valves	4	15%	0.60	Heavy corrosion. Check valve 1 not operational. No vent pipe.
Site - Drainage, Access Drive, Security, Fencing	4	10%	0.40	complete submersion during recent heavy rain event. Low lying area close proximity to drainage ditch.
Total Inspection Score	-	100%	3.50	
Impact of Work Order Data	-	-	0.25	Above average number of work orders
<b>Condition Rating</b>	-	-	<b>3.75</b>

Condition Rating	Criticality Rating	Overall Risk Rating	Risk Category
<b>Lift Station Risk Rating</b>	<b>3.75</b>	<b>4.00</b>	<b>7.75</b>	<b>Extreme Risk</b>

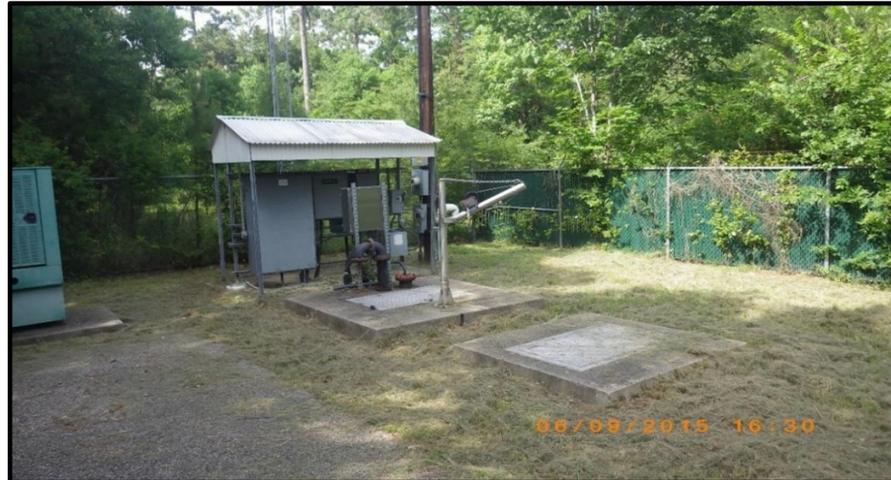
Facility Information	
Address:	3021 Simmons St
Year in Service:	
Type of Facility:	Submersible
Number of Pumps:	
Firm Capacity:	
Horsepower:	15 hp
Monitoring:	SCADA
Generator:	50 kW

Component Group	Component Condition Rating	Weight Factor	Weighted Component Rating	Comments
Electrical – MCC, Back-up Power, Cables	3	20%	0.60	Power line in trees.
Pumps and Motors	2	20%	0.40	Age. Not new but no issues.
Instrumentation - SCADA, alarms	2	15%	0.30	
Structure - Hatches, Corrosion, Cracks, Leaking, Ventilation, Odor Control	2	20%	0.40	Wet well coating needs touch up.
Piping and Valves	3	15%	0.45	Moderate corrosion in wet well and valve vault.
Site - Drainage, Access Drive, Security, Fencing	2	10%	0.20	Overgrowth on fence.
Total Inspection Score	-	100%	2.35	
Impact of Work Order Data	-	-	0.00	Below average number of work orders
<b>Condition Rating</b>	-	-	<b>2.35</b>

Condition Rating	Criticality Rating	Overall Risk Rating	Risk Category
<b>Lift Station Risk Rating</b>	<b>2.35</b>	<b>3.50</b>	<b>5.85</b>	<b>High Risk</b>

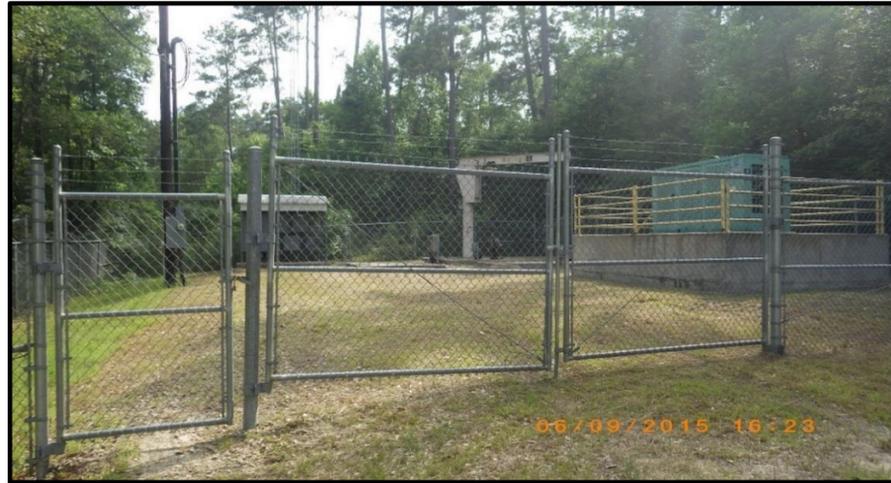
Facility Information	
Address:	1489 Fish Hatchery Rd
Year in Service:	
Type of Facility:	Submersible
Number of Pumps:	2
Firm Capacity:	2.59 MGD @ 90' TDH
Horsepower:	65 hp
Monitoring:	
Generator:	175 kW

Component Group	Component Condition Rating	Weight Factor	Weighted Component Rating	Comments
Electrical – MCC, Back-up Power, Cables	2	20%	0.40	
Pumps and Motors	2	20%	0.40	Pump 2 observed 20% deficiency compared to Pump 1. One pump is new and the other is re-built.
Instrumentation - SCADA, alarms	2	15%	0.30	
Structure - Hatches, Corrosion, Cracks, Leaking, Ventilation, Odor Control	2	20%	0.40	Structure in good condition overall.
Piping and Valves	2	15%	0.30	Moderate corrosion in wet well.
Site - Drainage, Access Drive, Security, Fencing	2	10%	0.20	Driveway needs touch up. No turn around.
Total Inspection Score	-	100%	2.00	
Impact of Work Order Data	-	-	0.25	Above average number of work orders
<b>Condition Rating</b>	-	-	<b>2.25</b>

Condition Rating	Criticality Rating	Overall Risk Rating	Risk Category
<b>Lift Station Risk Rating</b>	<b>2.25</b>	<b>3.50</b>	<b>5.75</b>	<b>Moderate Risk</b>
