## **APPENDIX C**

### **Water System Field Testing Results**

**PROJECT:** Water and Wastewater Condition and Capacity Assessment Studies  
Spring Lake Water Plant Pump Testing

### Water and Wastewater System Condition and Capacity Studies

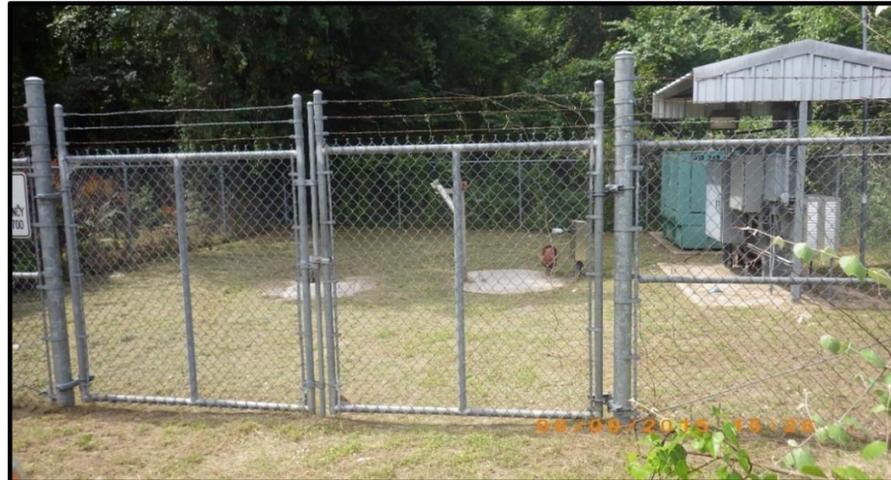
Facility Information	
Address:	110 Sims Ln
Year in Service:	
Type of Facility:	Submersible
Number of Pumps:	2
Firm Capacity:	
Horsepower:	15 hp
Monitoring:	
Generator:	50 kW

Component Group	Component Condition Rating	Weight Factor	Weighted Component Rating	Comments
Electrical – MCC, Back-up Power, Cables	4	20%	0.80	ATS needs work. Phase maker unavailable.
Pumps and Motors	2	20%	0.40	Age
Instrumentation - SCADA, alarms	2	15%	0.30	
Structure - Hatches, Corrosion, Cracks, Leaking, Ventilation, Odor Control	2	20%	0.40	No coating on wet well. Non-sealing hatch.
Piping and Valves	2	15%	0.30	Light corrosion in wet well.
Site - Drainage, Access Drive, Security, Fencing	4	10%	0.40	Graded across wet well. One inch rain causes site to submerge.
Total Inspection Score	-	100%	2.60	
Impact of Work Order Data	-	-	0.25	Above average number of work orders
<b>Condition Rating</b>	-	-	<b>2.85</b>

Condition Rating	Criticality Rating	Overall Risk Rating	Risk Category
<b>Lift Station Risk Rating</b>	<b>2.85</b>	<b>3.25</b>	<b>6.10</b>	<b>High Risk</b>

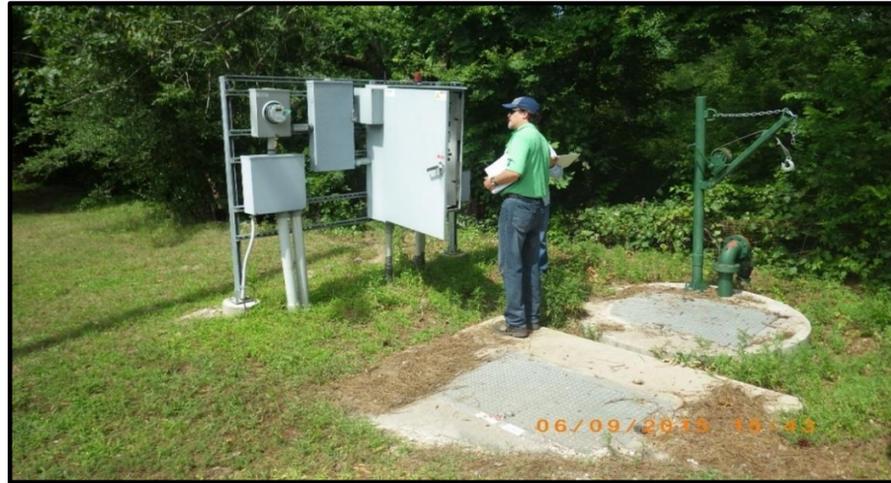
Facility Information	
Address:	2319 Badger Ln
Year in Service:	Approx. 5
Type of Facility:	Submersible
Number of Pumps:	2
Firm Capacity:	
Horsepower:	7.5 hp
Monitoring:	No SCADA
Generator:	No Generator

Component Group	Component Condition Rating	Weight Factor	Weighted Component Rating	Comments
Electrical – MCC, Back-up Power, Cables	1	20%	0.20	
Pumps and Motors	1	20%	0.20	New pumps within last 5 years.
Instrumentation - SCADA, alarms	1	15%	0.15	
Structure - Hatches, Corrosion, Cracks, Leaking, Ventilation, Odor Control	2	20%	0.40	Non-sealing valve vault and wet well hatches.
Piping and Valves	2	15%	0.30	Light corrosion in wet well.
Site - Drainage, Access Drive, Security, Fencing	3	10%	0.30	Some grade across wet well. No fence and hatches unlocked.
Total Inspection Score	-	100%	1.55	
Impact of Work Order Data	-	-	0.00	Below average number of work orders
<b>Condition Rating</b>	-	-	<b>1.55</b>

Condition Rating	Criticality Rating	Overall Risk Rating	Risk Category
<b>Lift Station Risk Rating</b>	1.55	3.50	5.05	Moderate Risk
